# Corangamite Shire

## MUNICIPAL FLOOD EMERGENCY PLAN

A Sub-Plan of the Municipal Emergency  
Management Plan

MFEP Version 3.0 October 2020

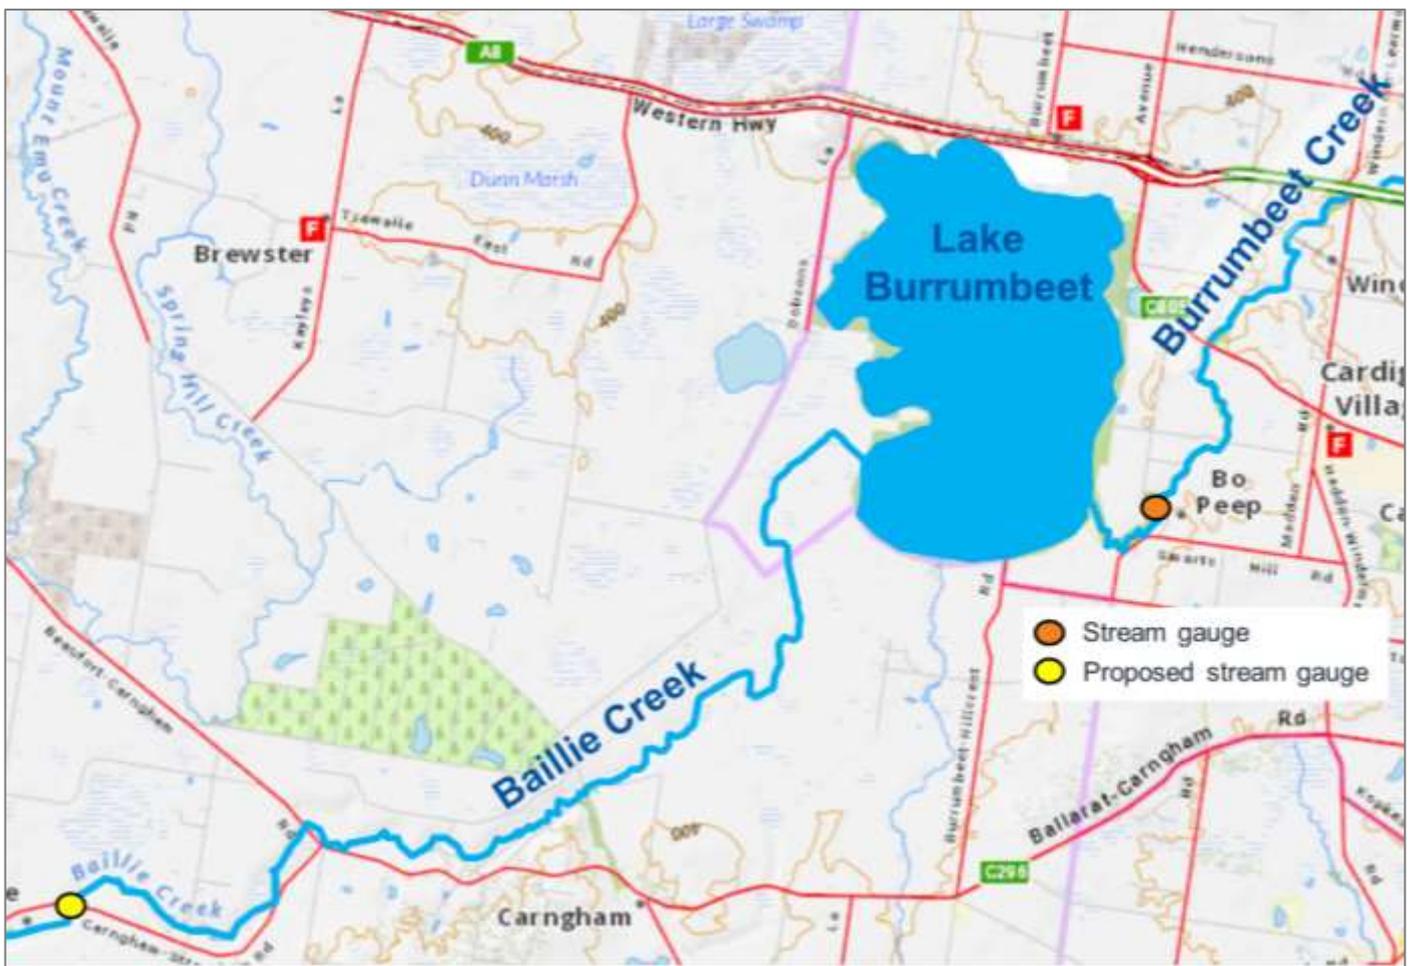
Figure 2. Lake Burrumbeet.

When Lake Burrumbeet is full water can spill into Baillie Creek. During historic flood events, Lake Burrumbeet has contributed significant flows to Mt. Emu Creek via Baillie Creek. Hydraulic modelling undertaken as part of the Skipton Flood Investigation (Water Technology 2020) demonstrated that spills from Lake Burrumbeet cause a 10 cm increase in flood level at Skipton. Modelling of a 1 in 100 AEP flood event, when Lake Burrumbeet's initial storage level was empty, shows the outflow of Lake Burrumbeet of 864 ML/d. This was found to be negligible when compared to the broader Mt. Emu Creek flow, 2% of the total peak flow. This occurred 40 hours after Skipton reached its peak flow. When Lake Burrumbeet was assumed full, much larger flows spilled to Baillie Creek, causing an increase of 2,592 ML/d in peak flow at Skipton, 6% of the total peak flow. This corresponds to a 10 cm increase in flood level.

Currently there is no stream gauge monitoring available to measure Lake Burrumbeet and Baillie Creek flows that contribute to flooding in Skipton. DELWP install a Portable Automatic Logging System (PALS) stream gauge at Baillie Creek during times when there is high flood risk to provide warning and an indication flood magnitude for future flood events in Skipton.

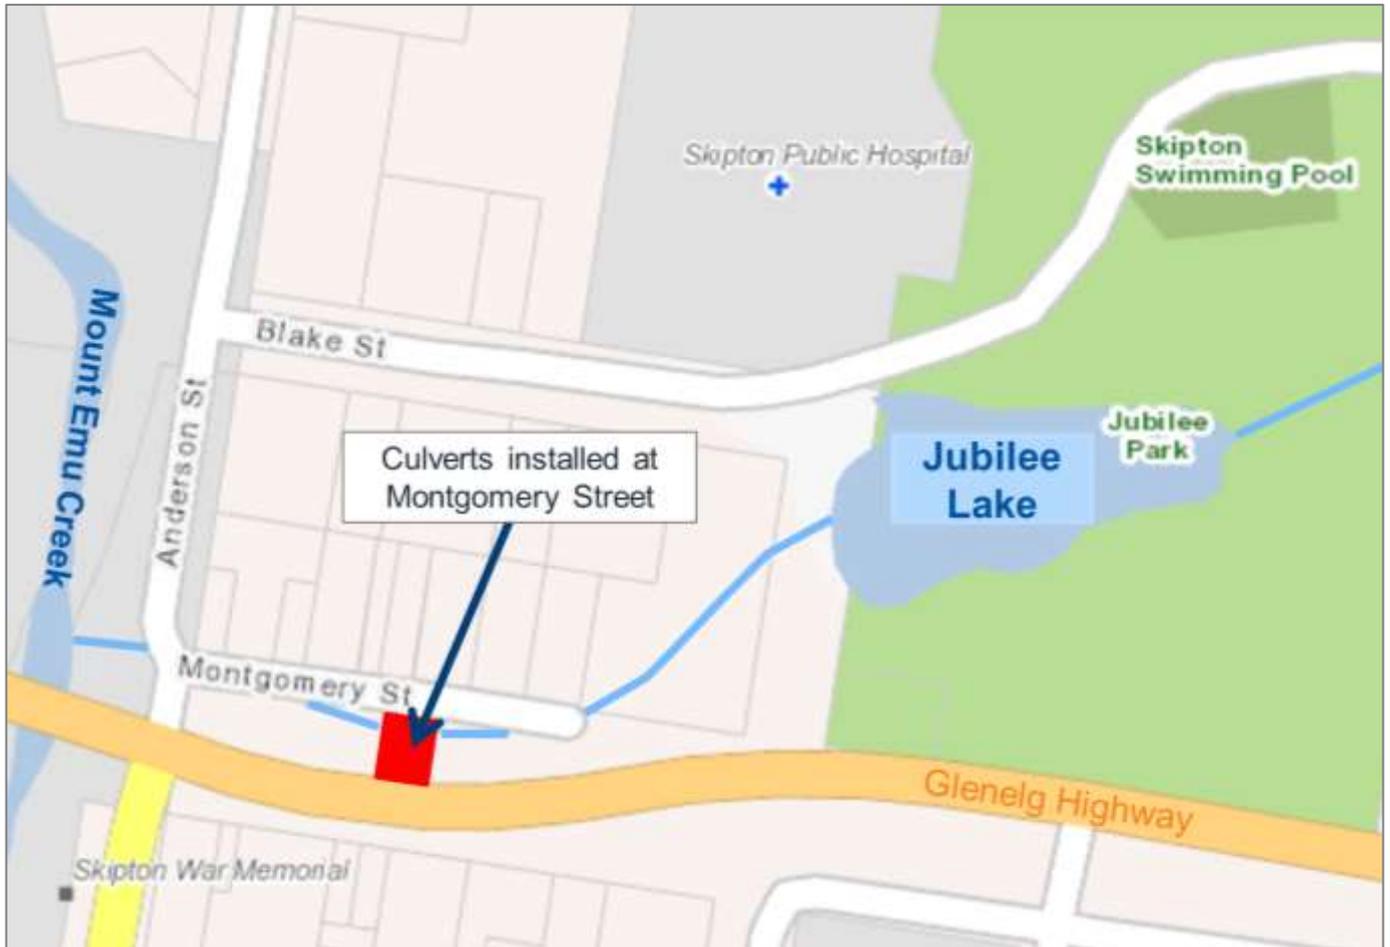
Figure 3. Jubilee Lake in Skipton.

The Jubilee Lake is located in Skipton at Jubilee Park, north of Montgomery Street, refer to the map below. Jubilee Lake has a storage volume of 16 ML, and a catchment area approximately 2.7 km<sup>2</sup>. After heavy rainfall events, a waterway that flows through Jubilee Lake causes the Lake quickly fill and spill. During the September 2010 flood event, spills from Jubilee Lake flooded Anderson Street and Montgomery Street and flooded a number of adjacent properties.

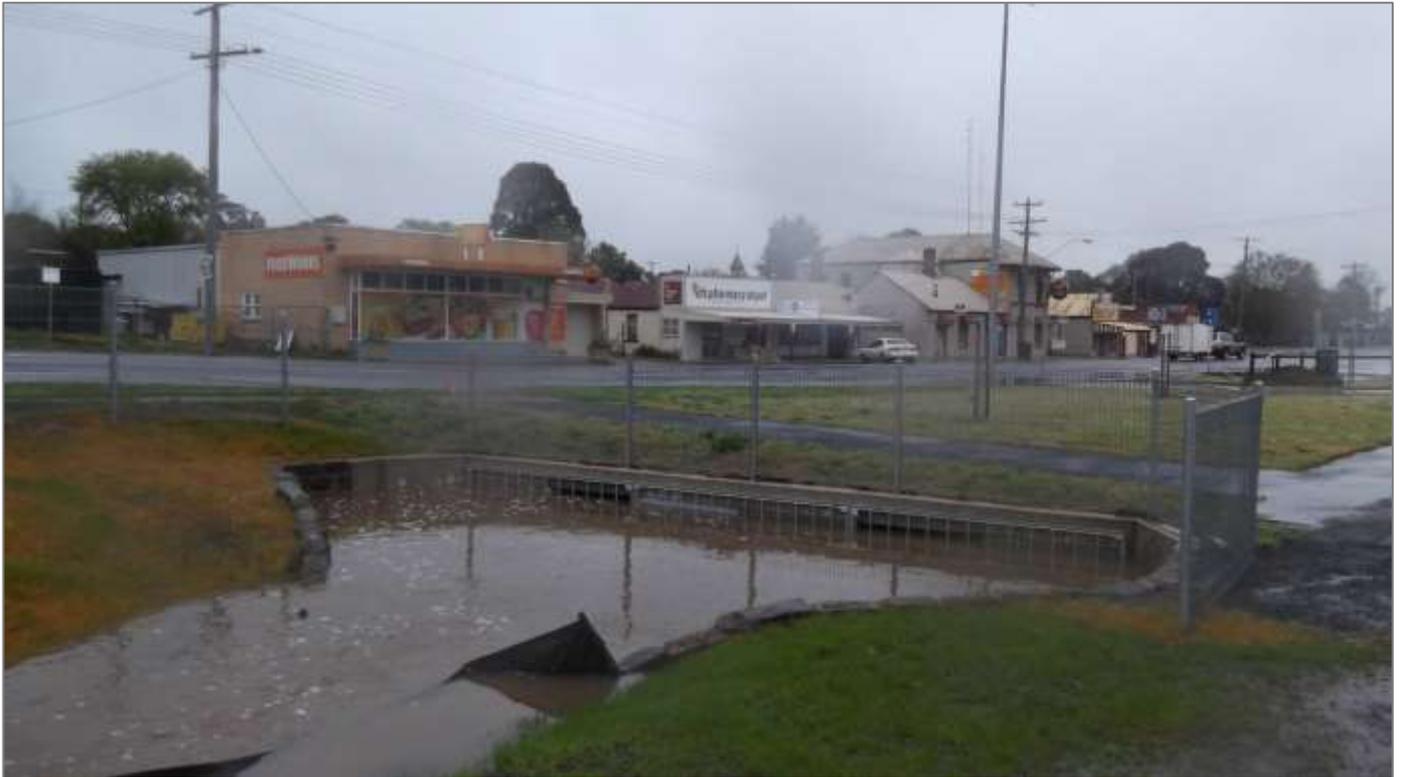
Figure 4. New culverts in Montgomery Street, during the September 2016 flood event.

However in mid-2016 mitigation works were undertaken to increase the capacity of culverts along Montgomery Street, refer to photo below. These works have significantly reduced flooding caused by Jubilee Lake spills, improving the conveyance of flows to Mt. Emu Creek.

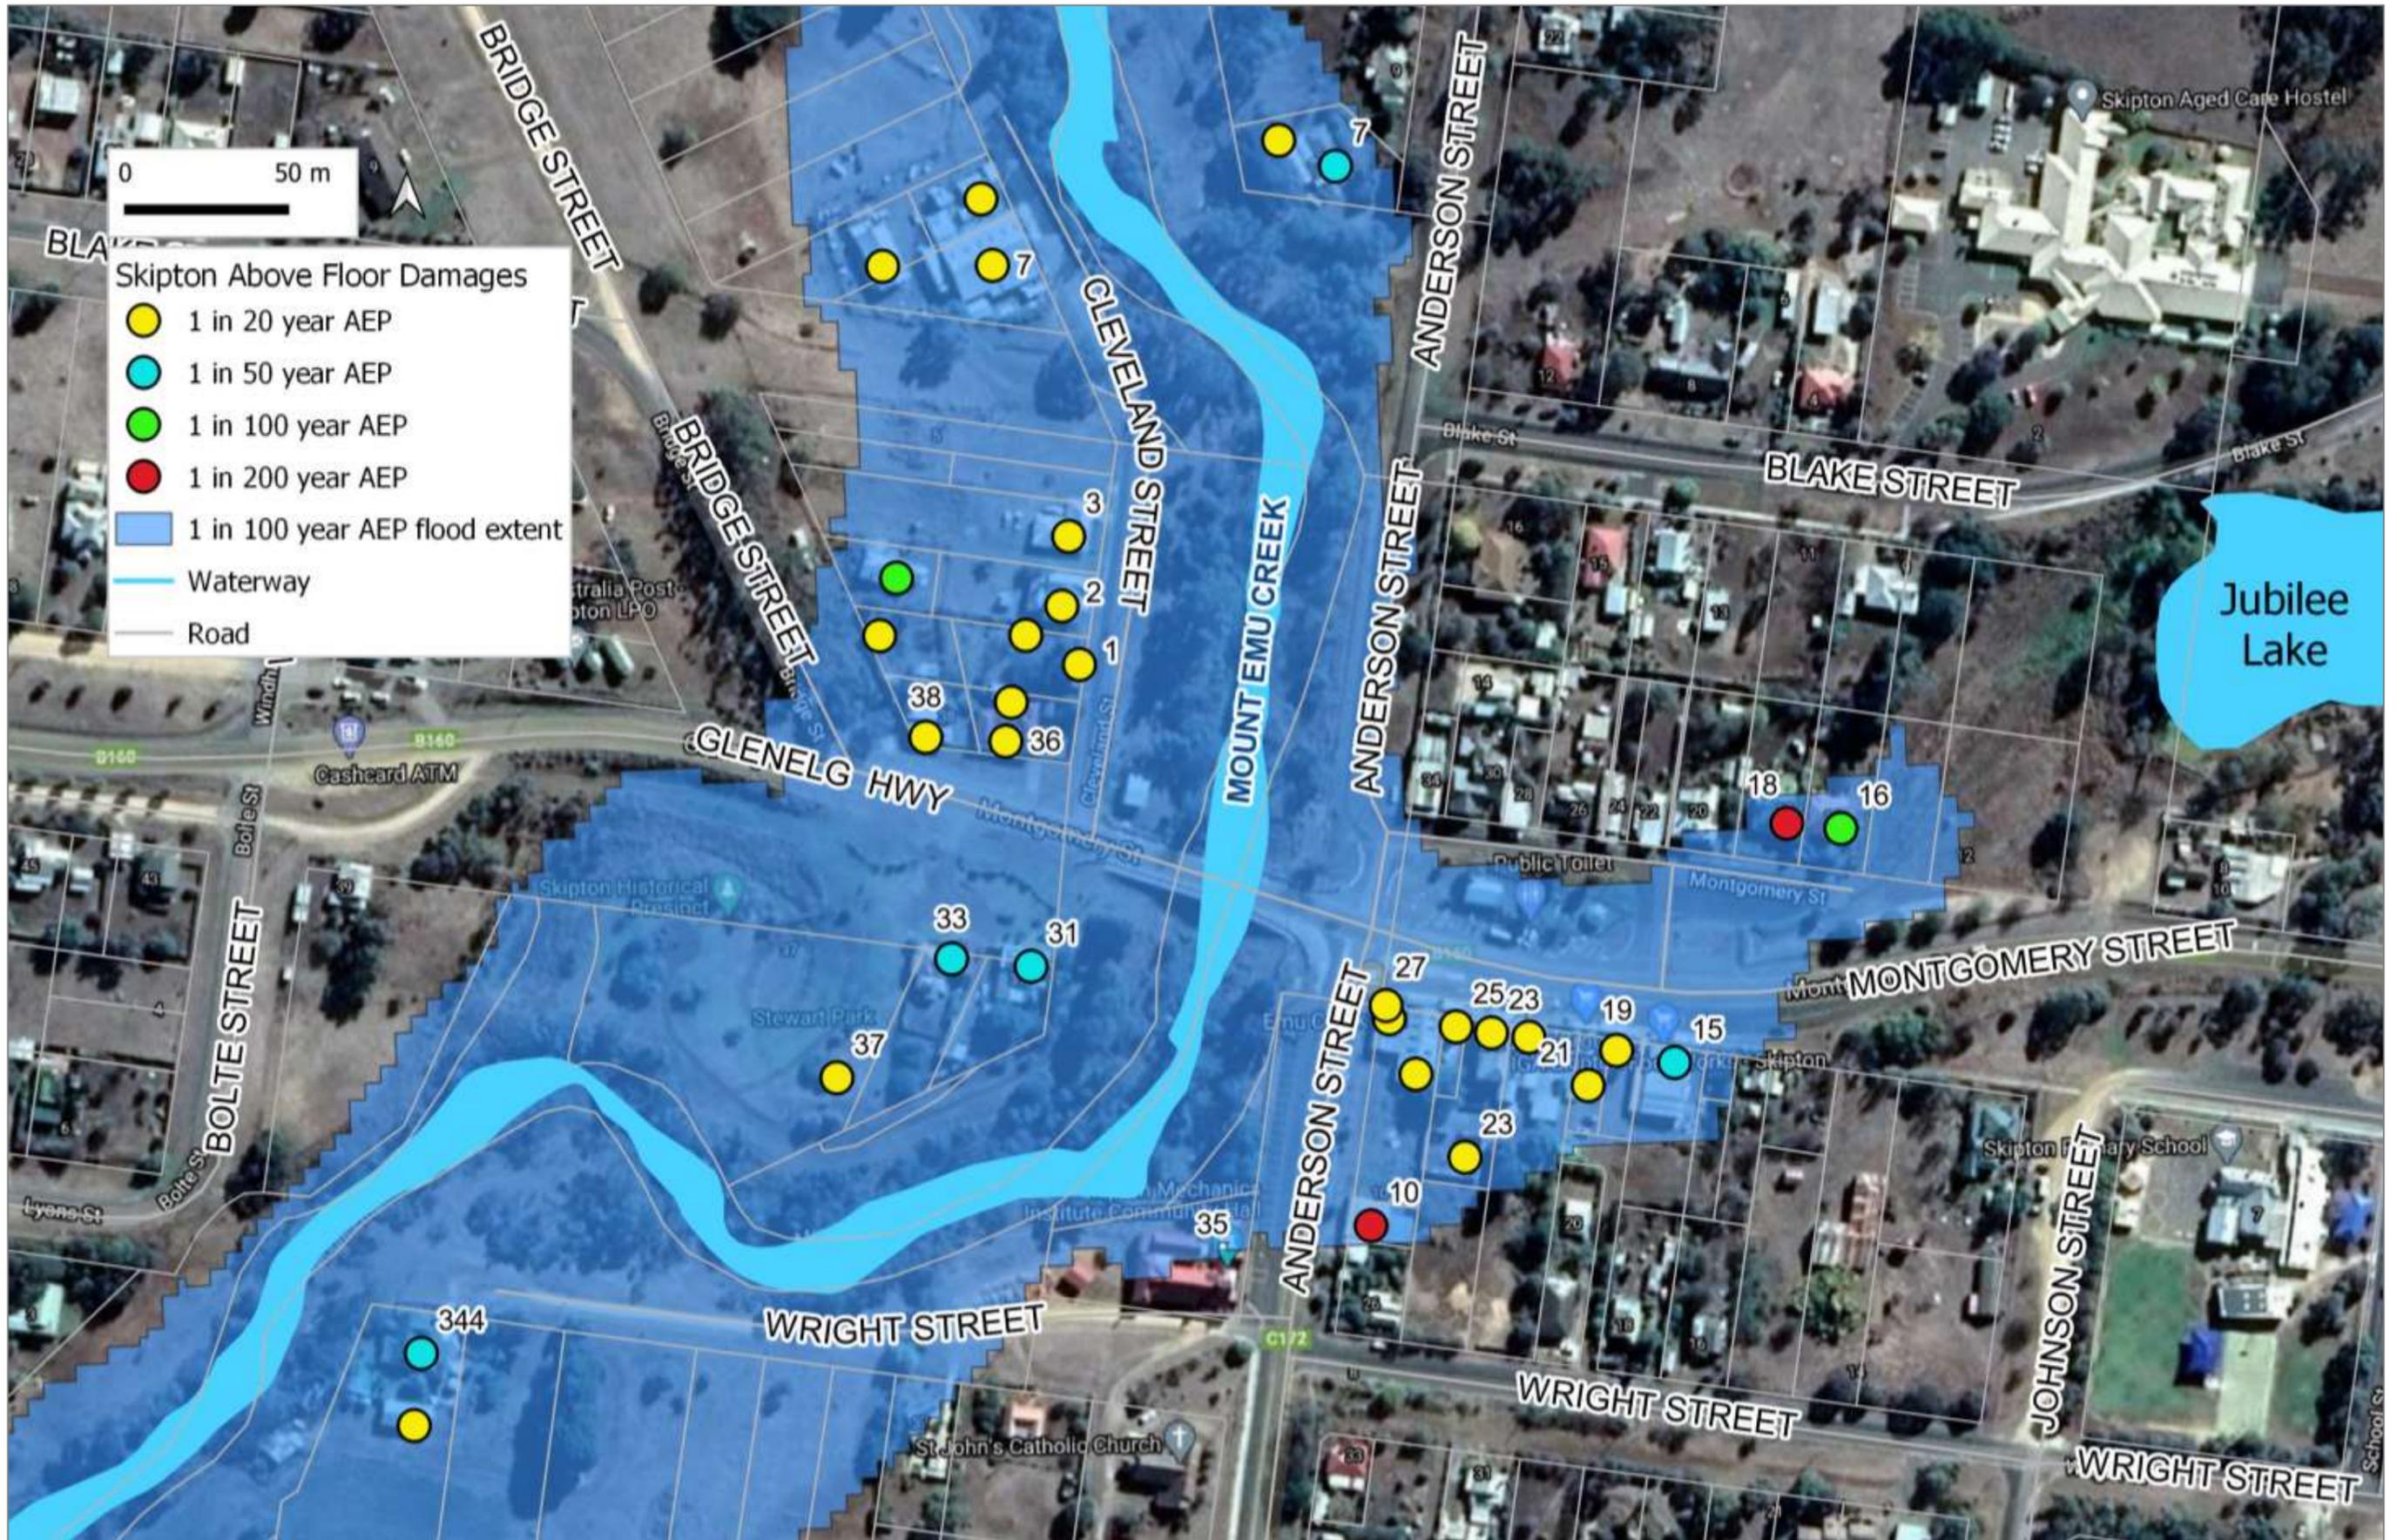
Figure 22. Skipton buildings impacted by over floor flooding for a range of design flood events (Water Technology 2020).

During a 1 in 20 year flood event there is extensive over floor inundation of buildings and access is cut to most main and minor roads. Flooding causes 28 buildings to be flooded over floor in Montgomery Street, Cleveland Street, Bridge Road, Hardy Street and Pett Street. Flooding cuts access to Montgomery Street (the Glenelg Highway), Cleveland Street and Wright Street.

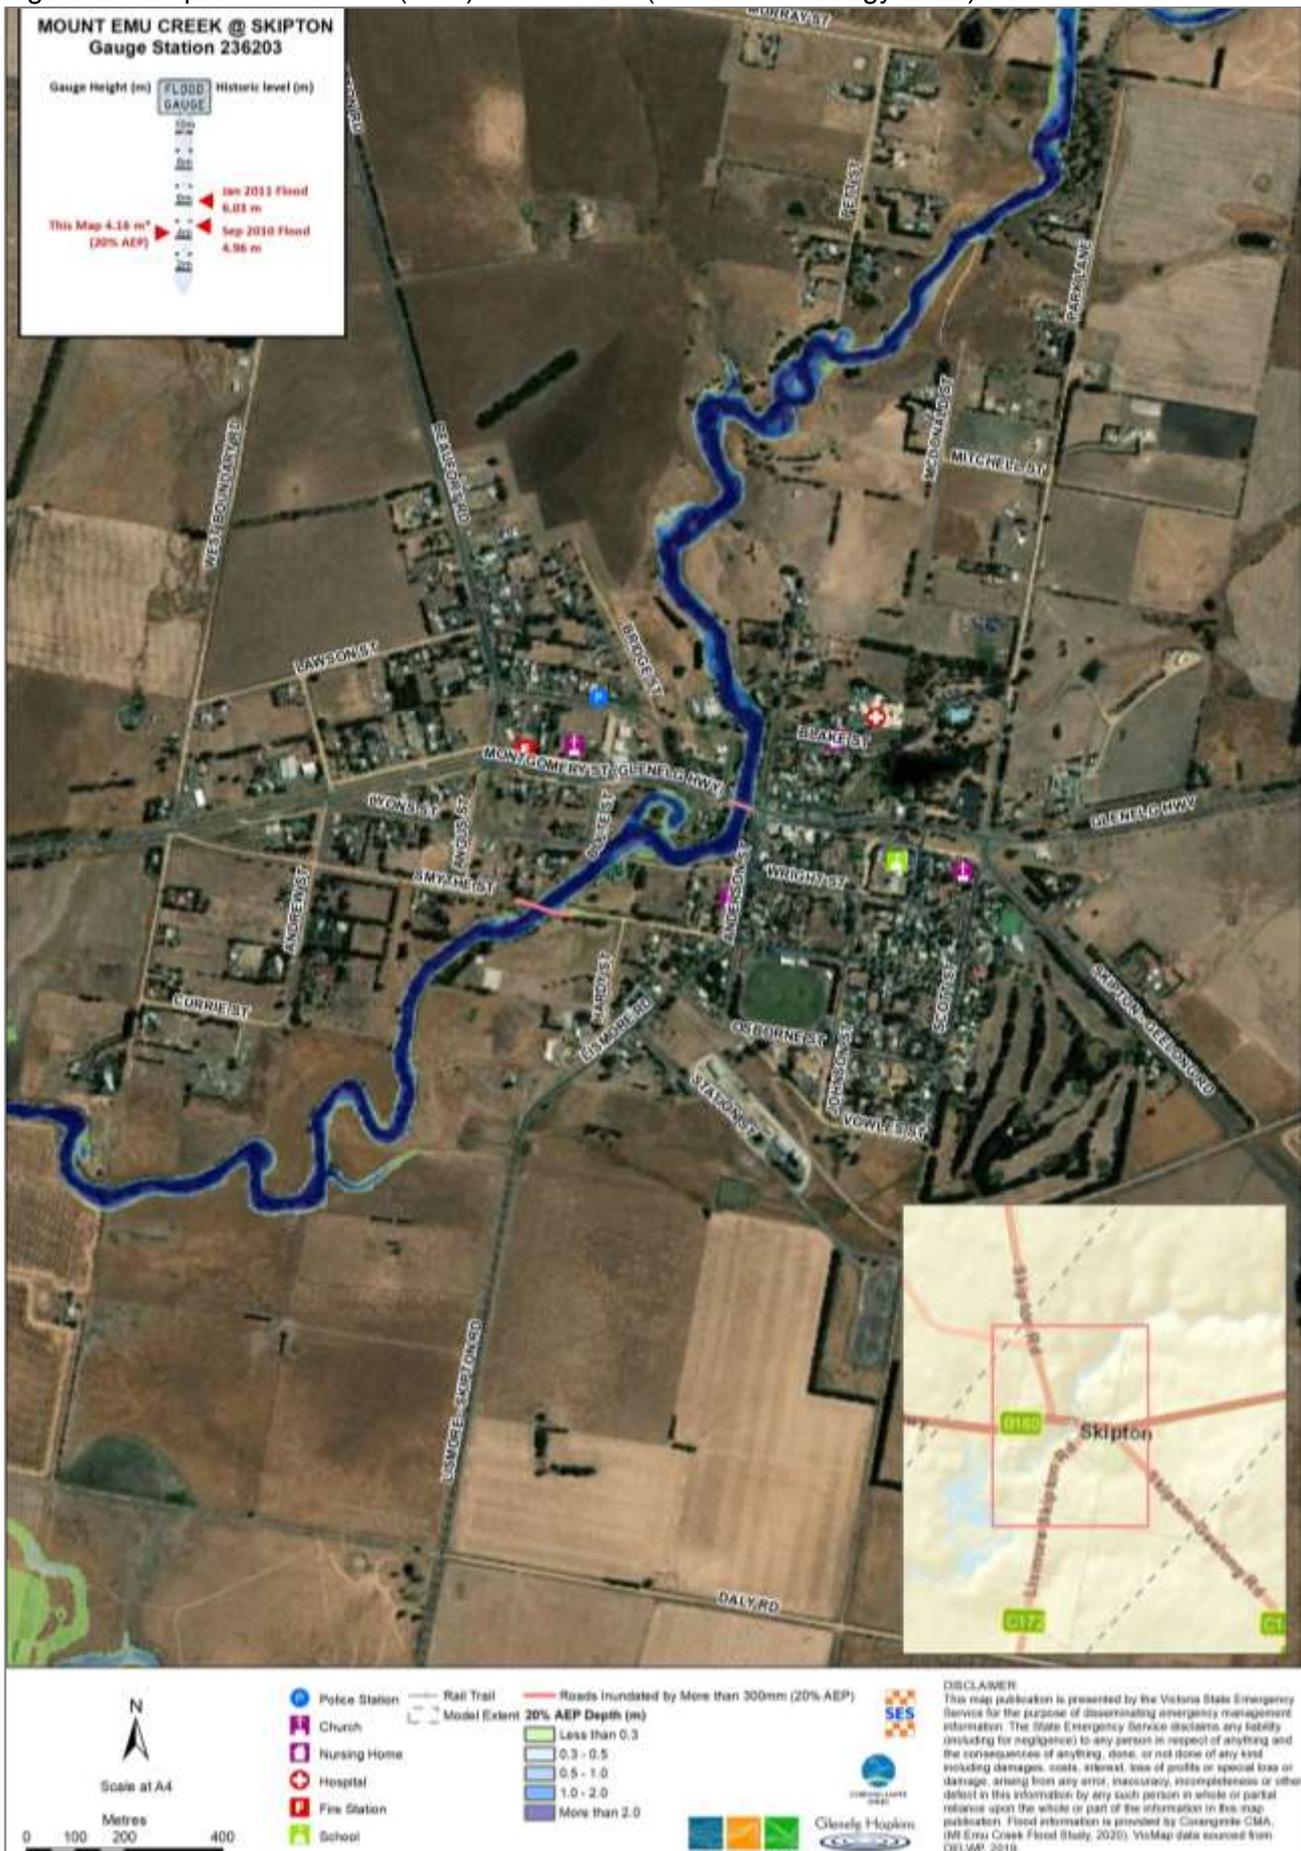
Figure 68. Skipton 1 in 20 AEP (5%) flood extent (Water Technology 2020).

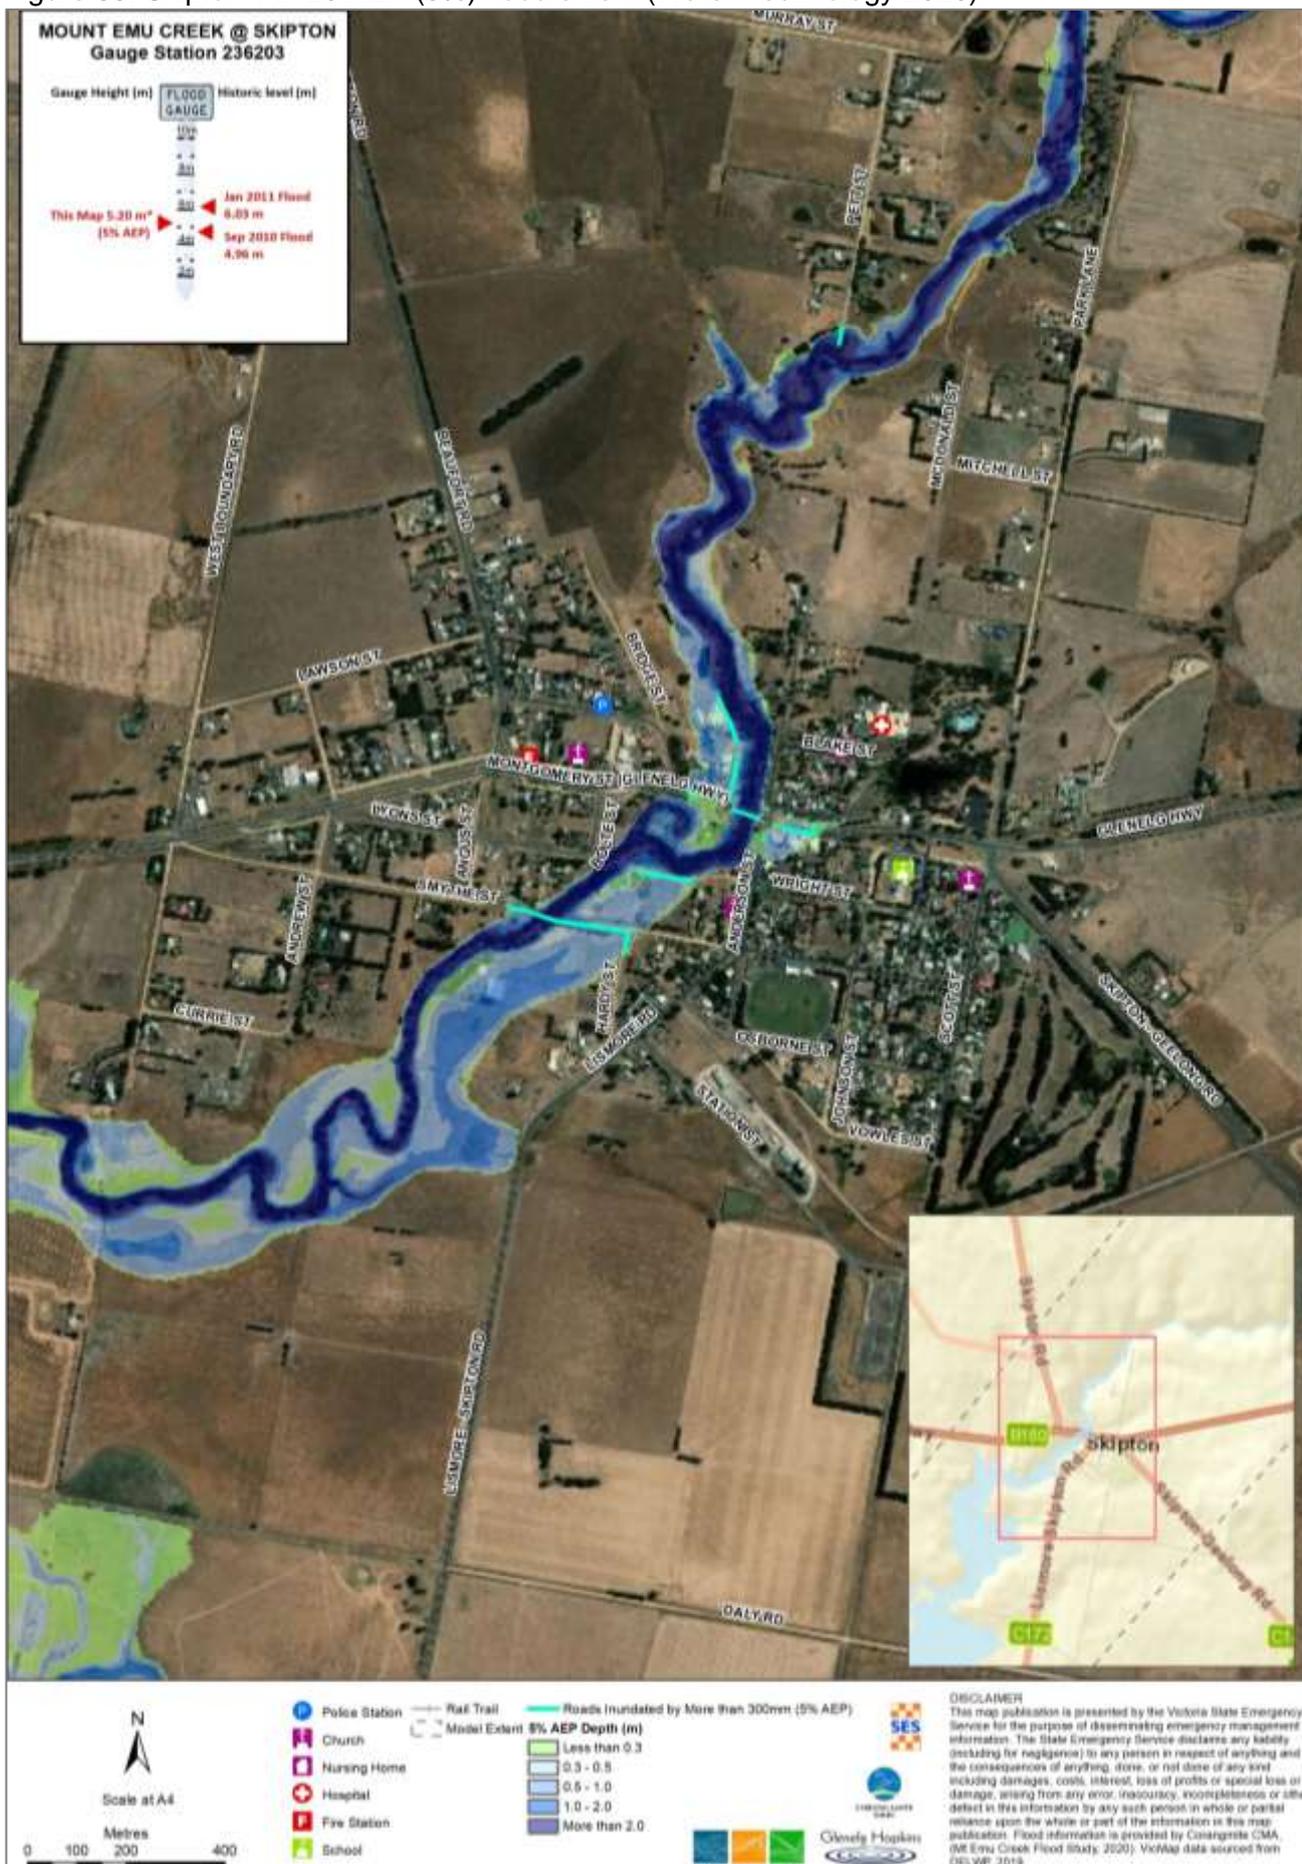
Figure 69. Skipton 1 in 50 AEP (2%) flood extent (Water Technology 2020).

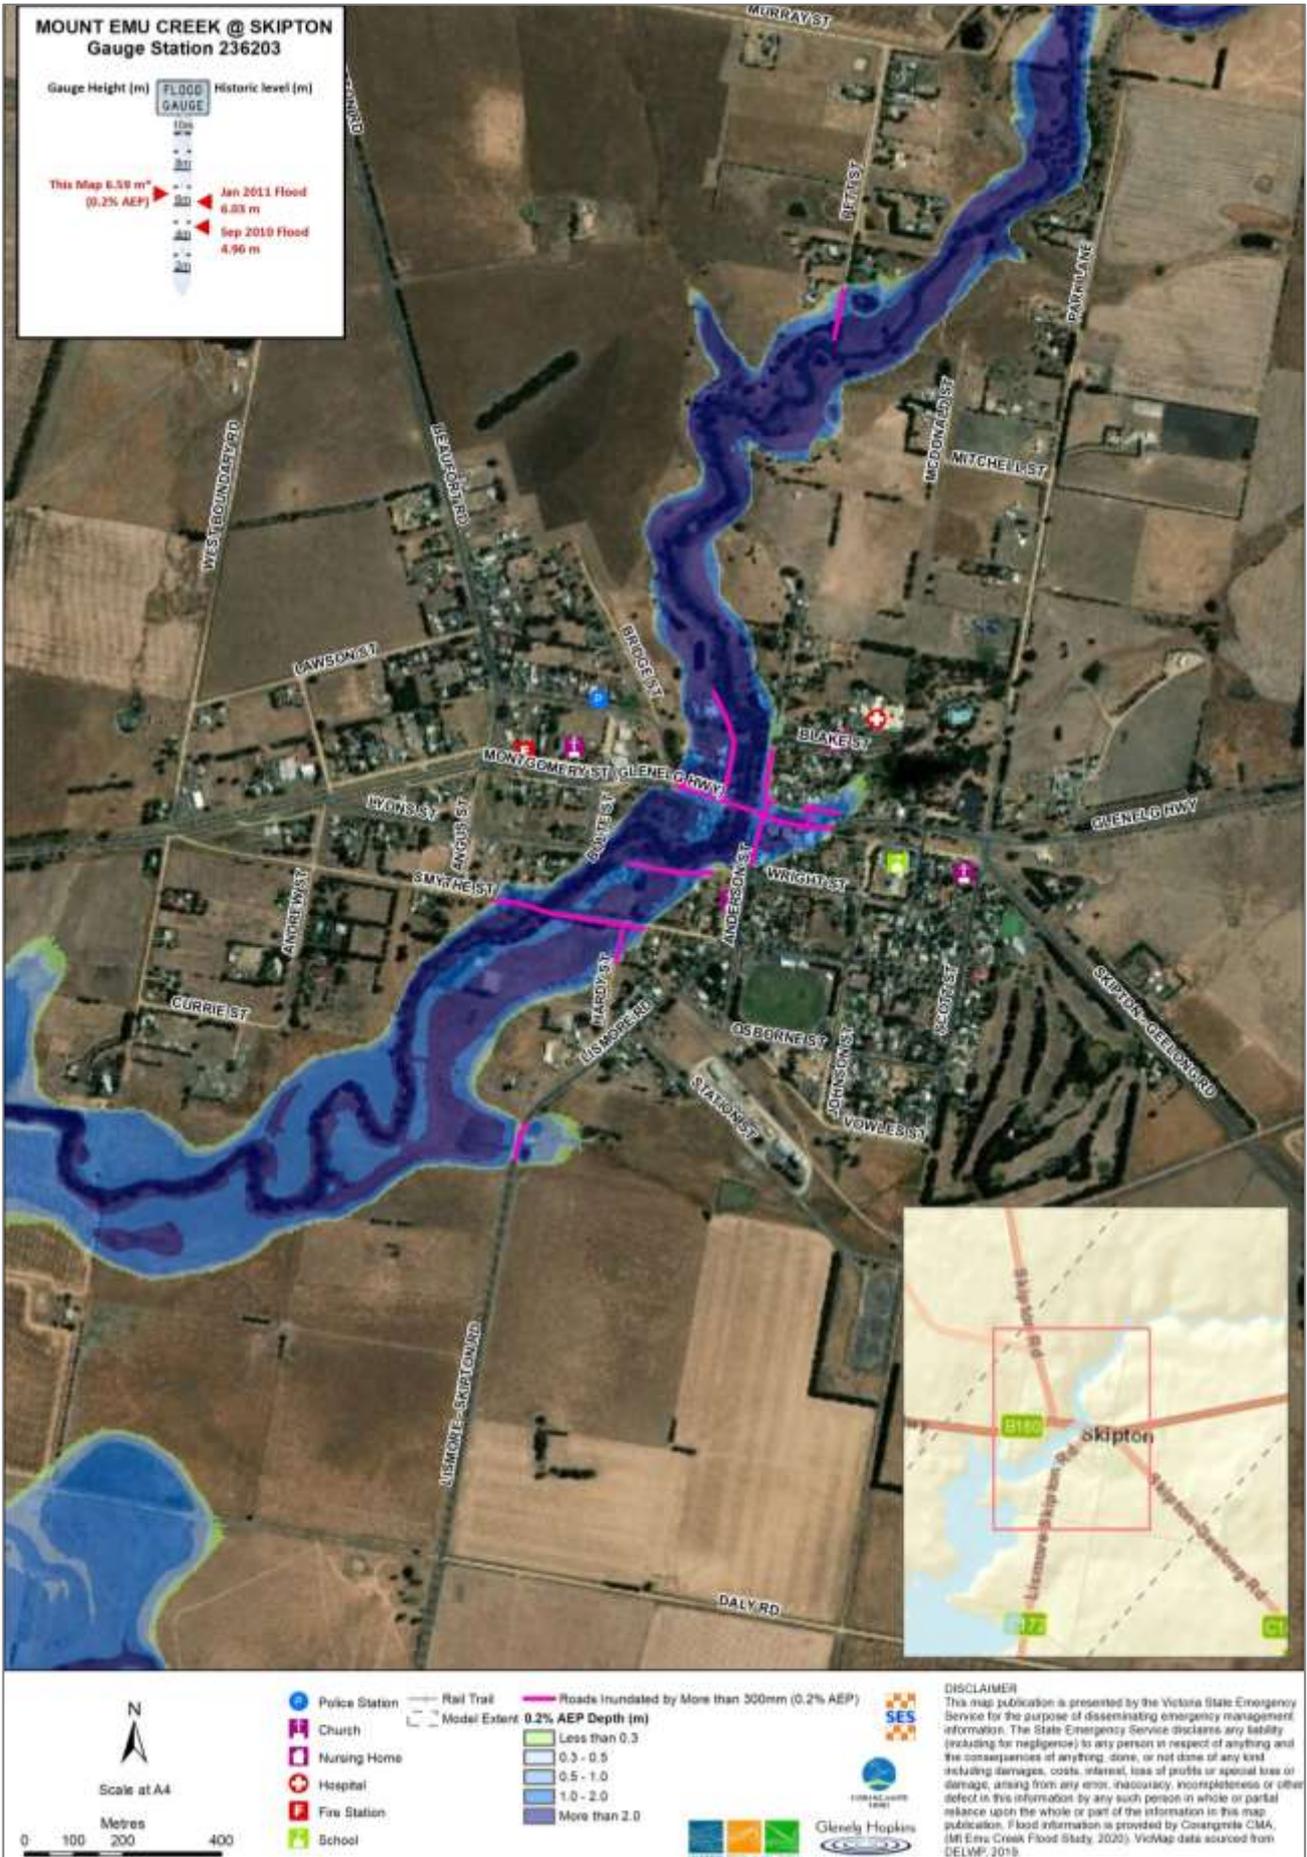
Figure 72. Skipton road flood impacts for all design flood events (Water Technology 2020).
