Yarriambiack Shire Council

FLOOD EMERGENCY PLAN

A Sub-Plan of the Municipal Emergency Management Plan

Version 2, February 2020

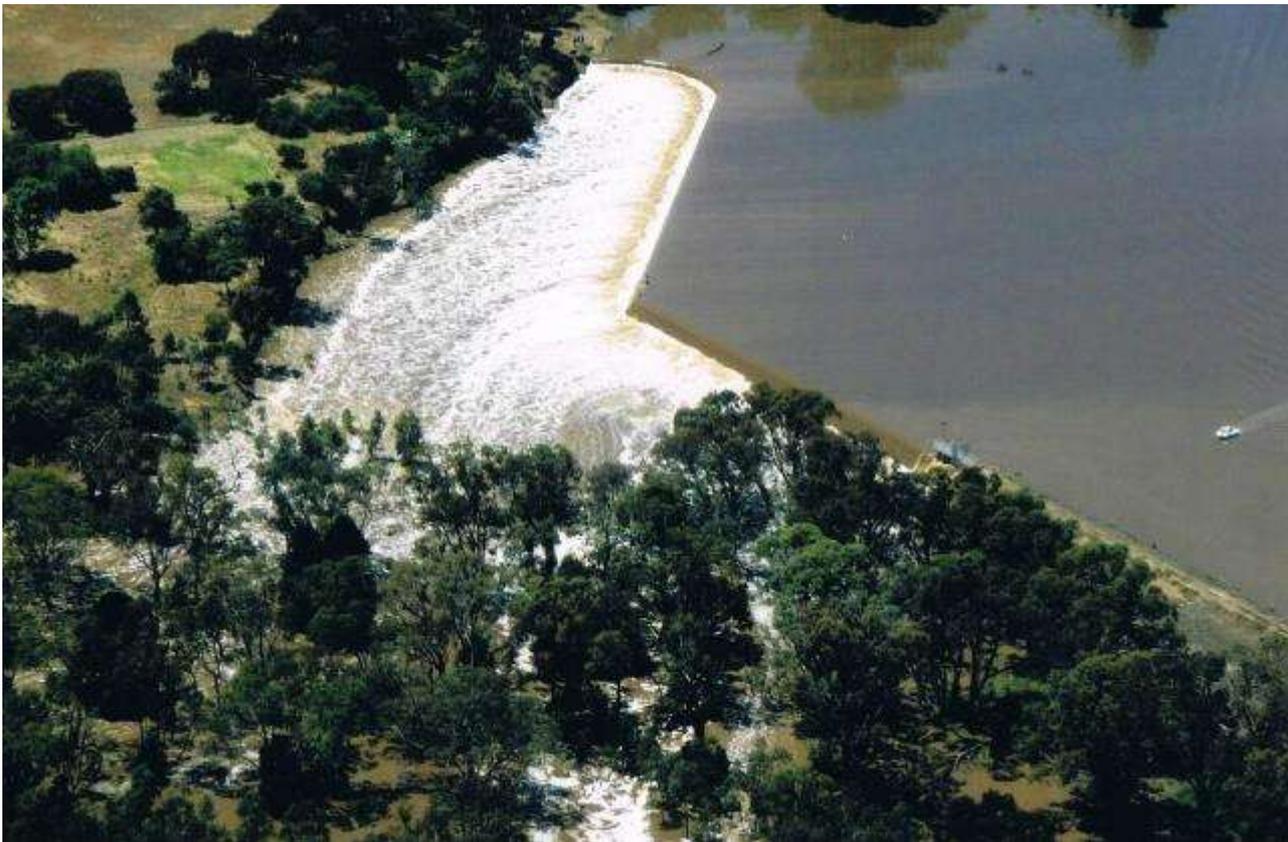
Lake Lonsdale spilling during the January 2011 flood event.

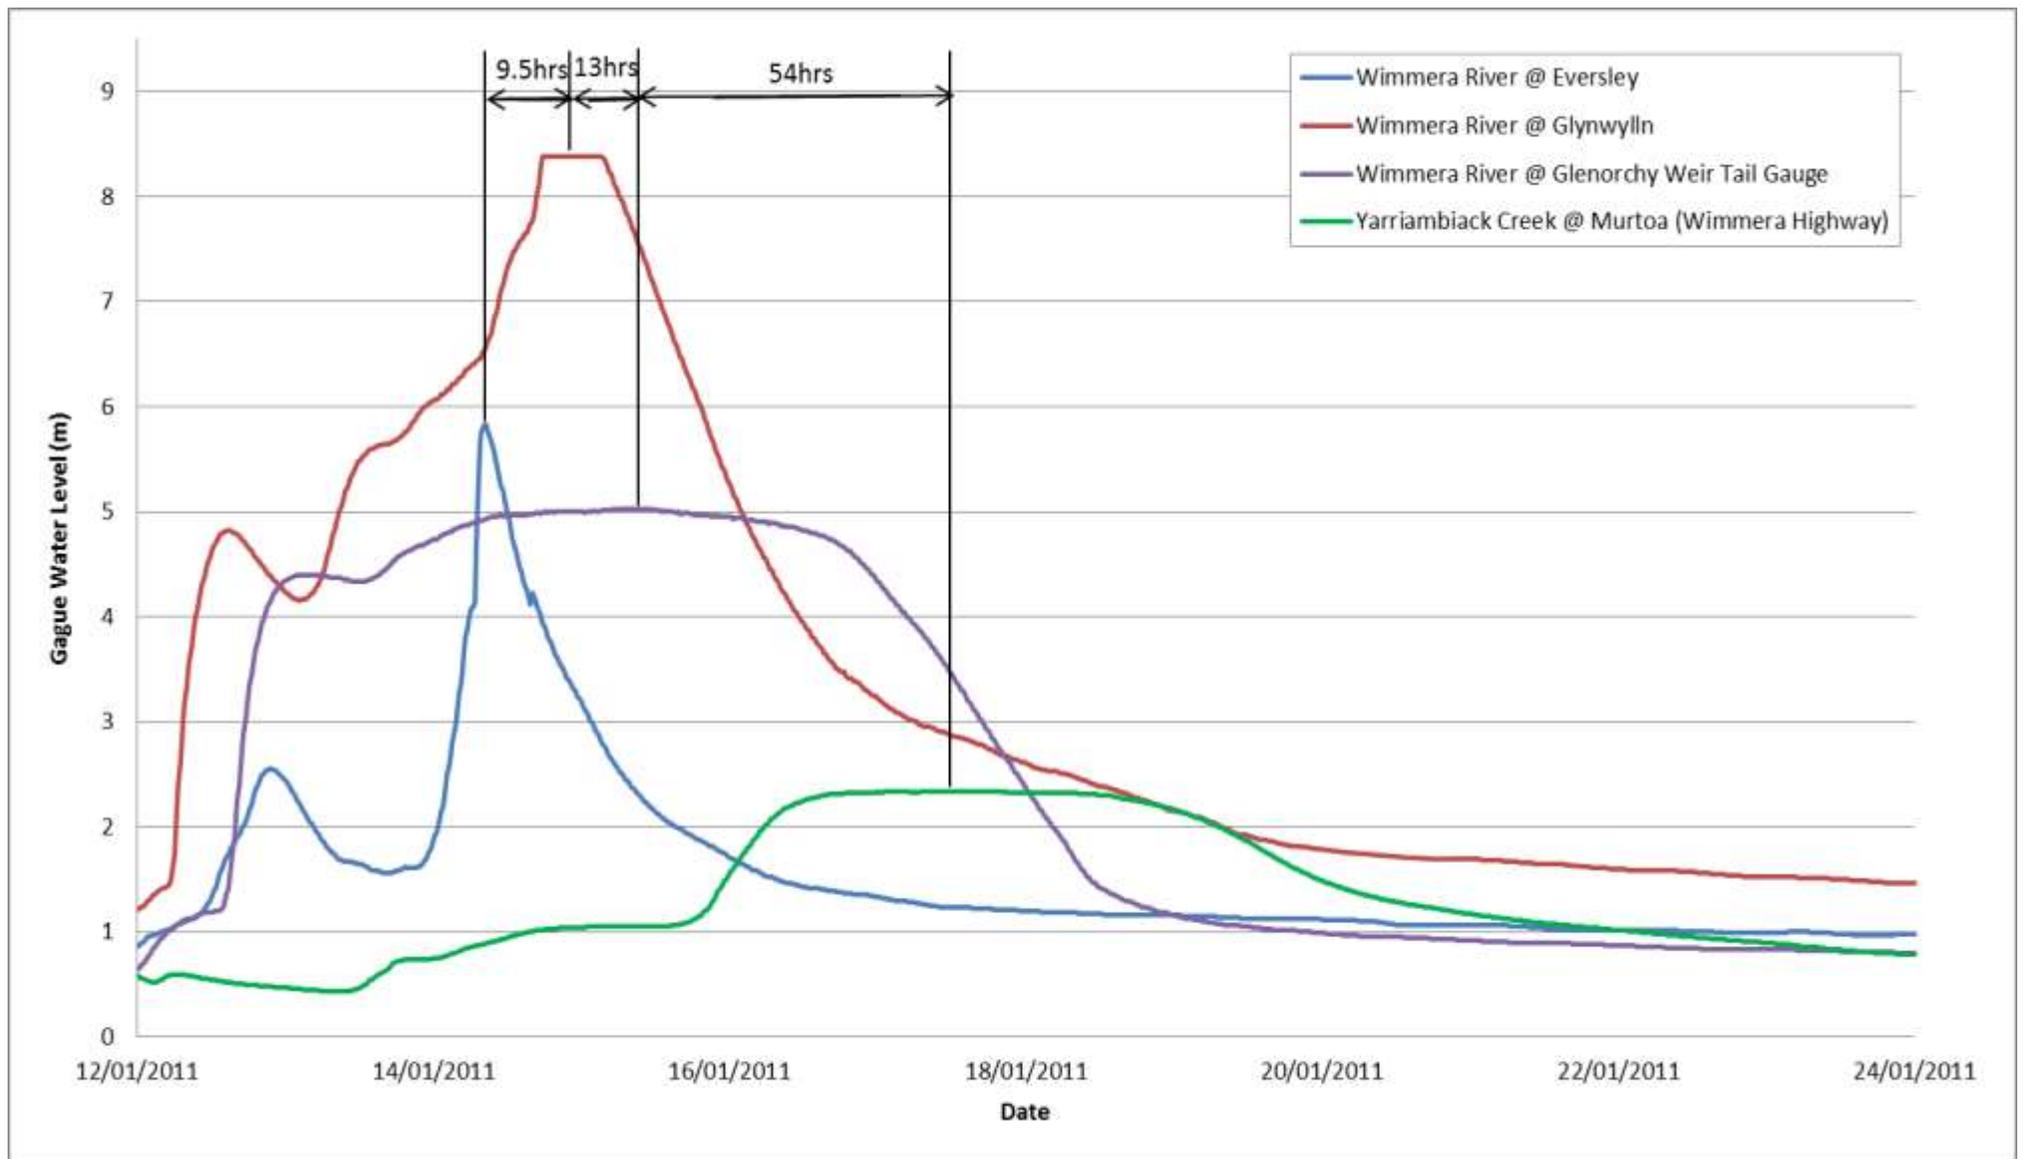
Yarriambiack Creek (Murtoa gauge) flood peak travel time during the January 2011 flood event.

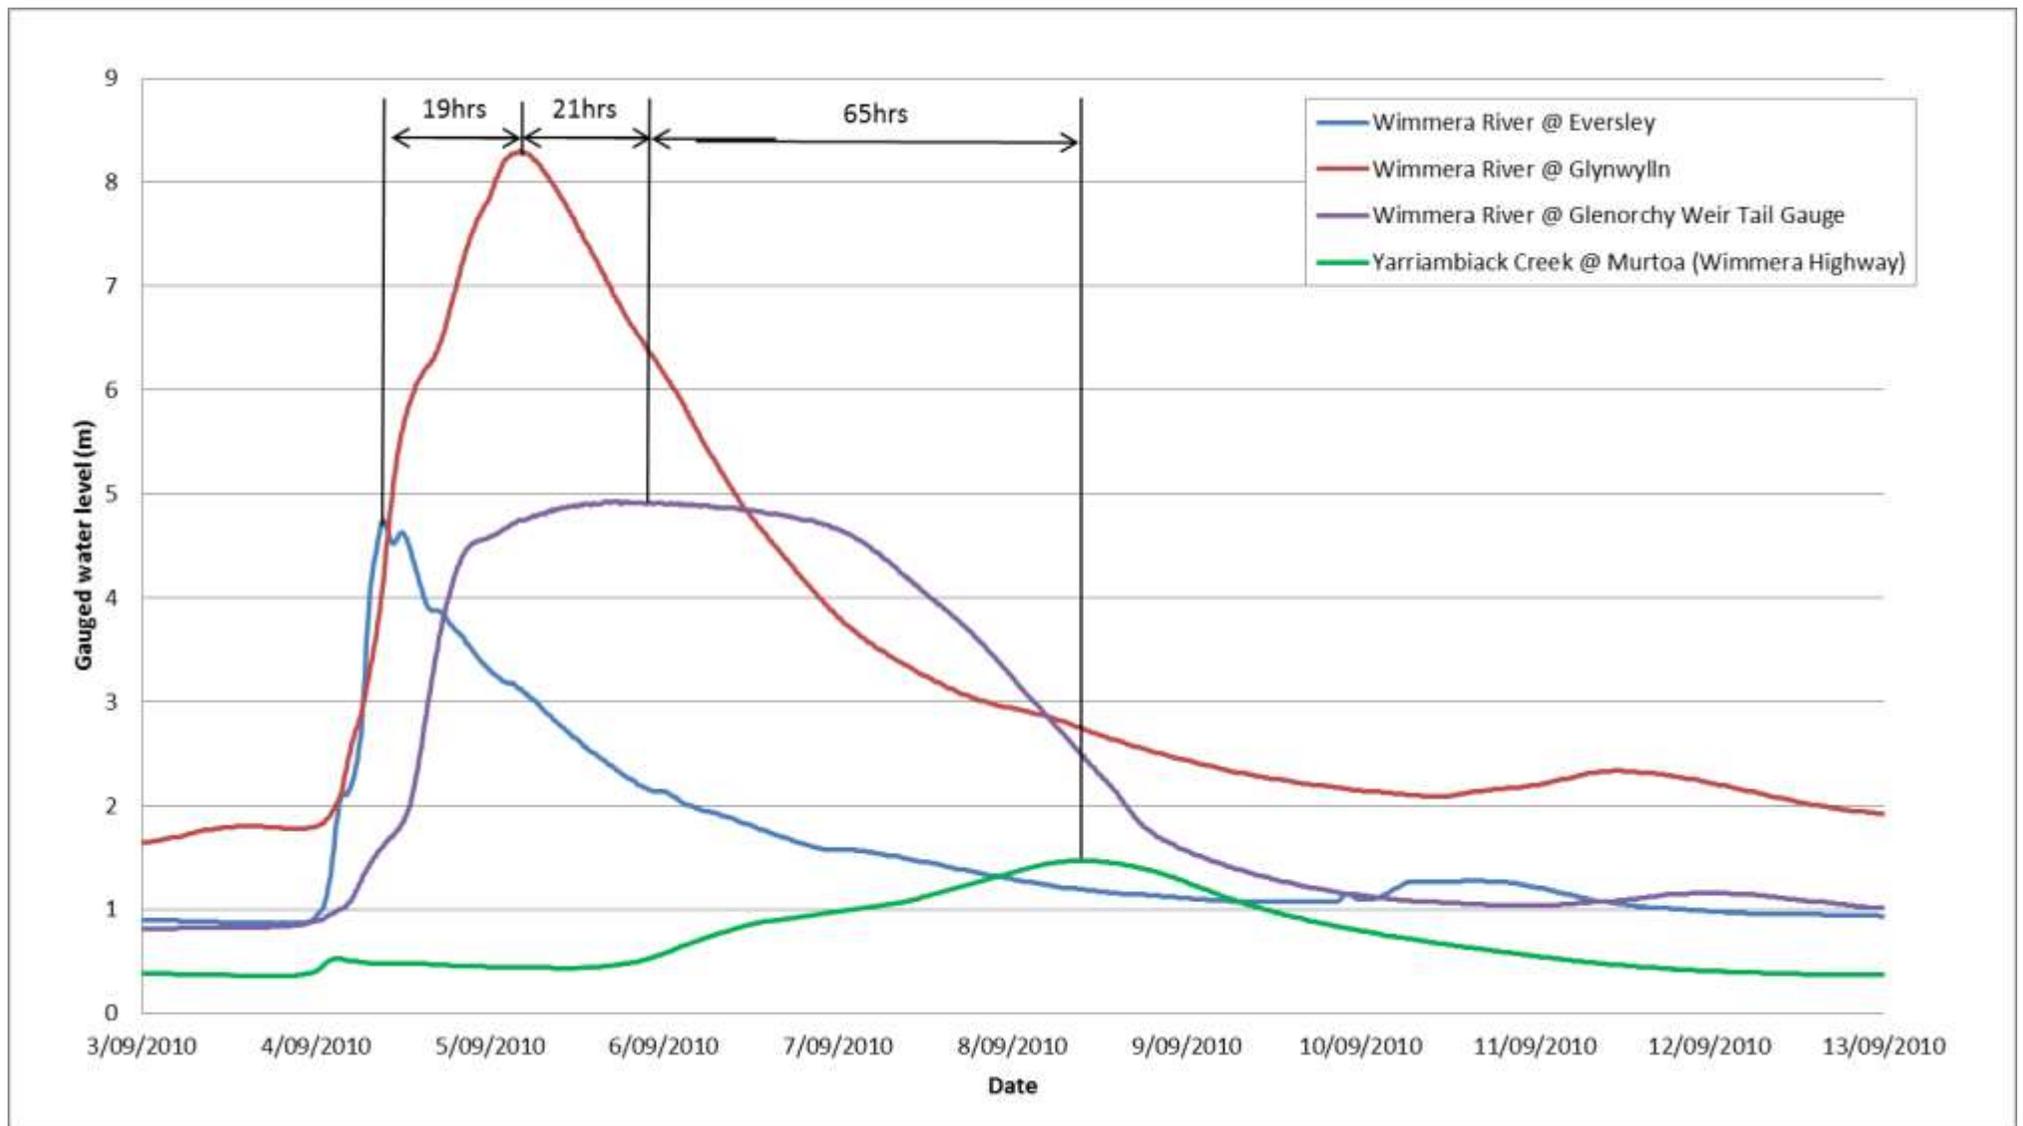
Yarriambiack Creek (Murtoa gauge) flood peak travel time during the September 2010 flood event.

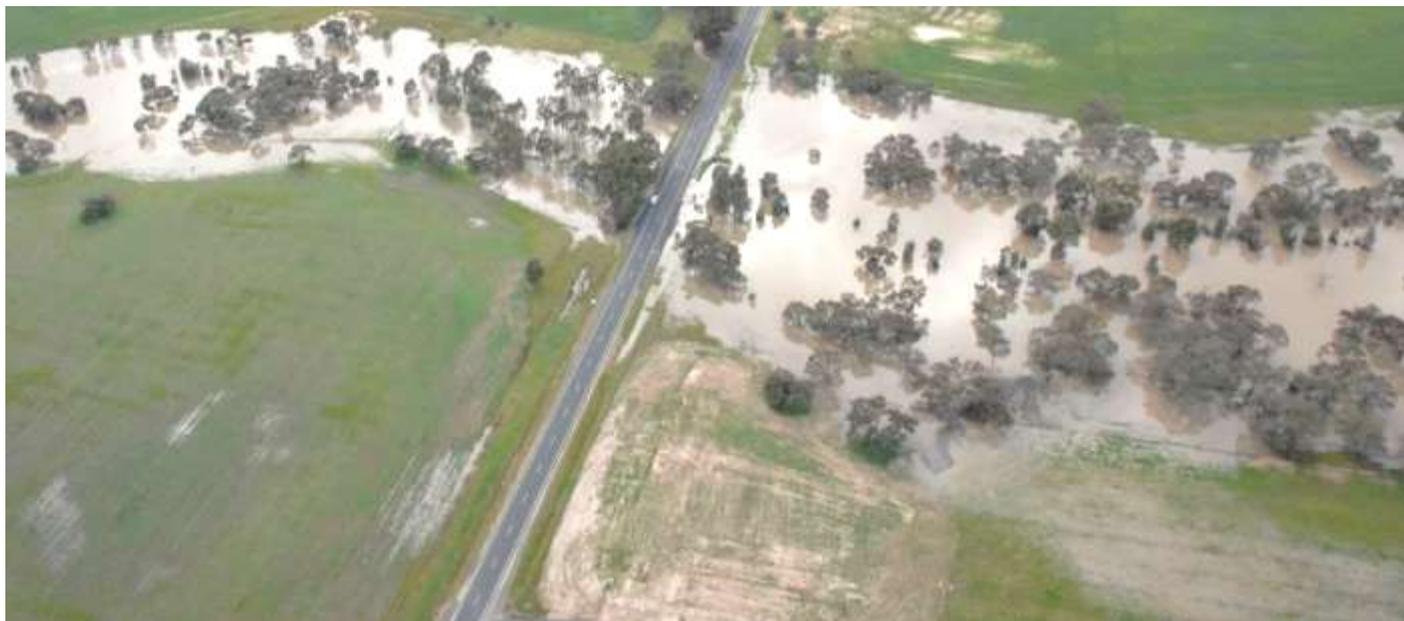
Flooding along Yarriambiack Creek at the Wimmera Highway Bridge during the September 2010 flood event.

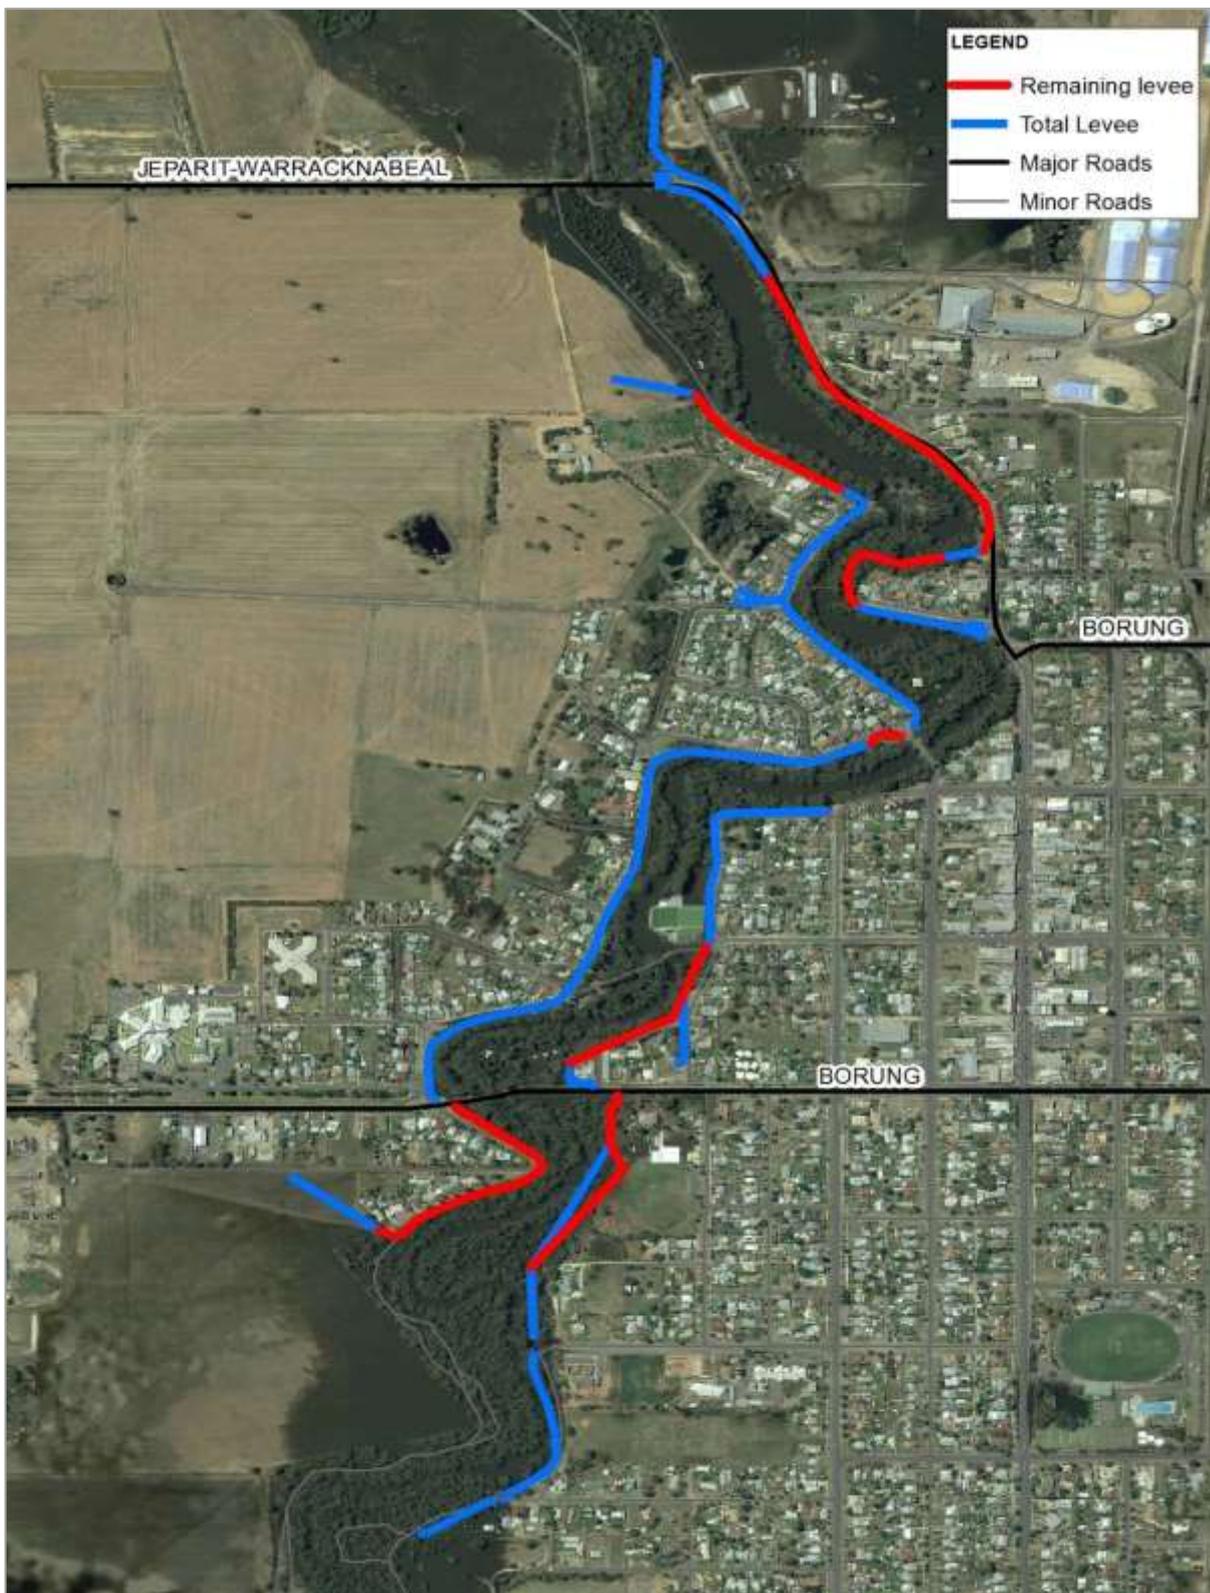
Location of the Warracknabeal Levee during the January 2011 flood event.

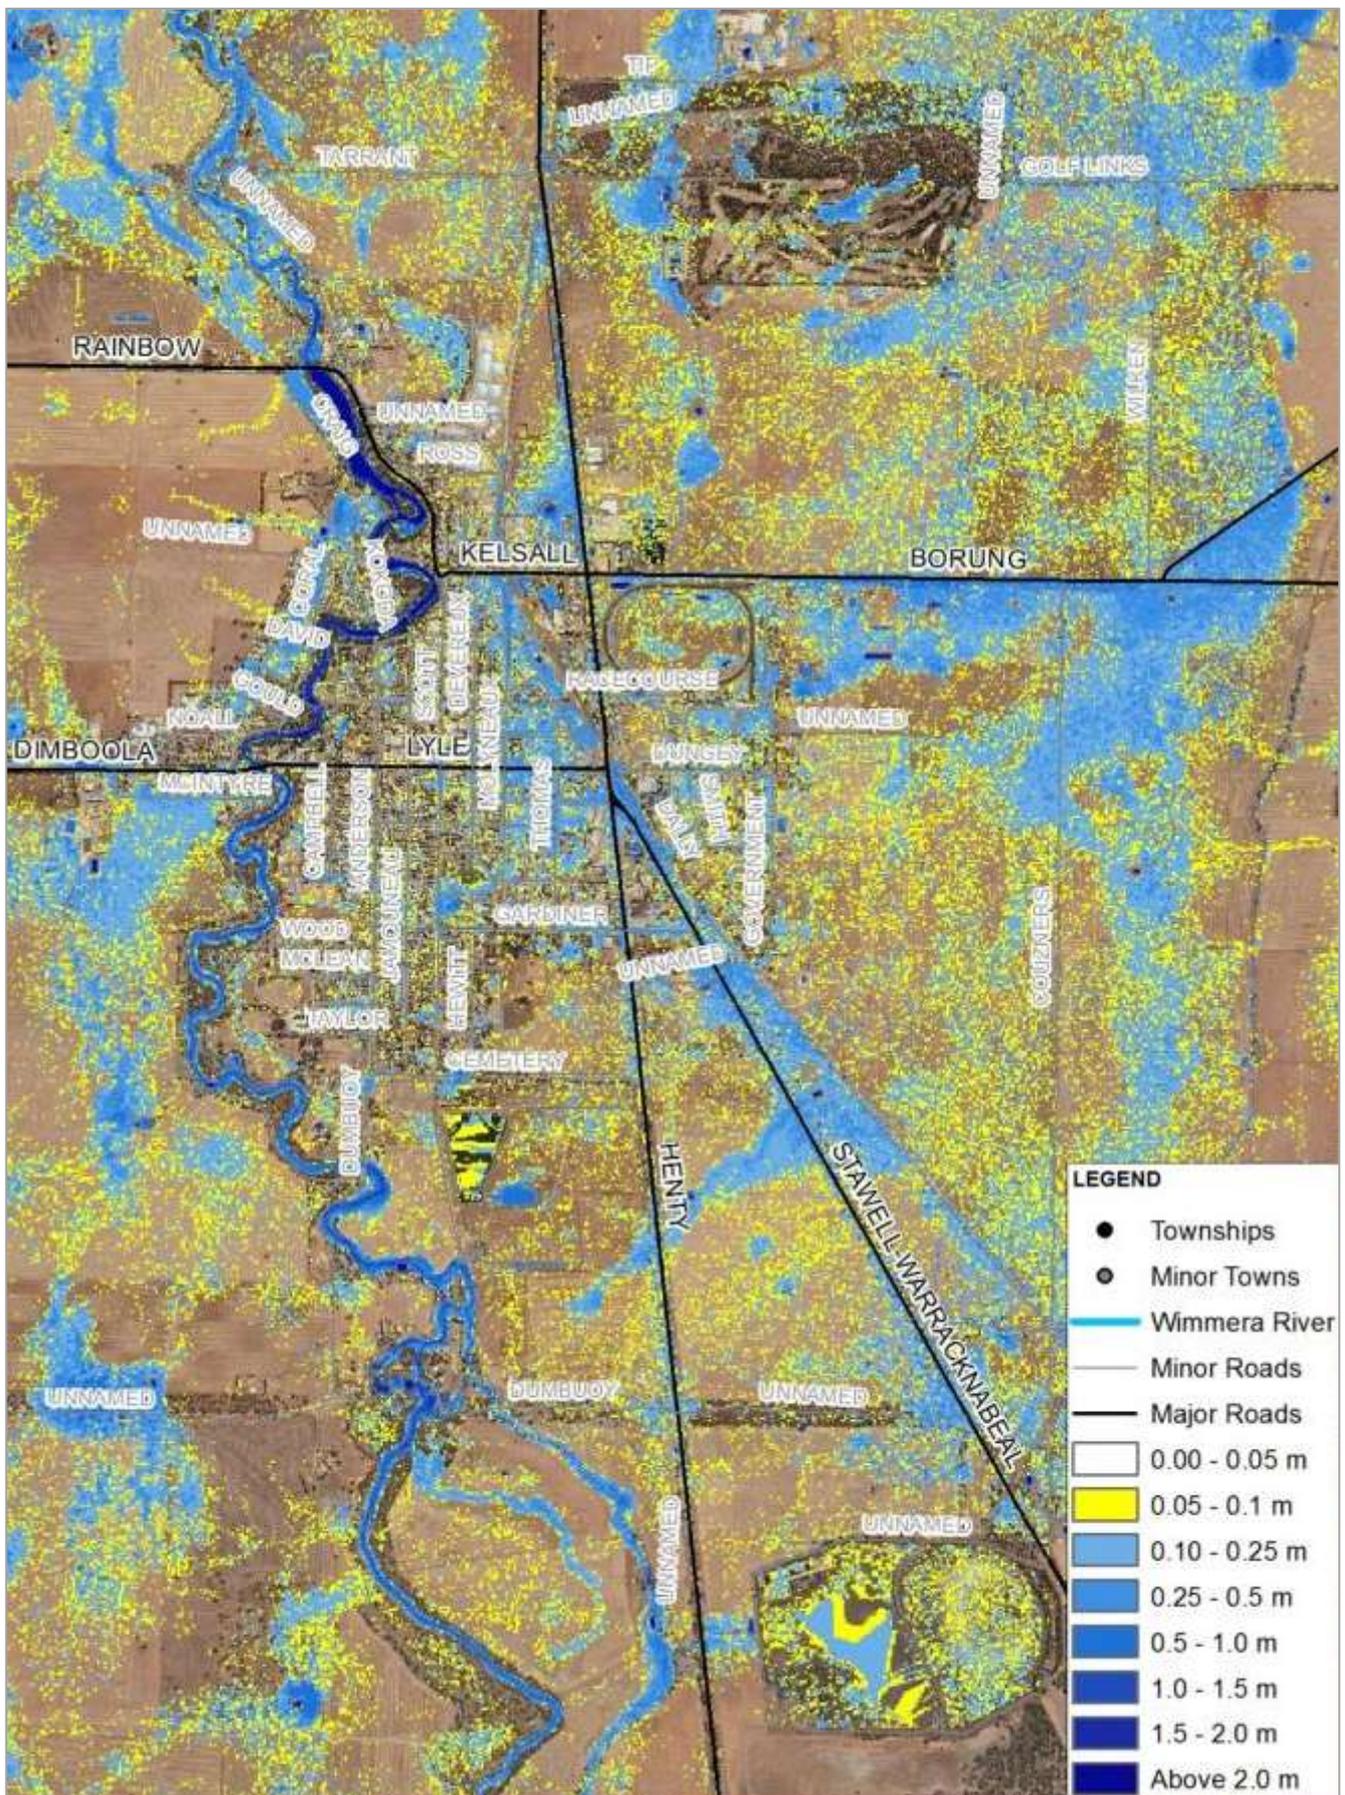
Warracknabeal stormwater flood mapping, 100 year ARI 2 hr duration event (Water Technology 2016).

Stormwater flooding can develop quickly as a result of local heavy rainfall. Heavy rainfall events can cause rapid rise of floodwater. The warning time available from rainfall to stormwater flood impacts occurring can range between 2 to 3 hours depending on the rainfall intensity.

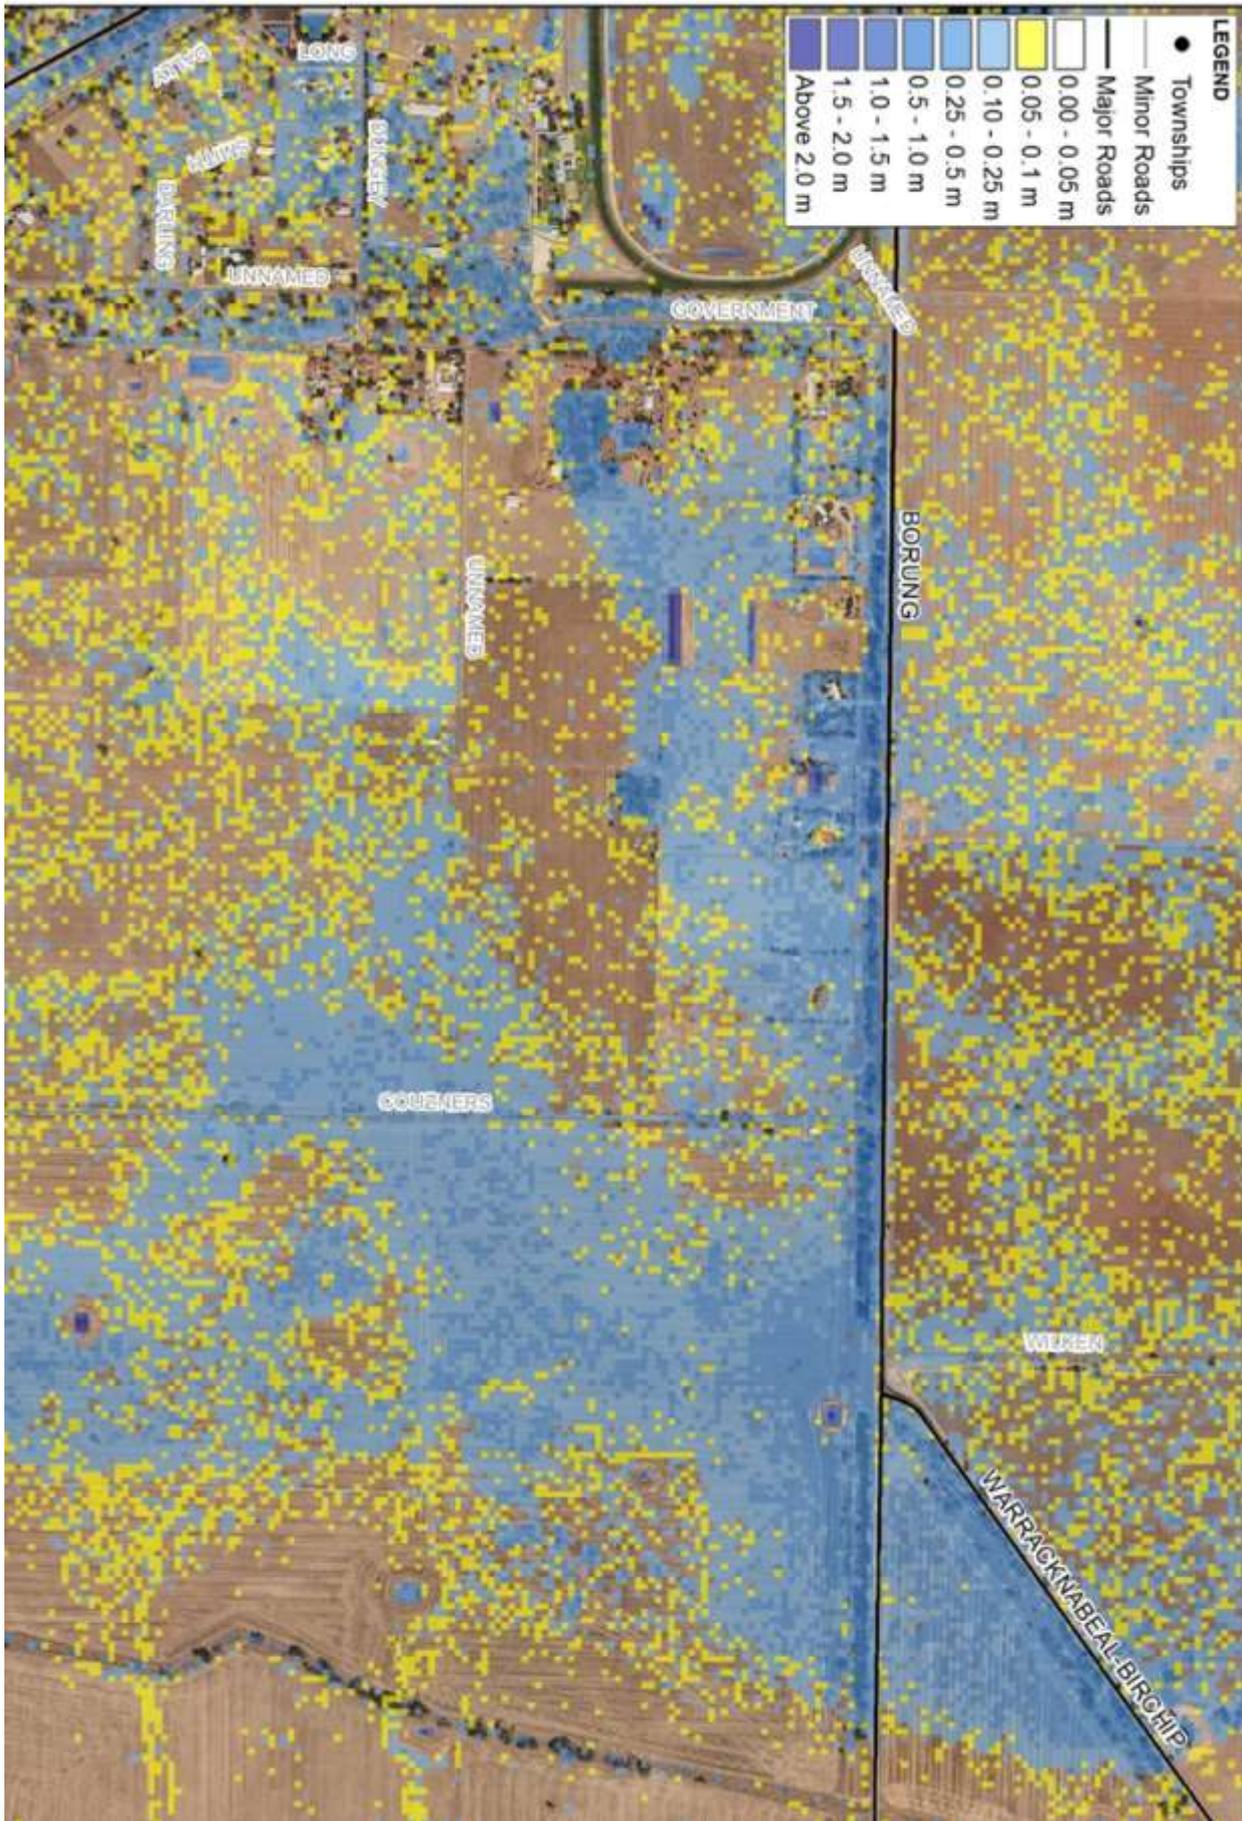
Borong Highway east of Warracknabeal, 100 year ARI 2 hr duration event (Water Technology 2016).

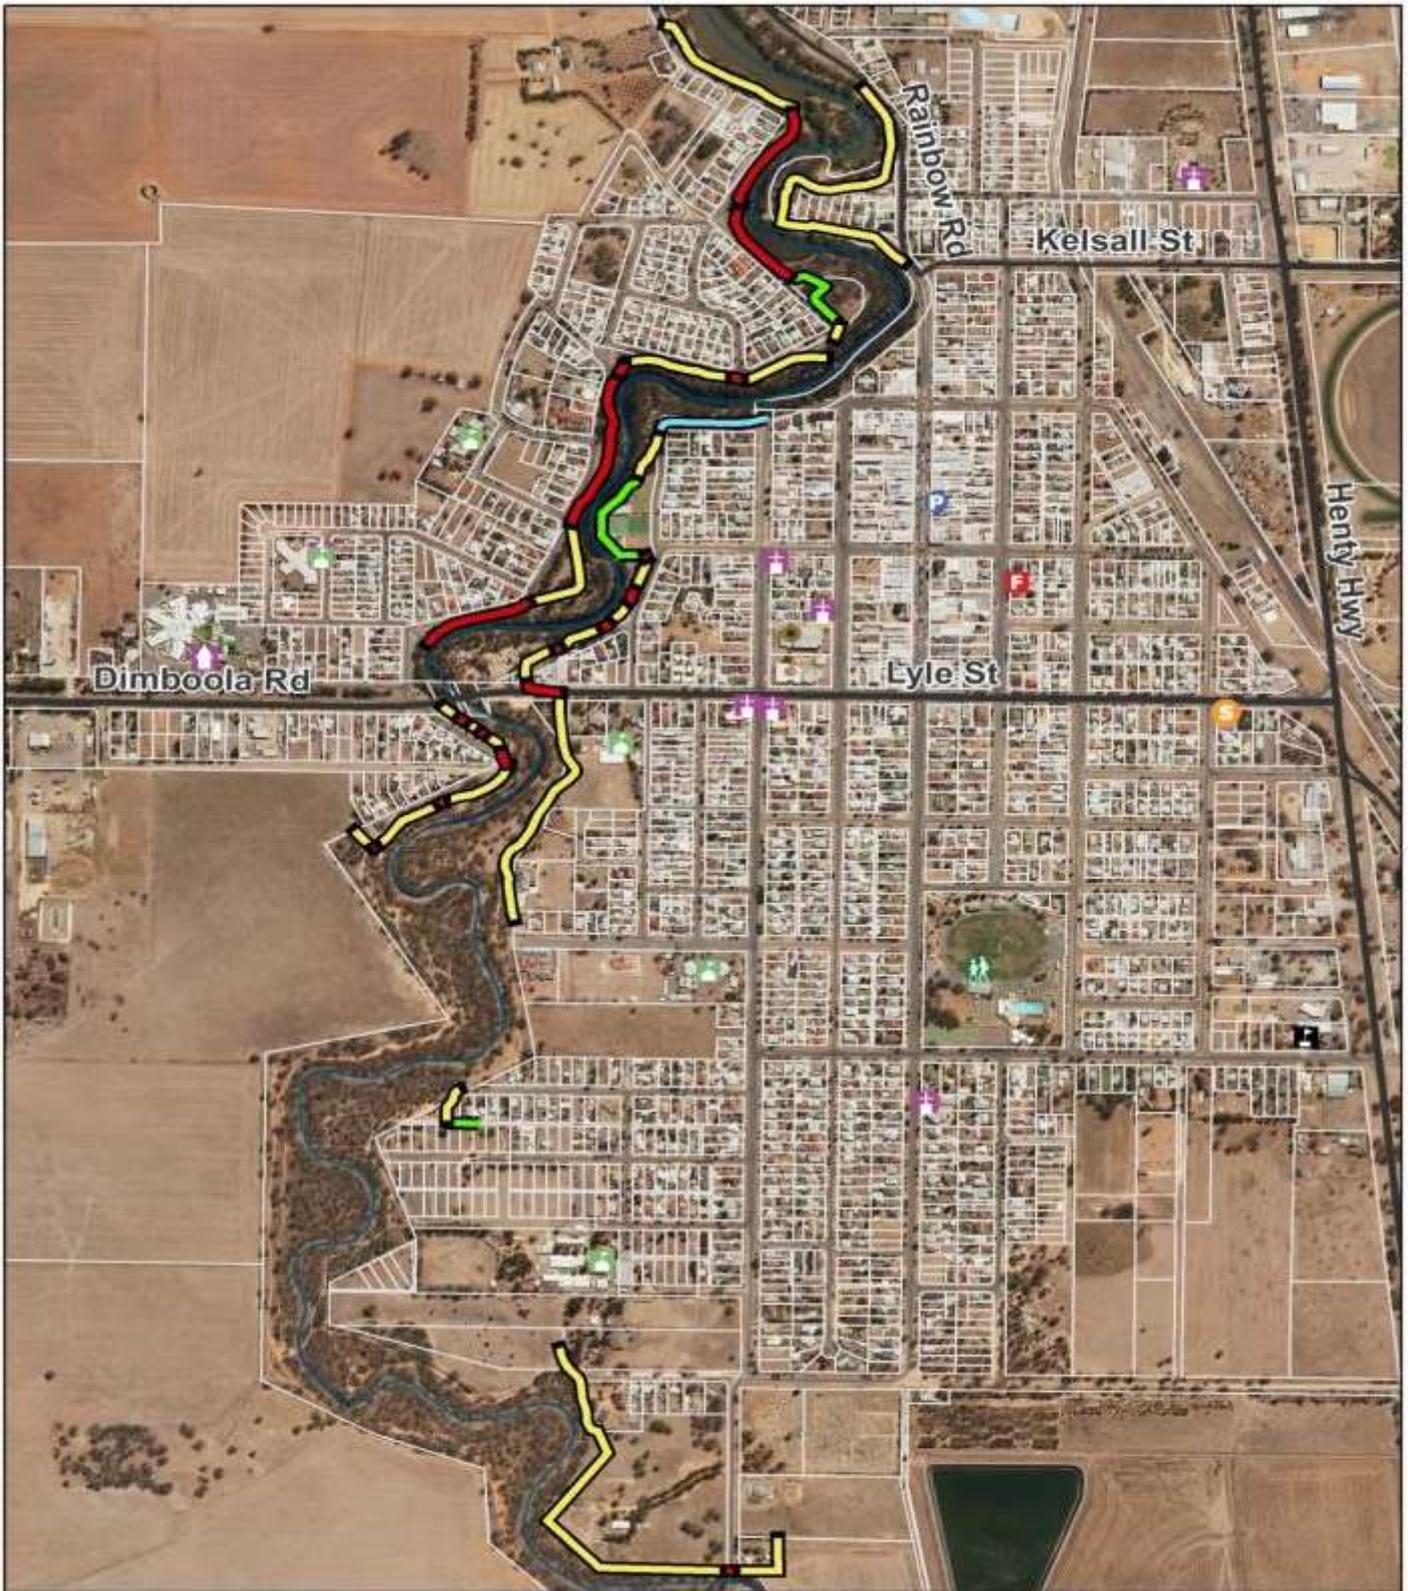
Warracknabeal proposed levee.

Yarriambiack Shire Council has received close to \$1,000,000 in April 2017 to construct a levee to provide flood protection in Warracknabeal up to a 100 year ARI flood event, with 100 mm freeboard. The construction of the Warracknabeal levee has started. Refer to the map below showing the proposed Warracknabeal levee design (Water Technology 2016).

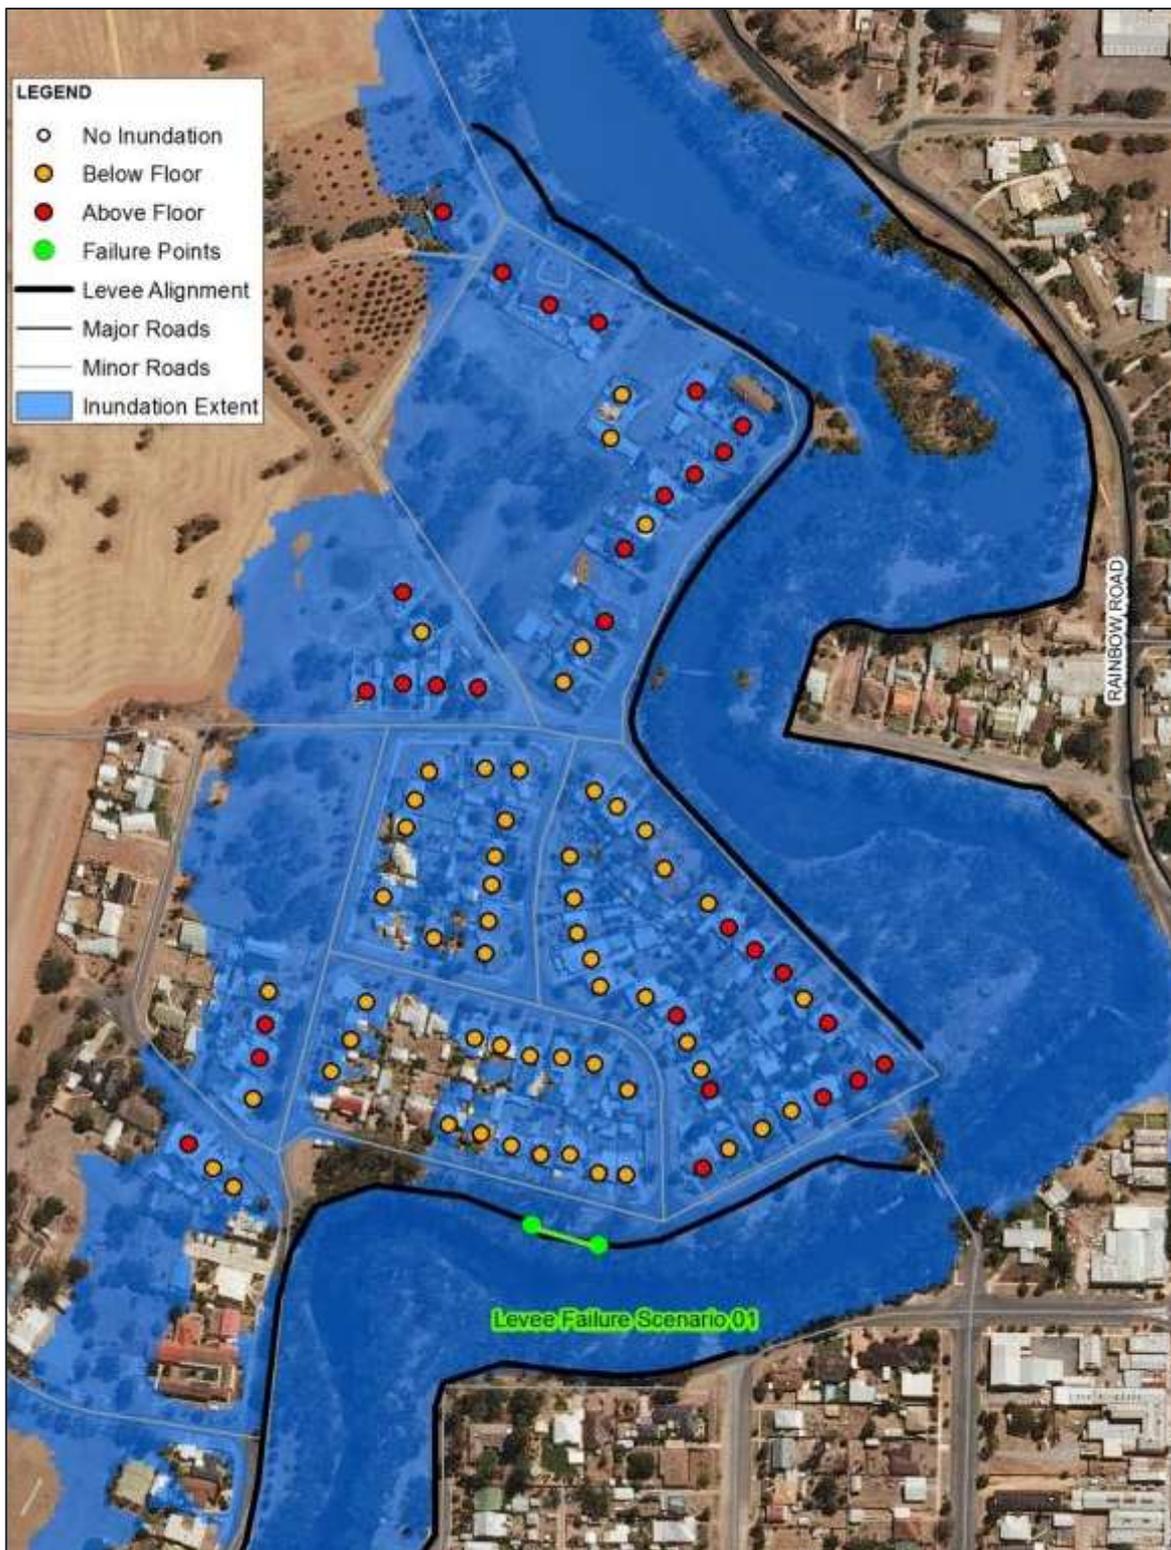
Impact assessment of the levee failure scenario.

With the construction of any flood protection levee there is a risk the levee may fail. The most likely points of levee failure are on the outside of bends where the velocity is the highest and there is a chance of the creek migrating and the bank collapsing, or where there are points of weakness in the levee such as cracks, holes, poorly constructed sections, informal crossings which lower the crest over time, services such as pipes that run through the levee which have not been adequately set in, etc (Water Technology 2016).

The levee failure section is approximately 15 m length at the peak height of the 100 year ARI event, with an hour duration for the levee failure to breach to ground level. The levee failure assessment assists in understanding the potential result of a levee failure. Refer to the map shown below for the inundation extent and properties flooded above floor. For the existing conditions (without the levee being constructed) 10 buildings would be flooded above floor. In the levee failure scenario in the map below 29 buildings are flooded above floor and 55 below floor. This demonstrates that failure of the levee will cause a significant impact. The area inundated is limited to the area of levee failure with flood water unable to re-enter Yarriambiack Creek, being trapped outside of the levee (Water Technology 2016).

These results demonstrate the residual risk of living behind a levee. There is a danger that complacency may set in with residents and authorities lulled into a false sense of security, with the assumption that all risk has been removed because they are behind a levee. It is important for the community to understand that larger flood events can overtop or outflank a levee, and a levee can fail. For these reasons it is imperative that a levee system is maintained, that flood related planning conditions are in place and that communities are educated to their risk and understand what it means for them (Water Technology 2016).

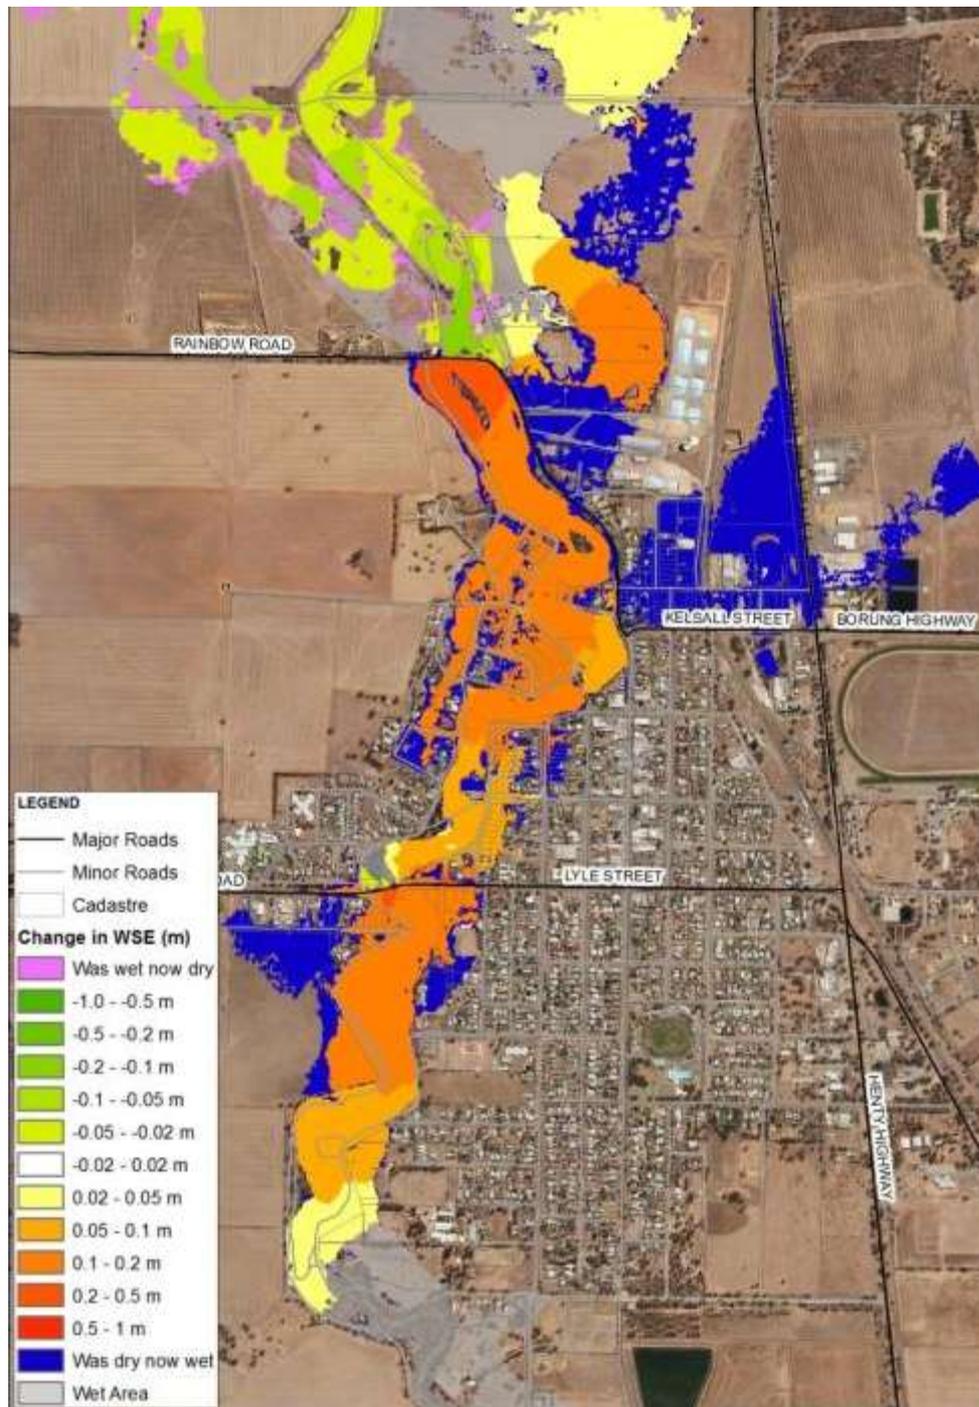
Blockage of structures along Yarriambiack Creek (Water Technology 2016).

The difference in flood level caused by blockage of all three structures is shown in the map below. There is a significant increase in inundation extent north of Kelsall Street and with the maximum increase in flood levels observed upstream of the Warracknabeal Weir at around 0.2-0.25 m. The blockage of all three structures simultaneously and to 100% is over-conservative, but provides a worst case scenario (Water Technology 2016).

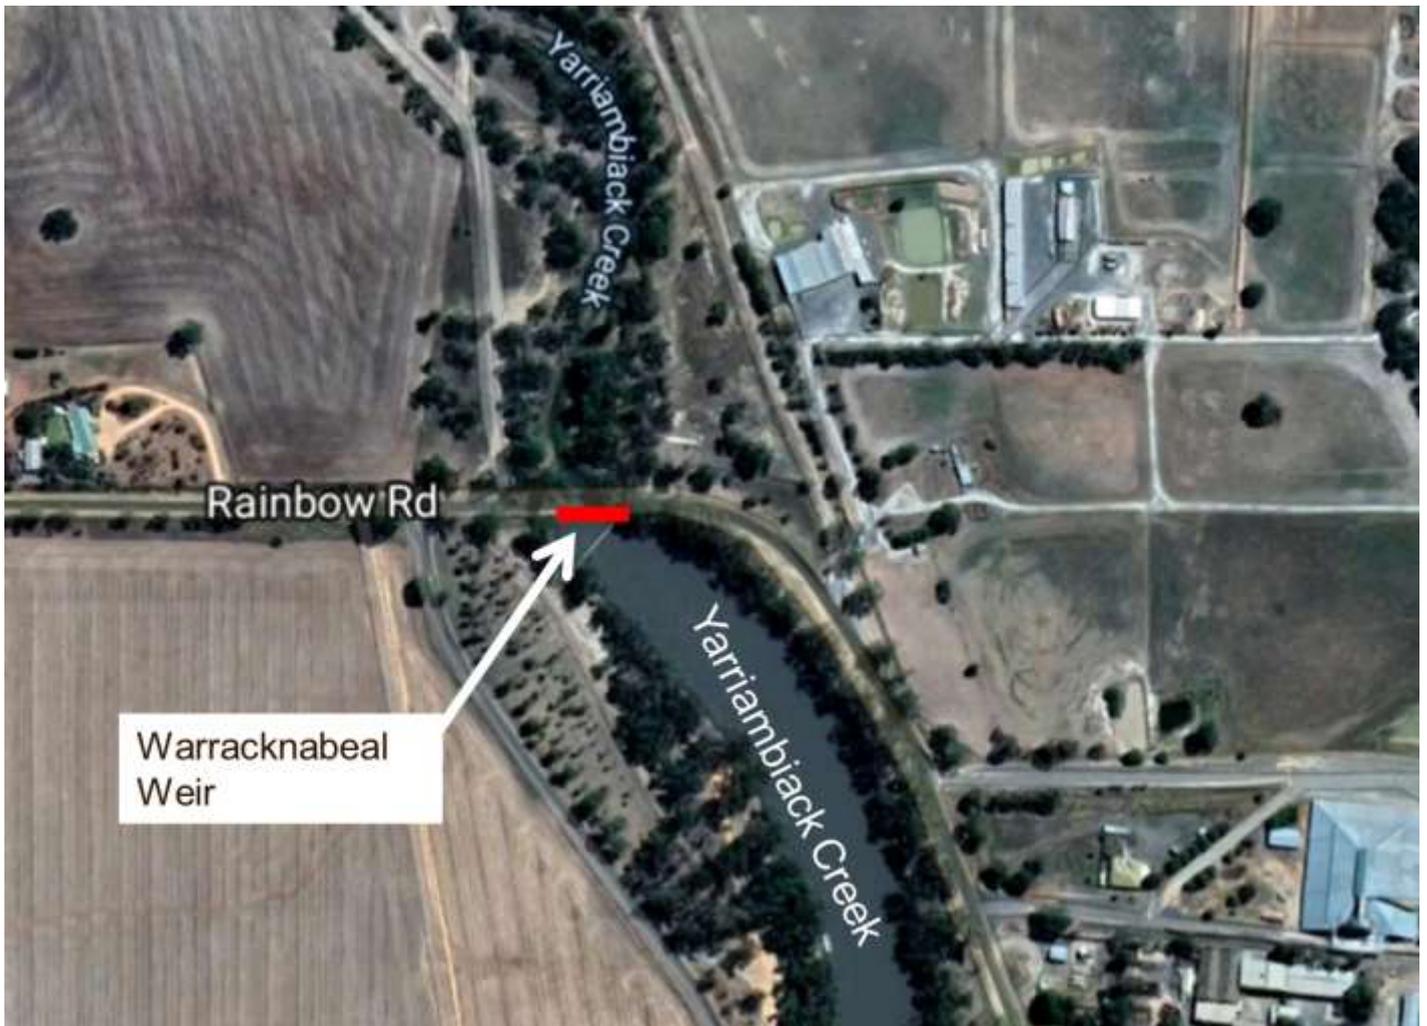
Location of the Warracknabeal Weir.
