Yarriambiack Shire Council

FLOOD EMERGENCY PLAN

A Sub-Plan of the Municipal Emergency Management Plan

Version 2, February 2020

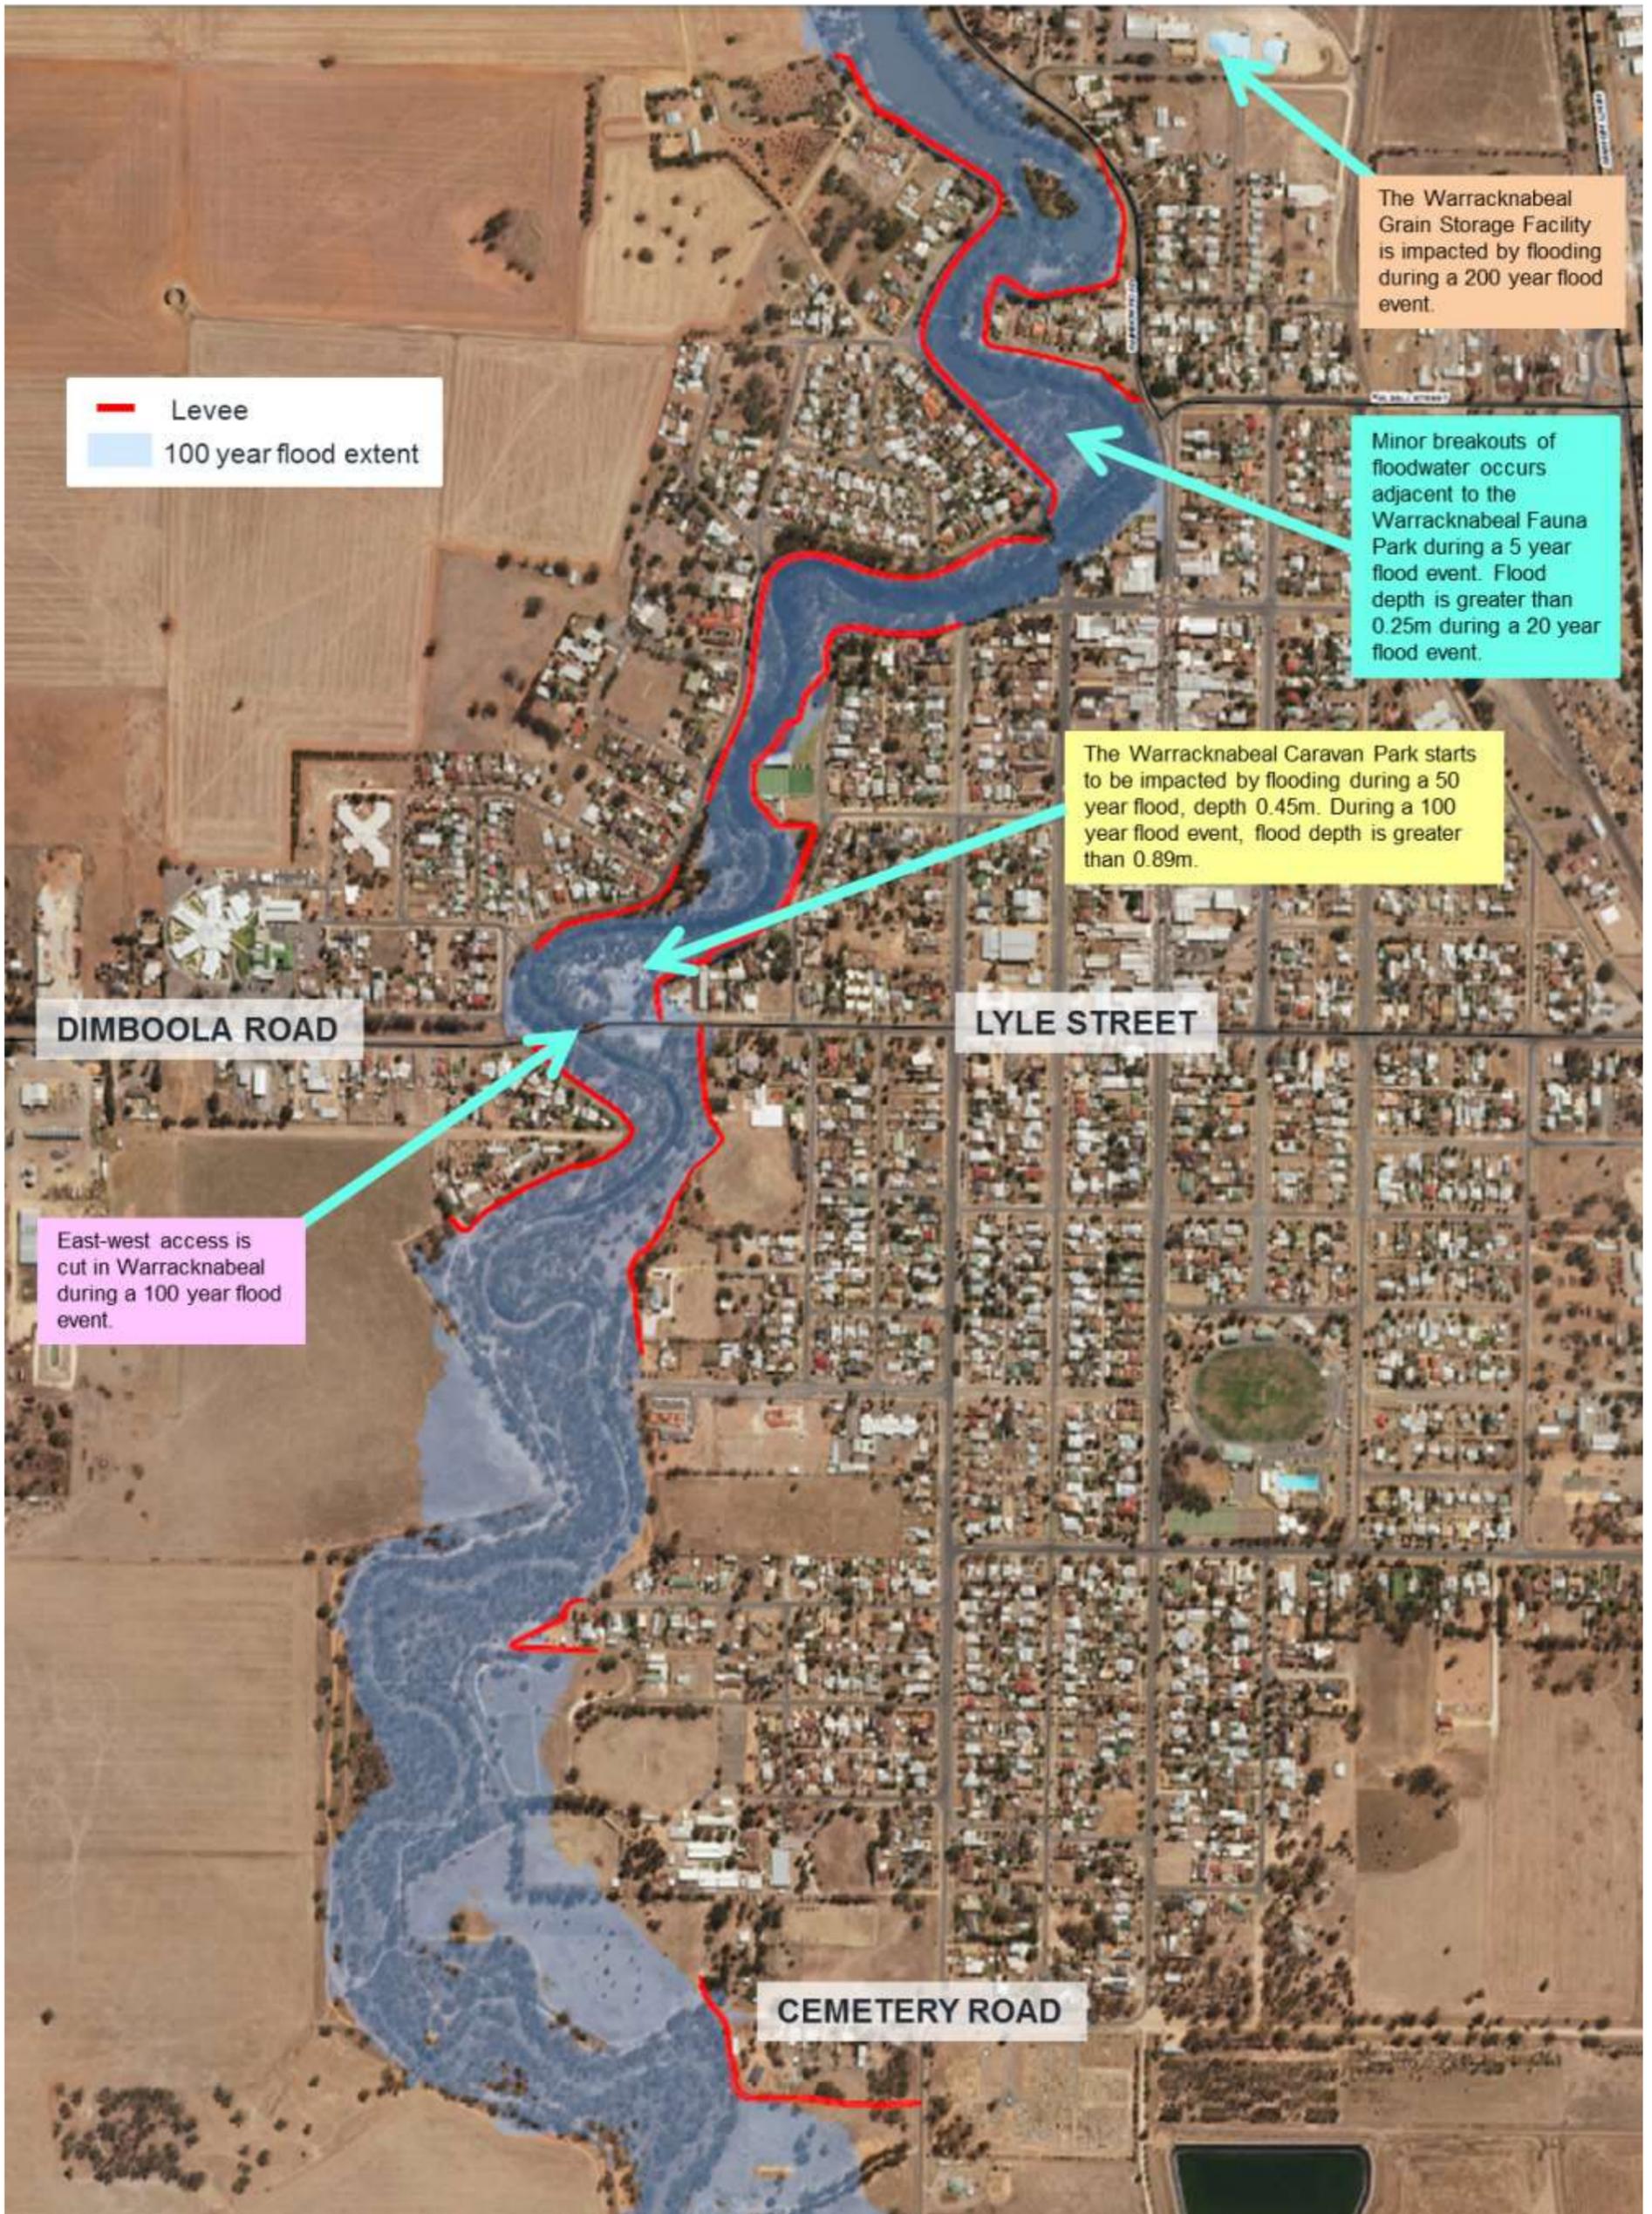
Roads and assets impacted by flooding in Warracknabeal, with the proposed levee and 100 year ARI extent (Water Technology 2016).

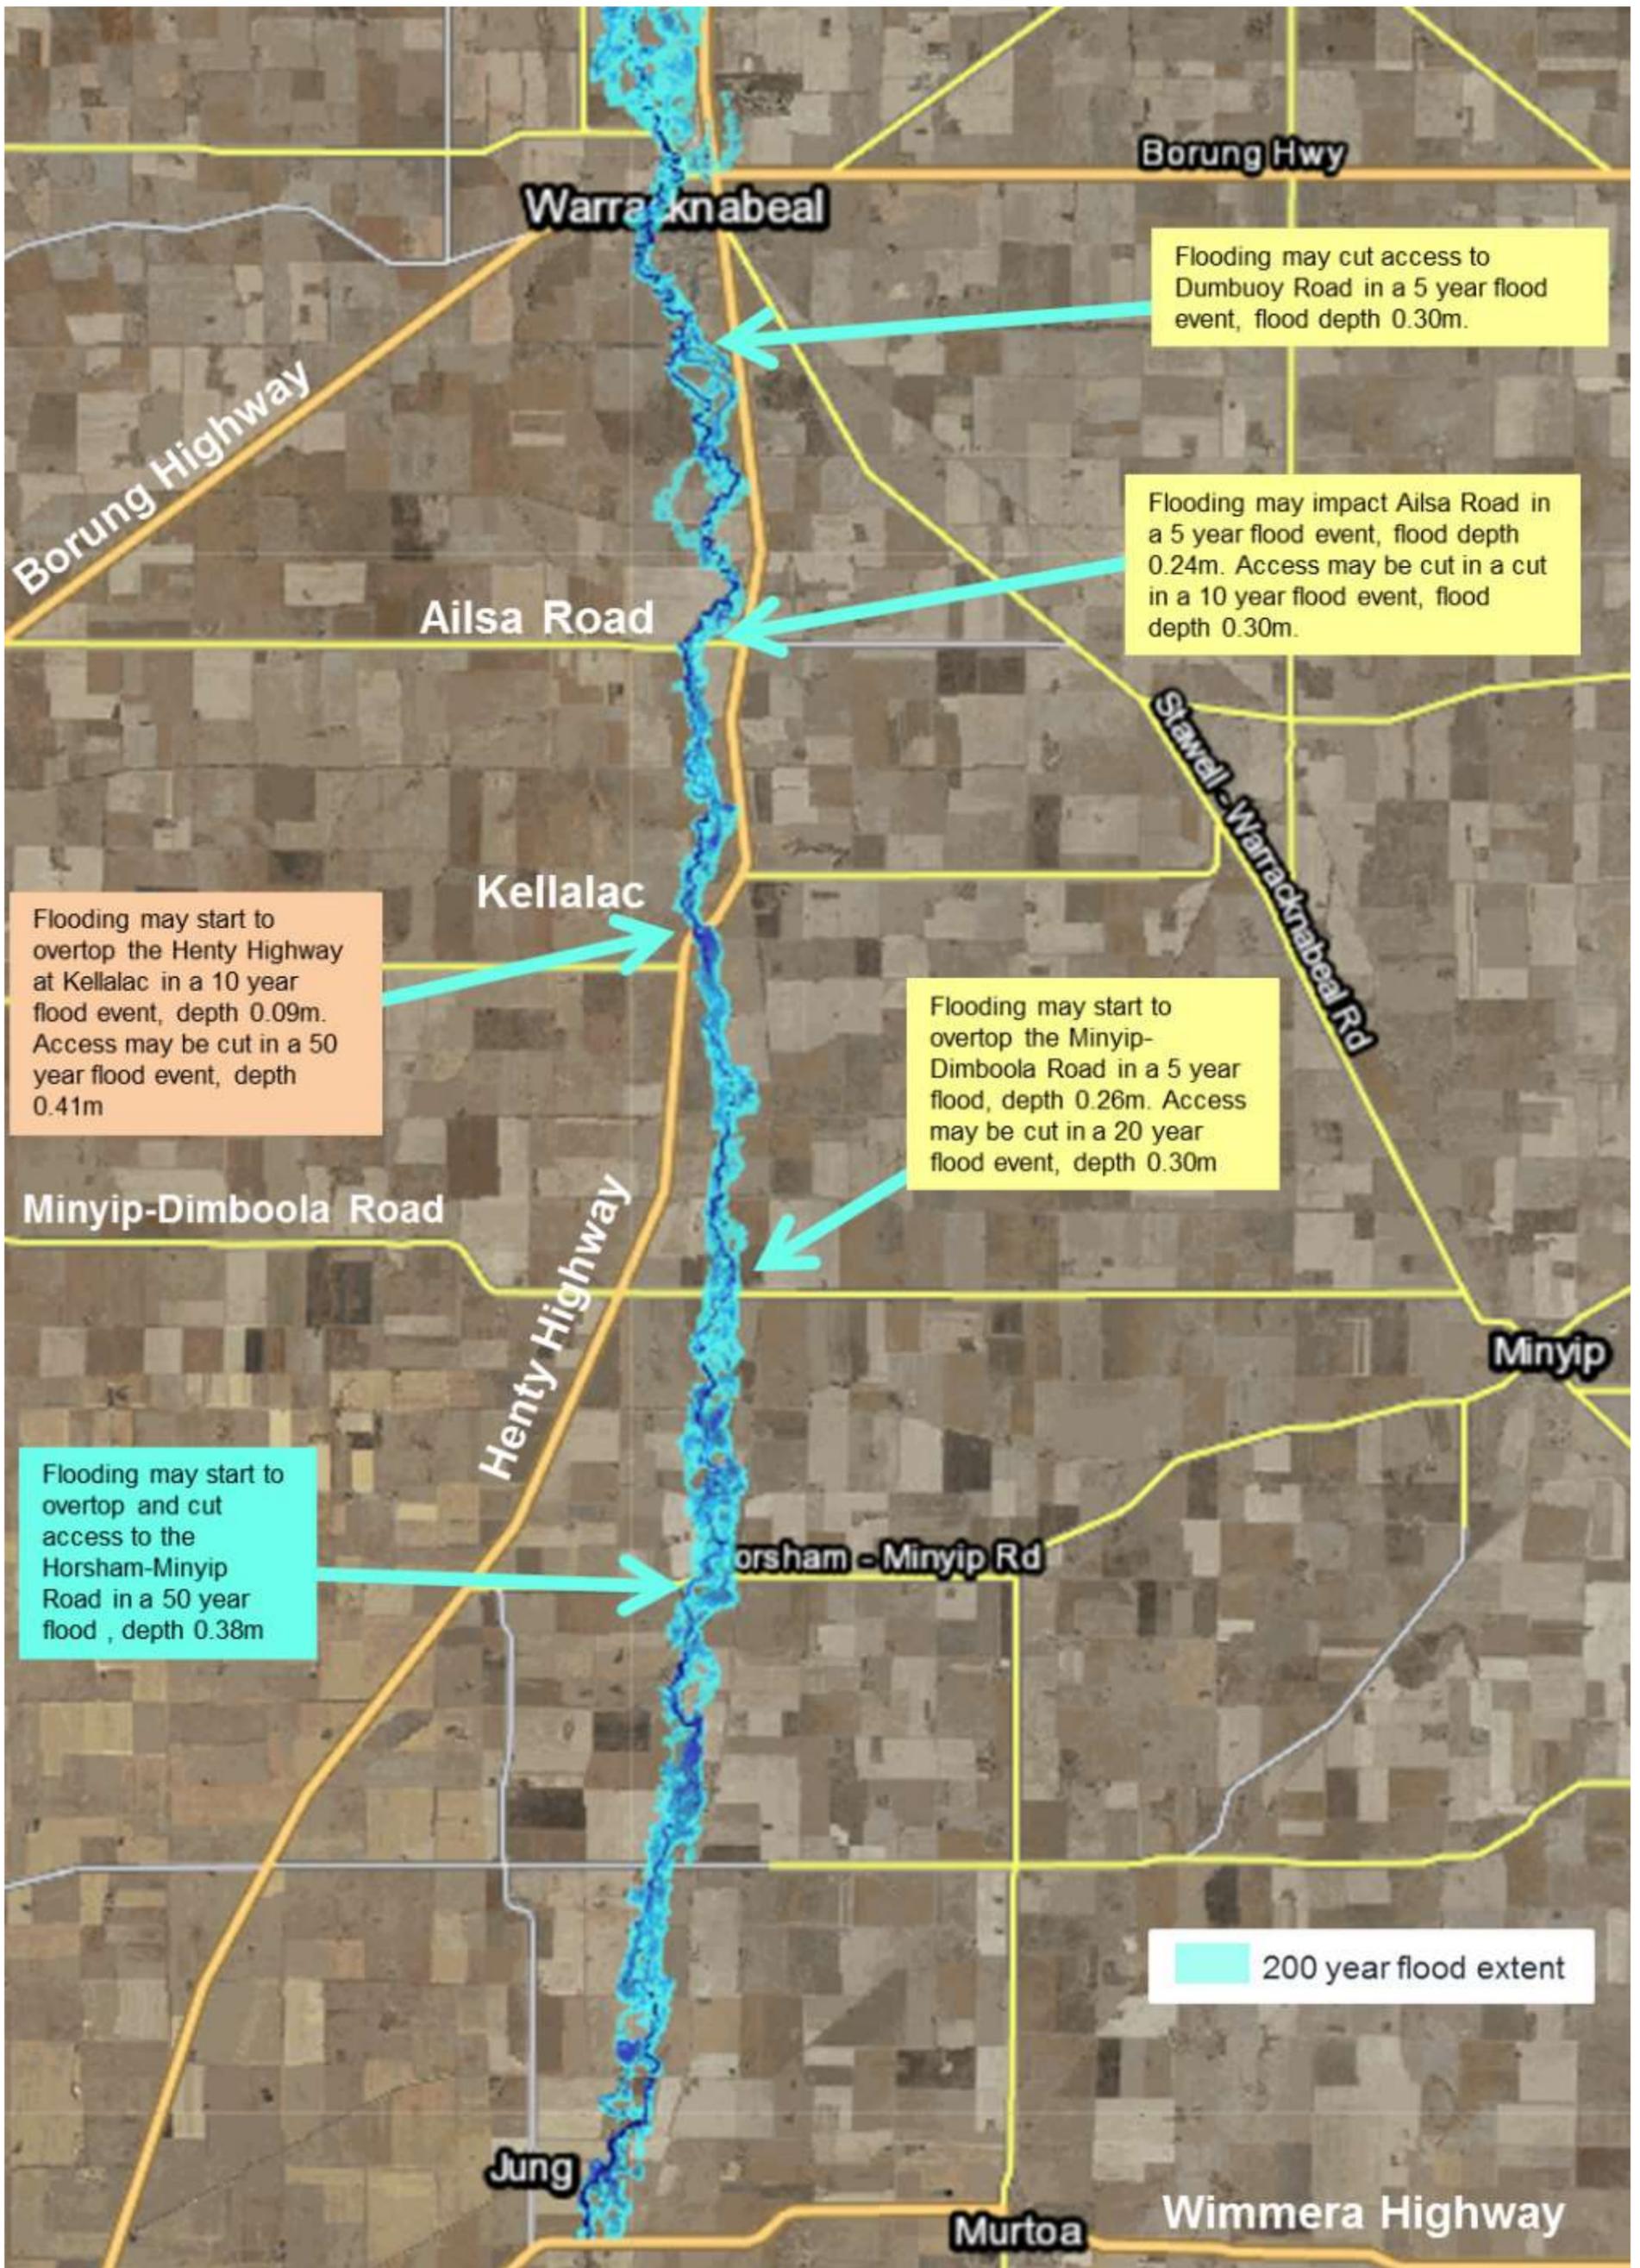
Roads impacted by flooding along Yarriambiack Creek, south of Warracknabeal.

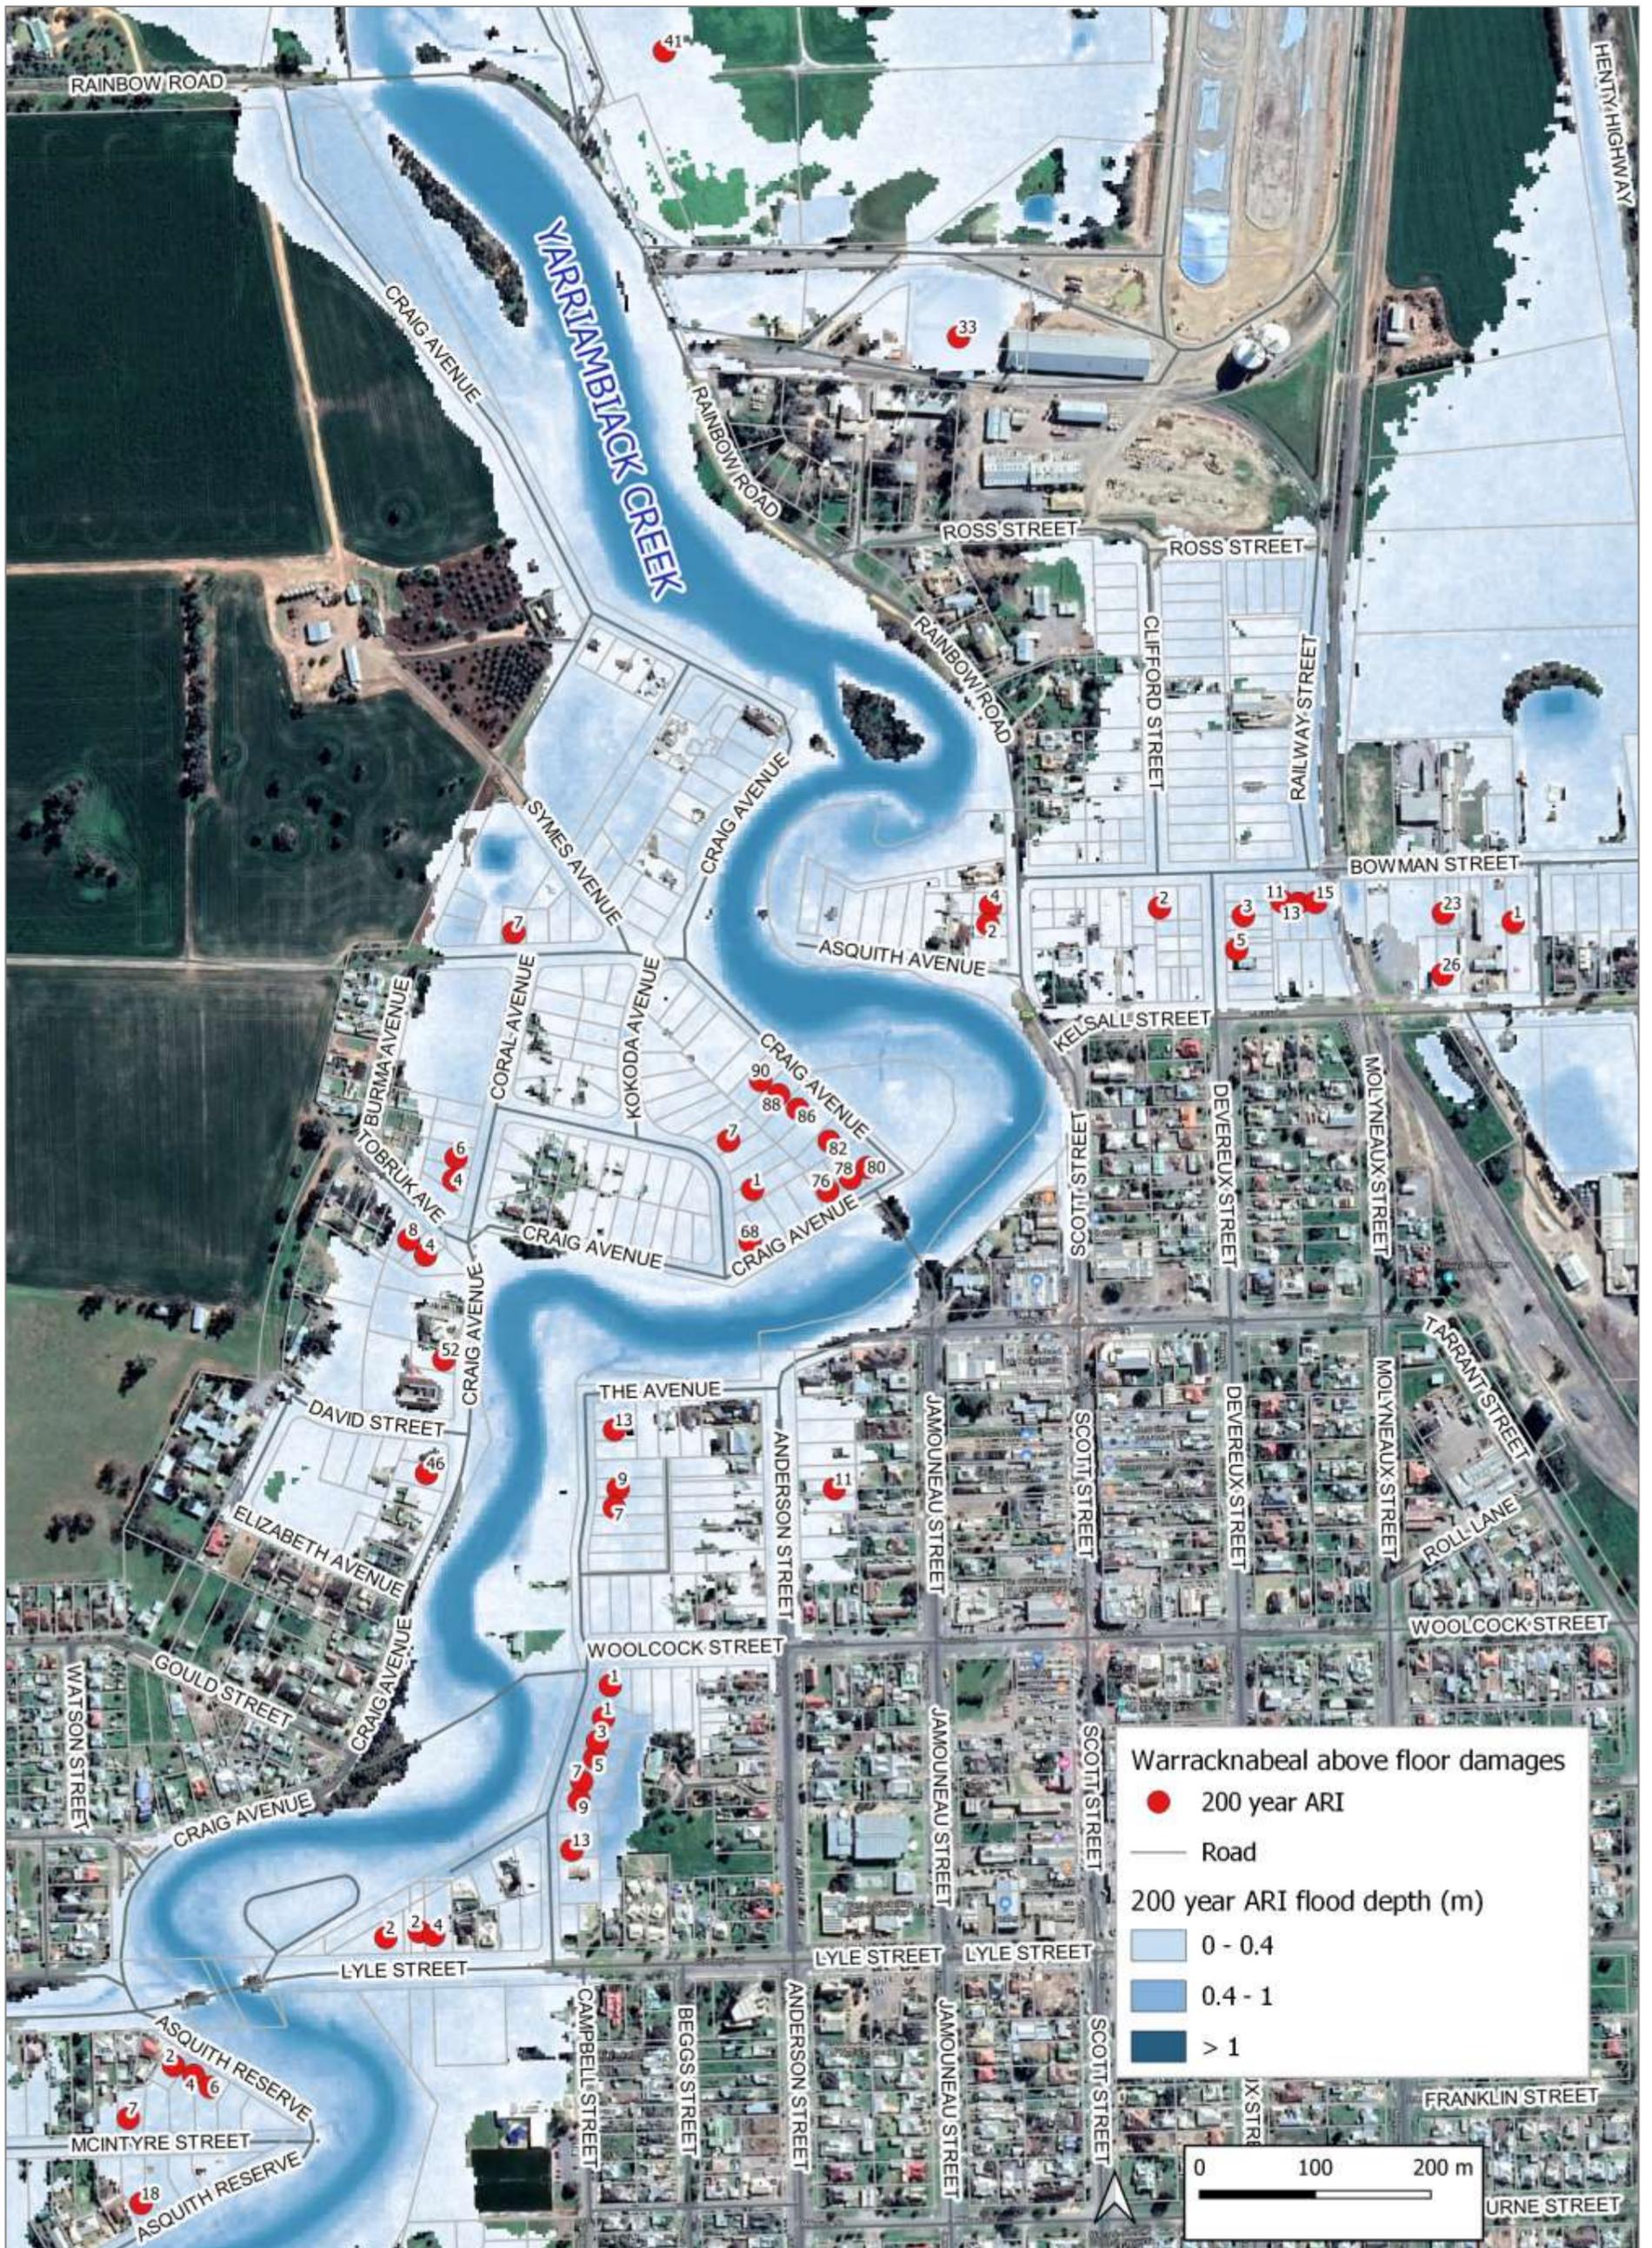
Warracknabeal above floor damages during a 200 year ARI flood event (Water Technology 2016)

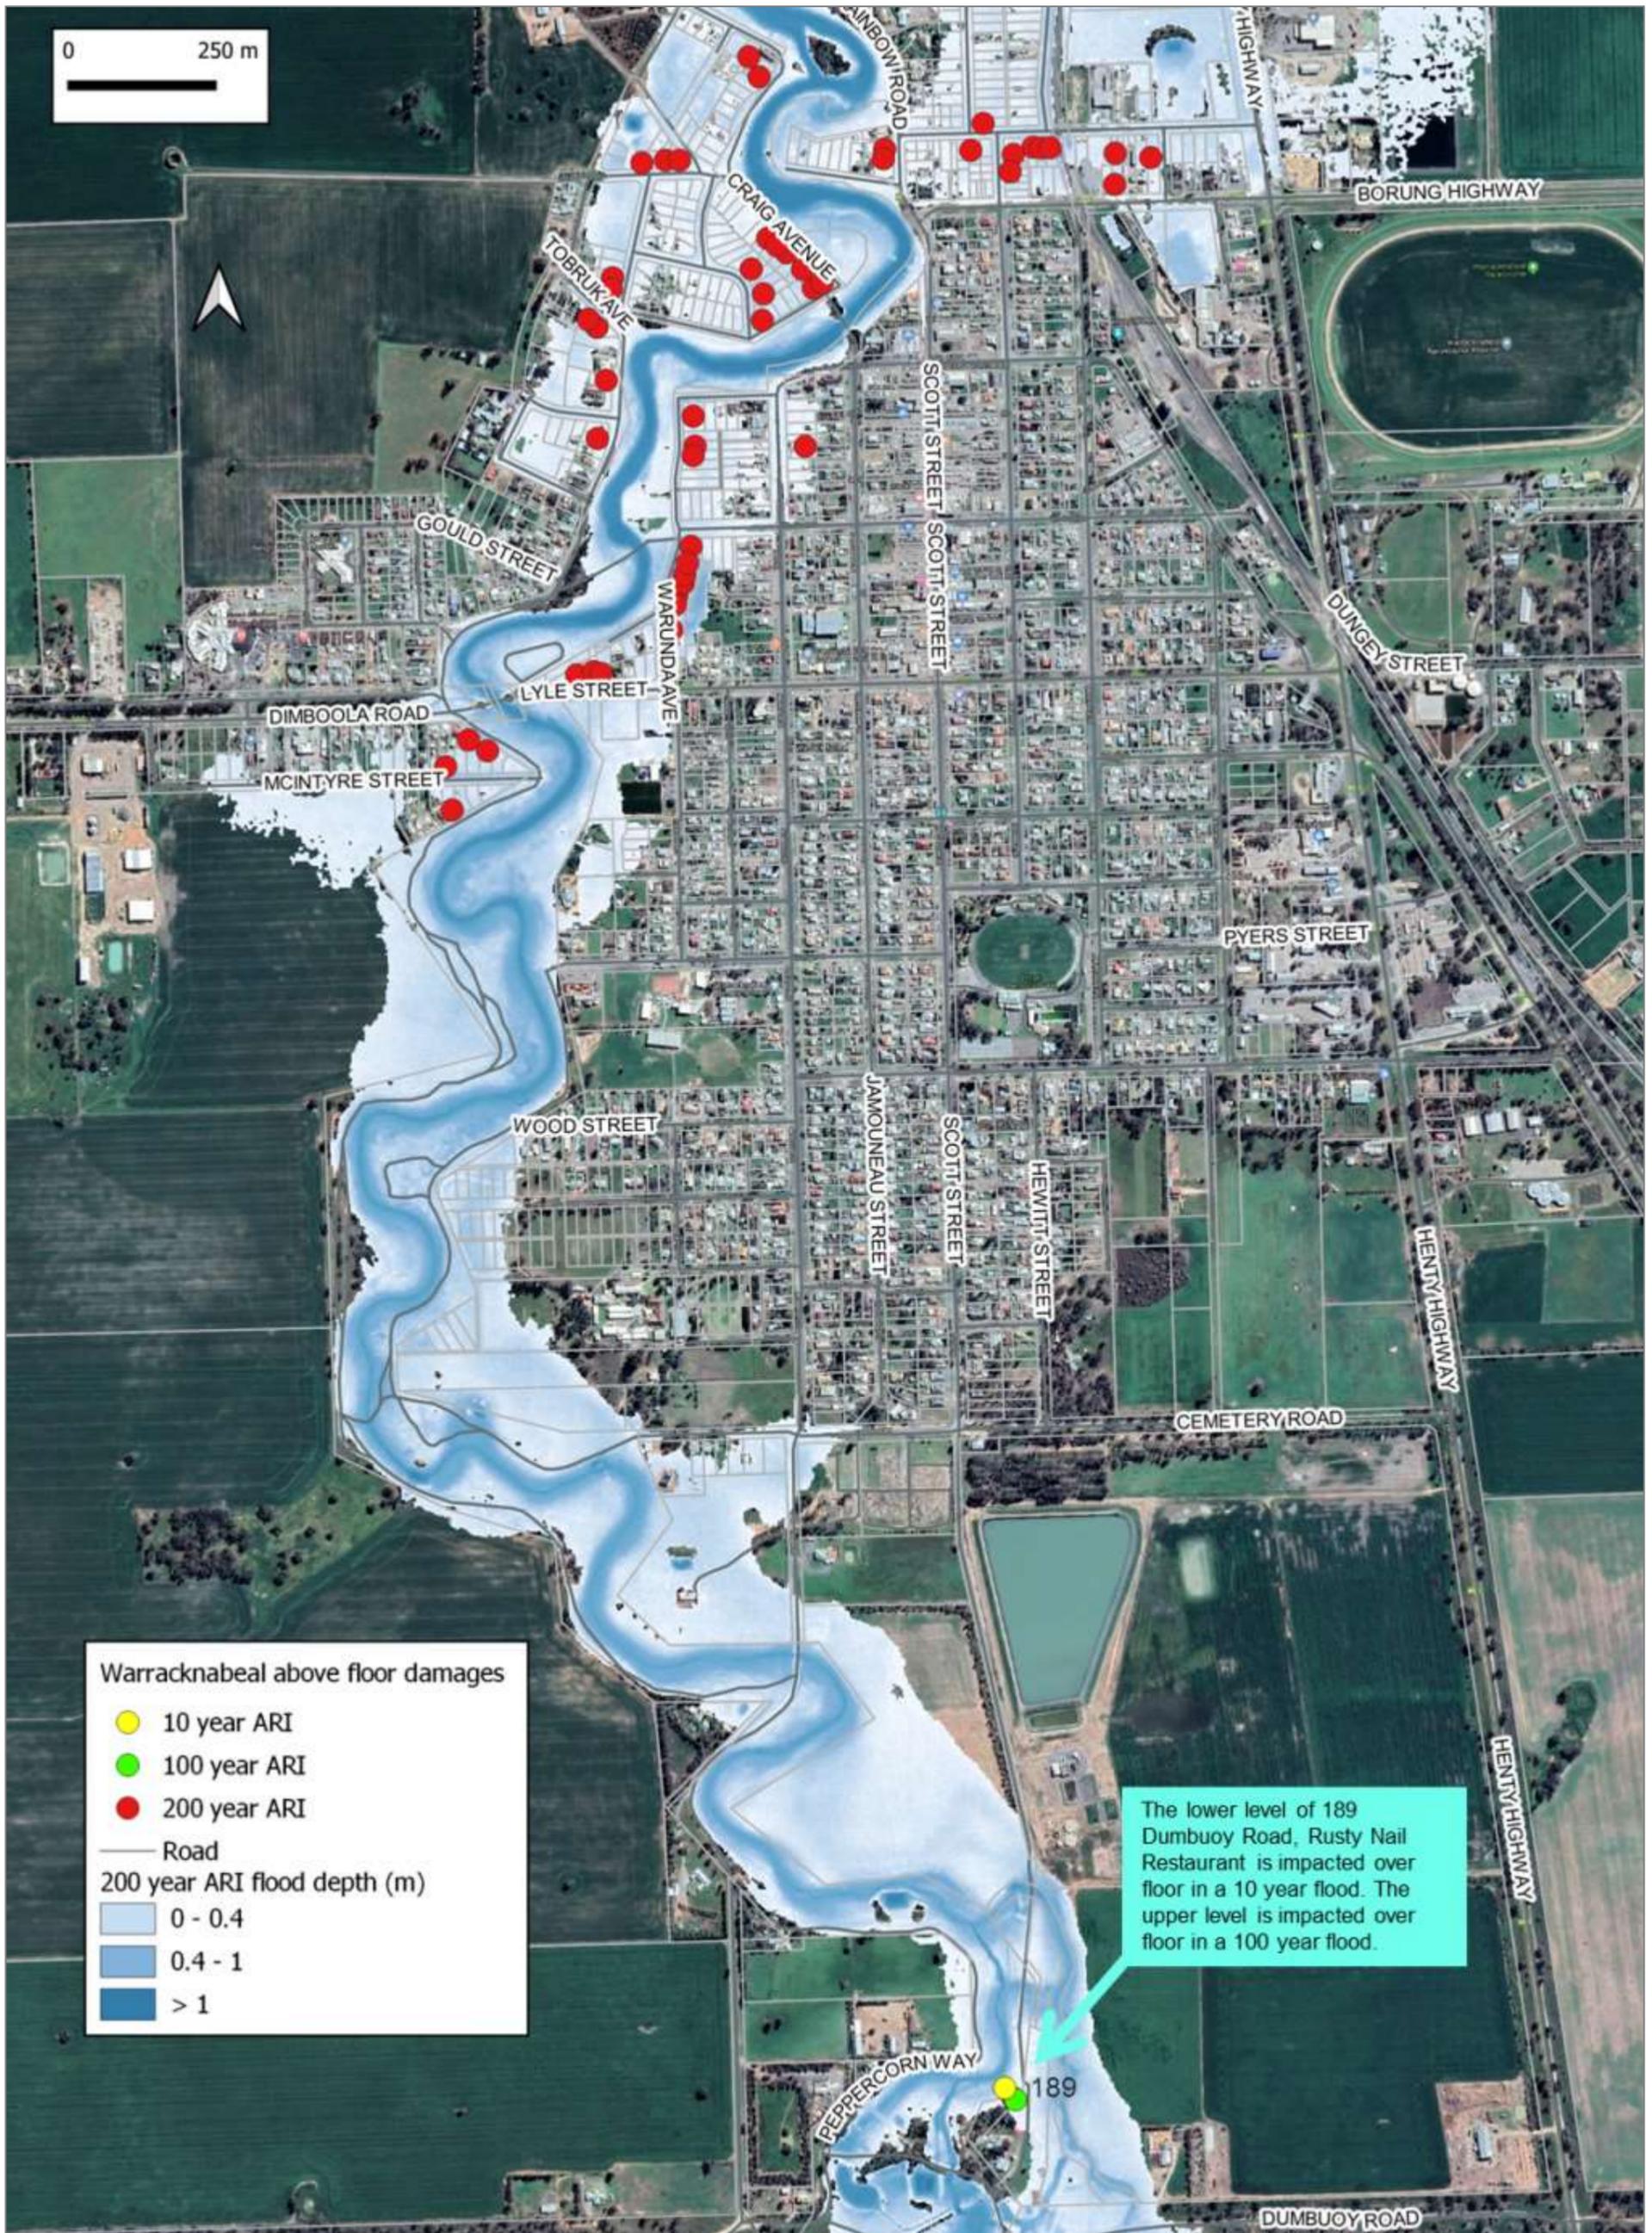
Warracknabeal above floor damages during a 200 year ARI flood event (Water Technology 2016)

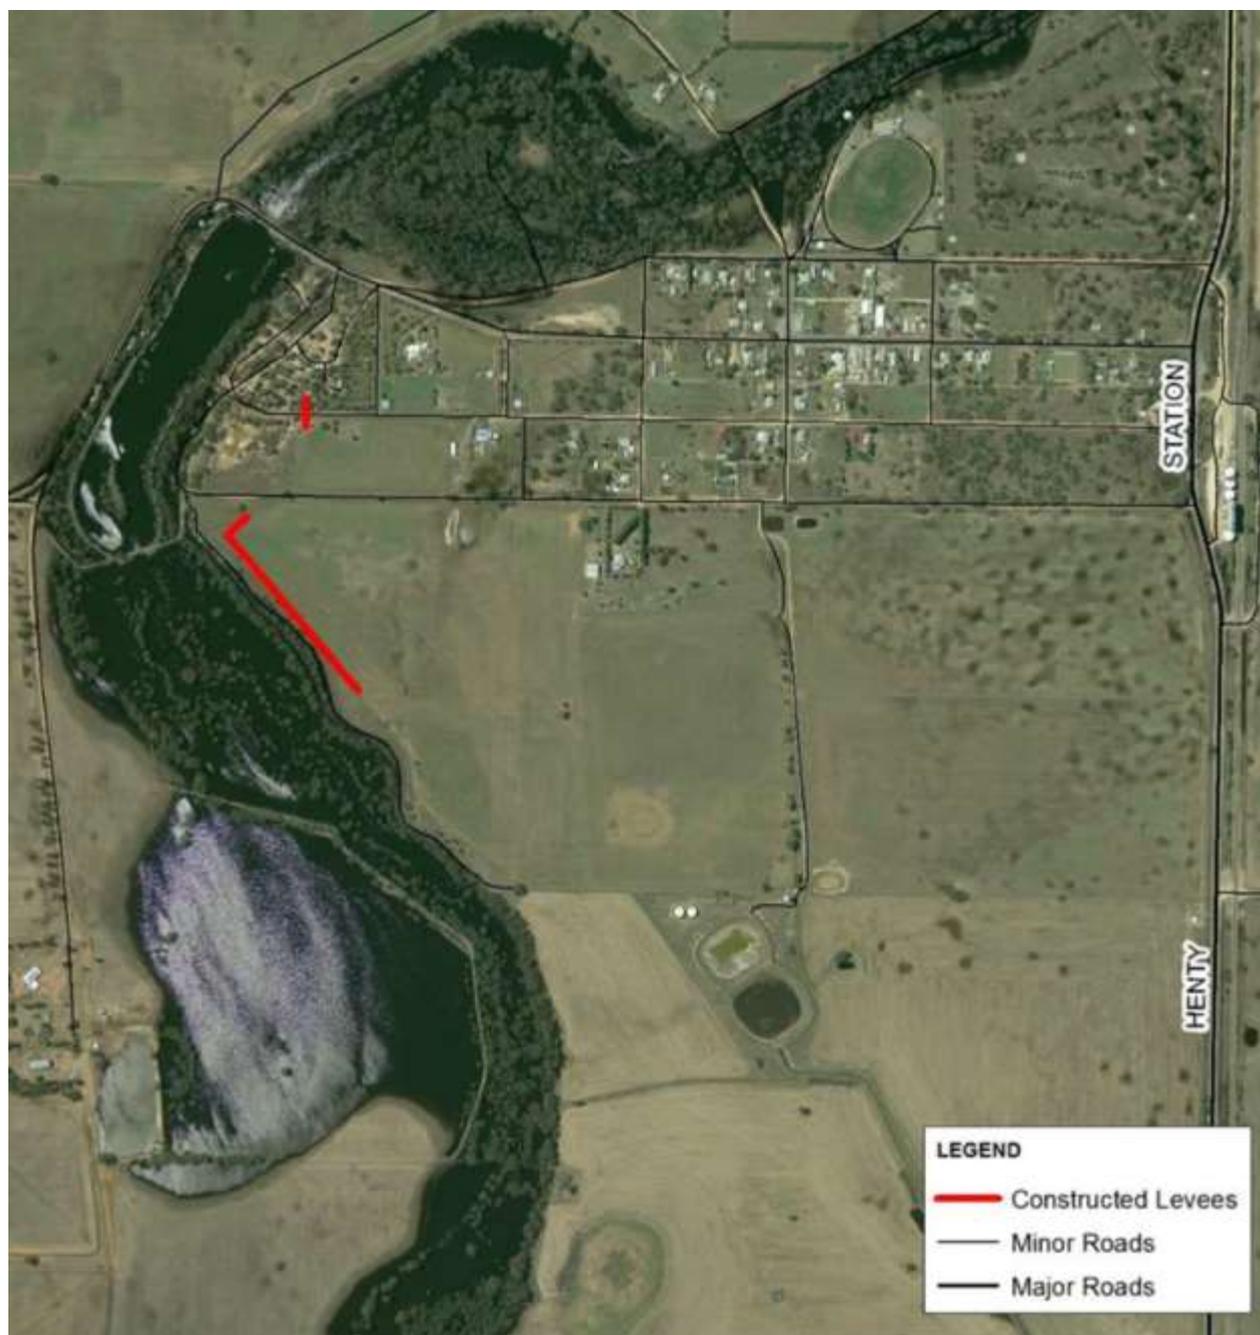
Brim levees during the January 2011 flood event.

Levees were also constructed in Brim during the January 2011 flood event, refer to map below. However these levees were not required. Modelling (Water Technology 2016) has shown these levees are unnecessary up to a 200 year ARI flood event.

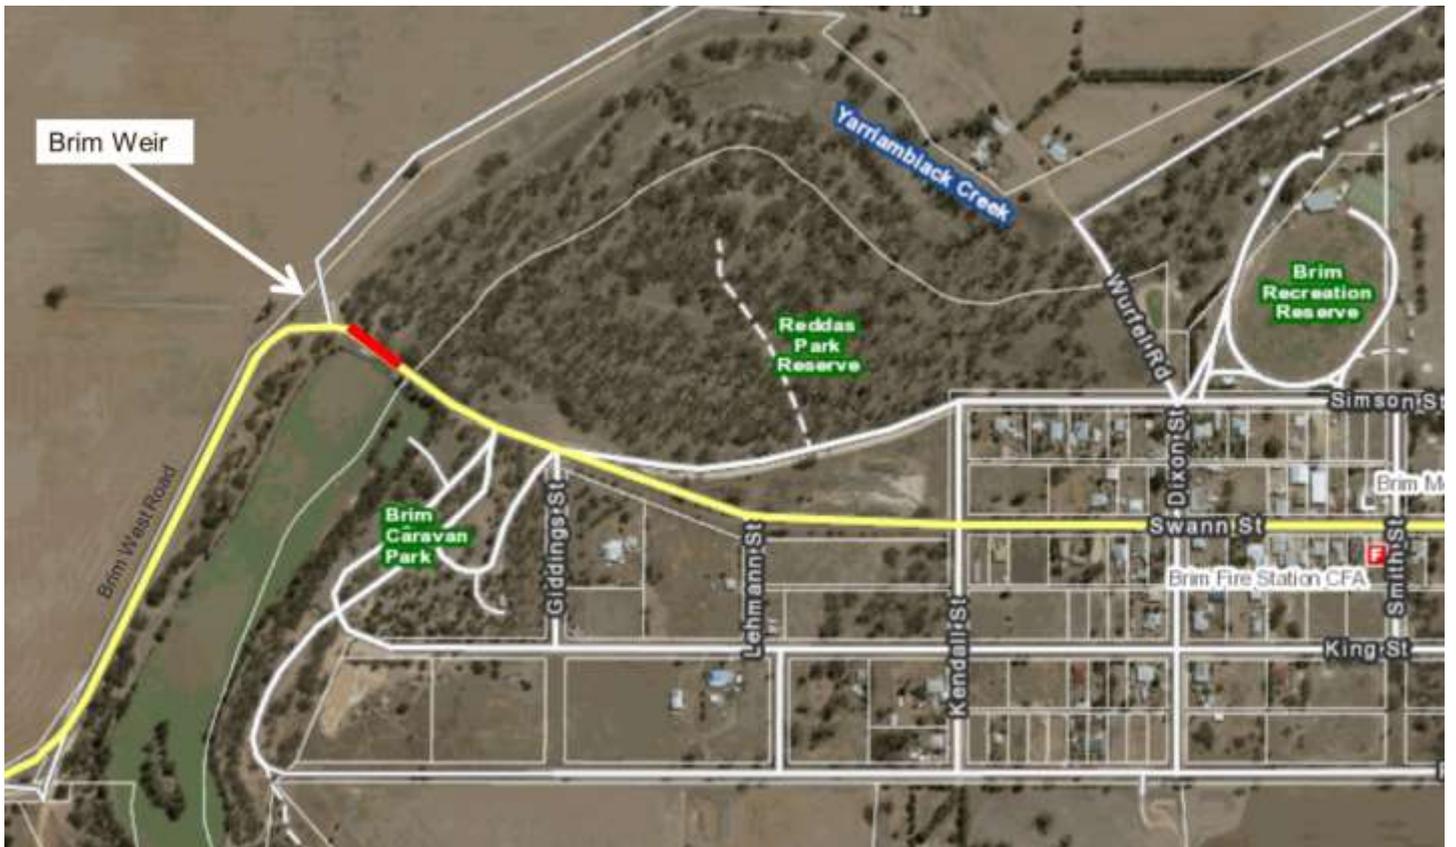
Location of the Brim Weir.

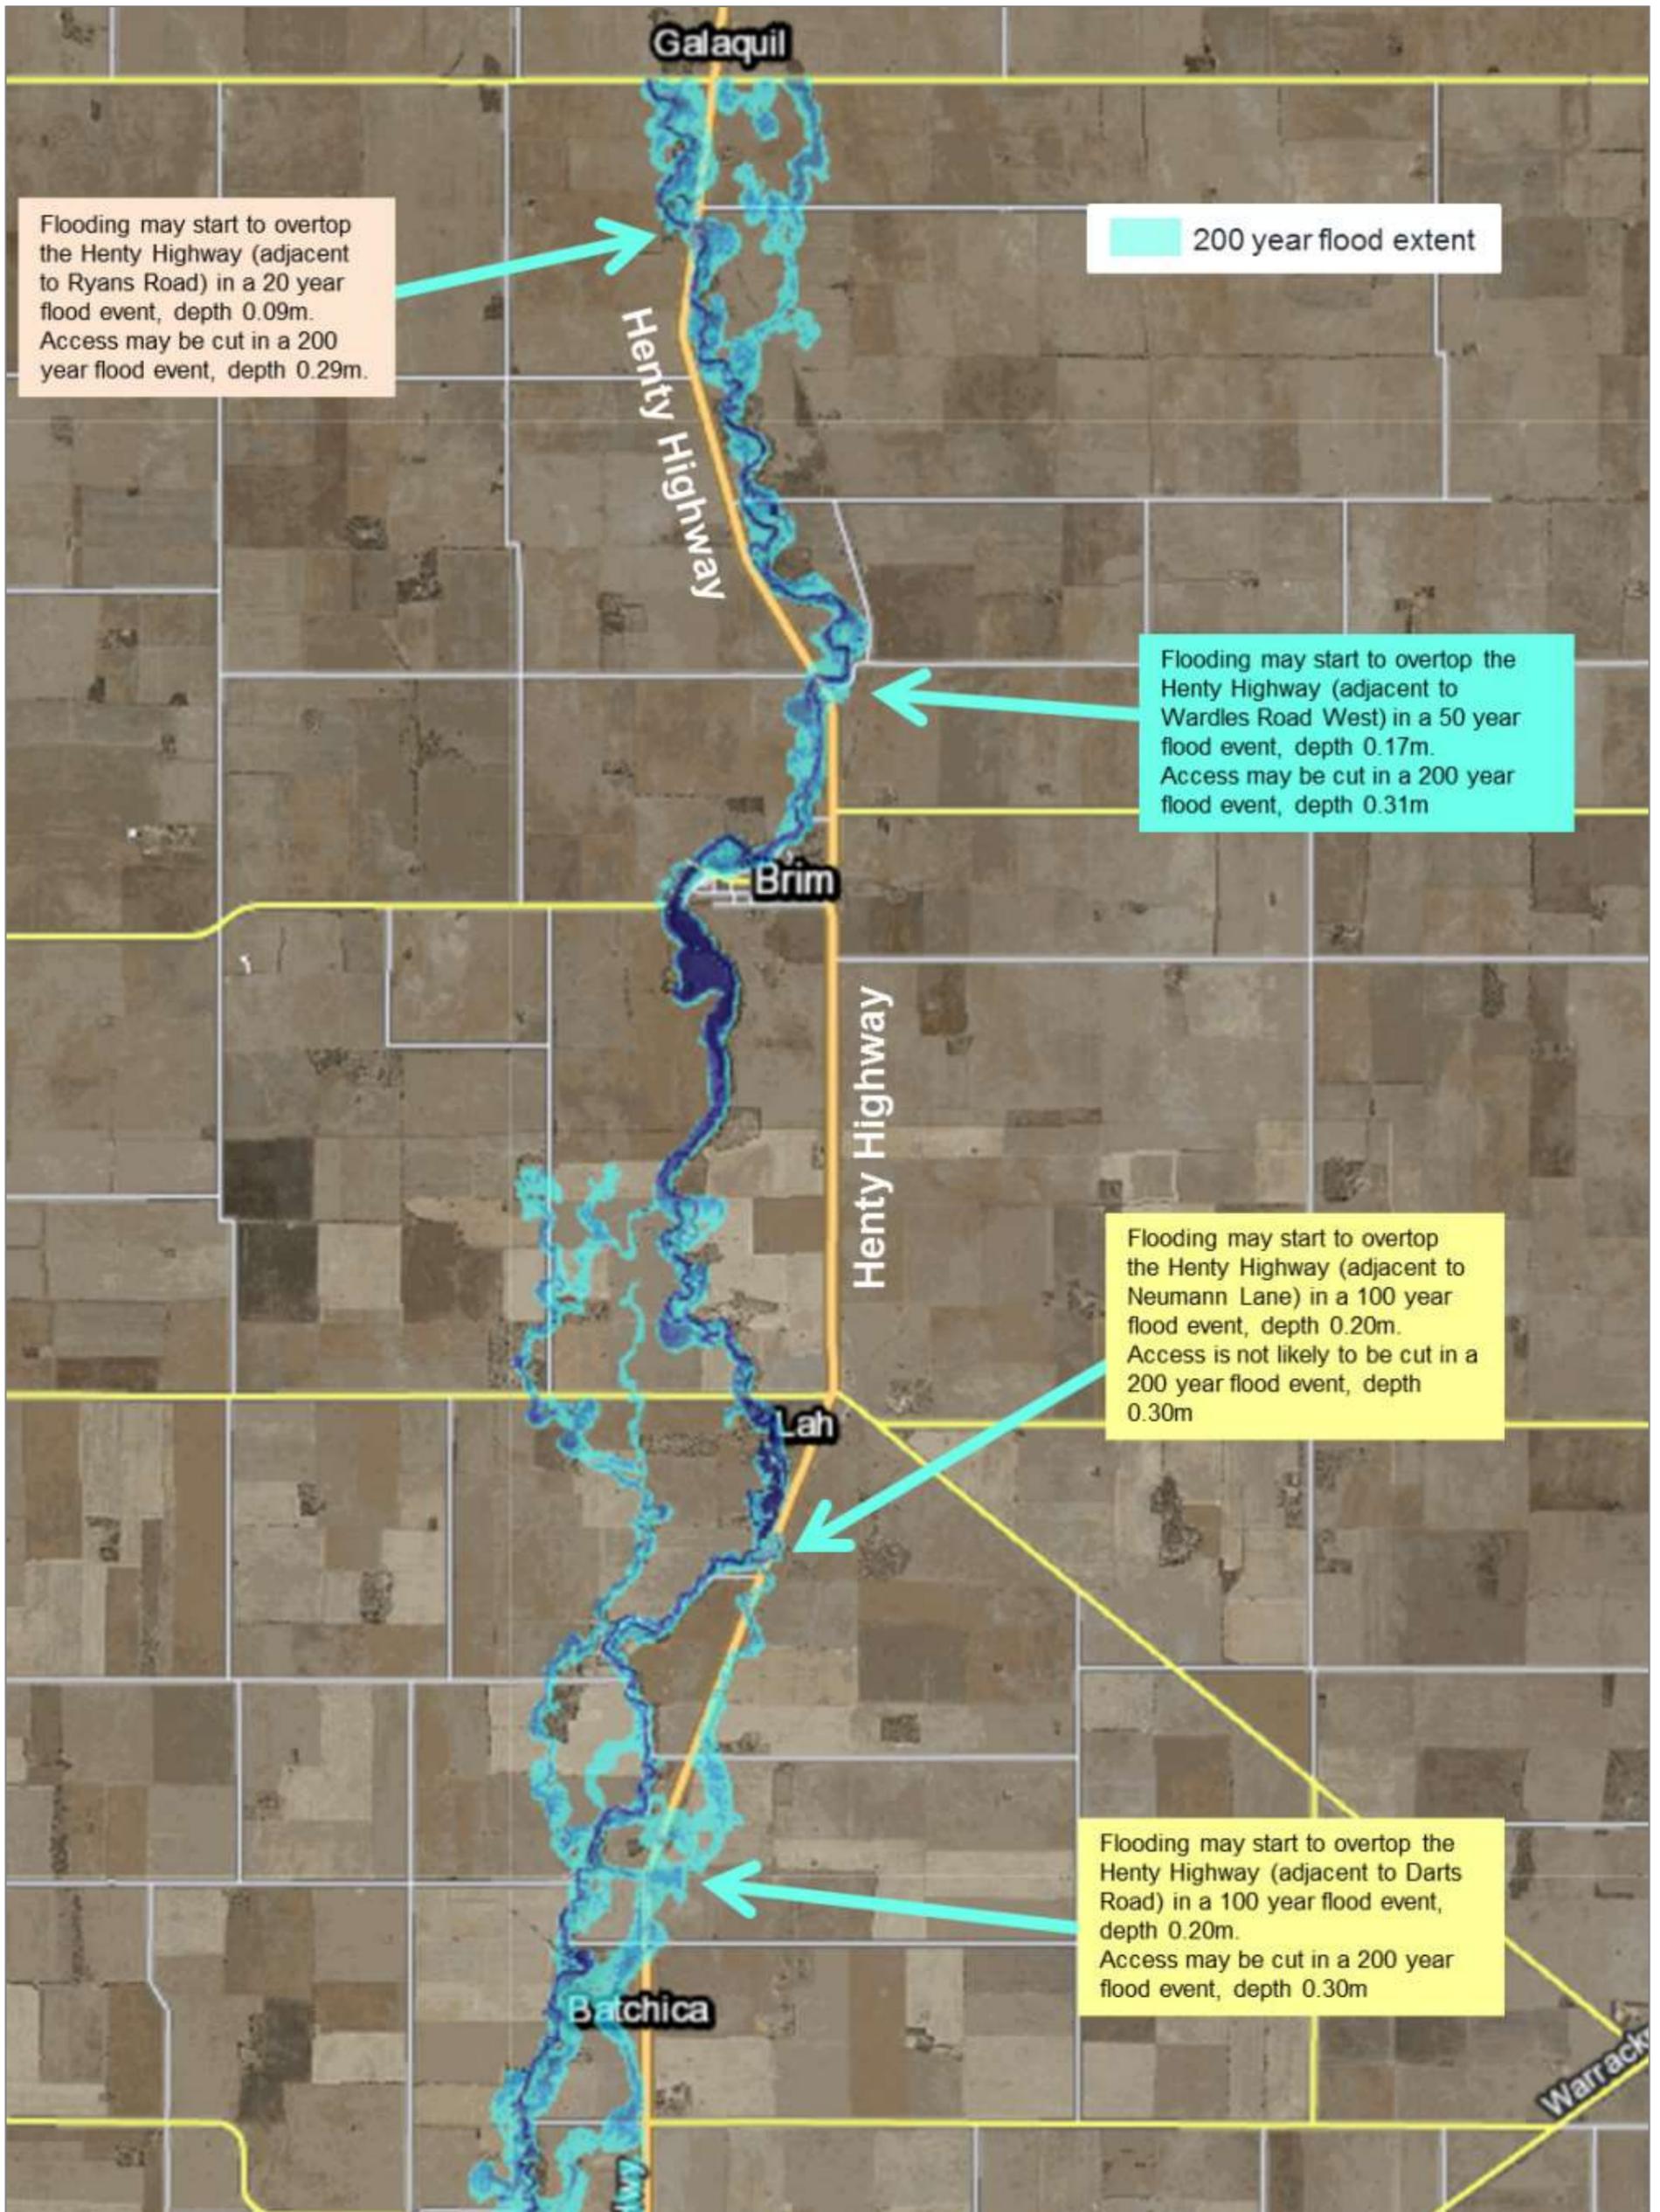
Roads impacted by flooding along the Yarriambiack Creek, north of Warracknabeal with the 200 year ARI flood extent.
