Yarriambiack Shire Council

FLOOD EMERGENCY PLAN

A Sub-Plan of the Municipal Emergency Management Plan

Version 2, February 2020

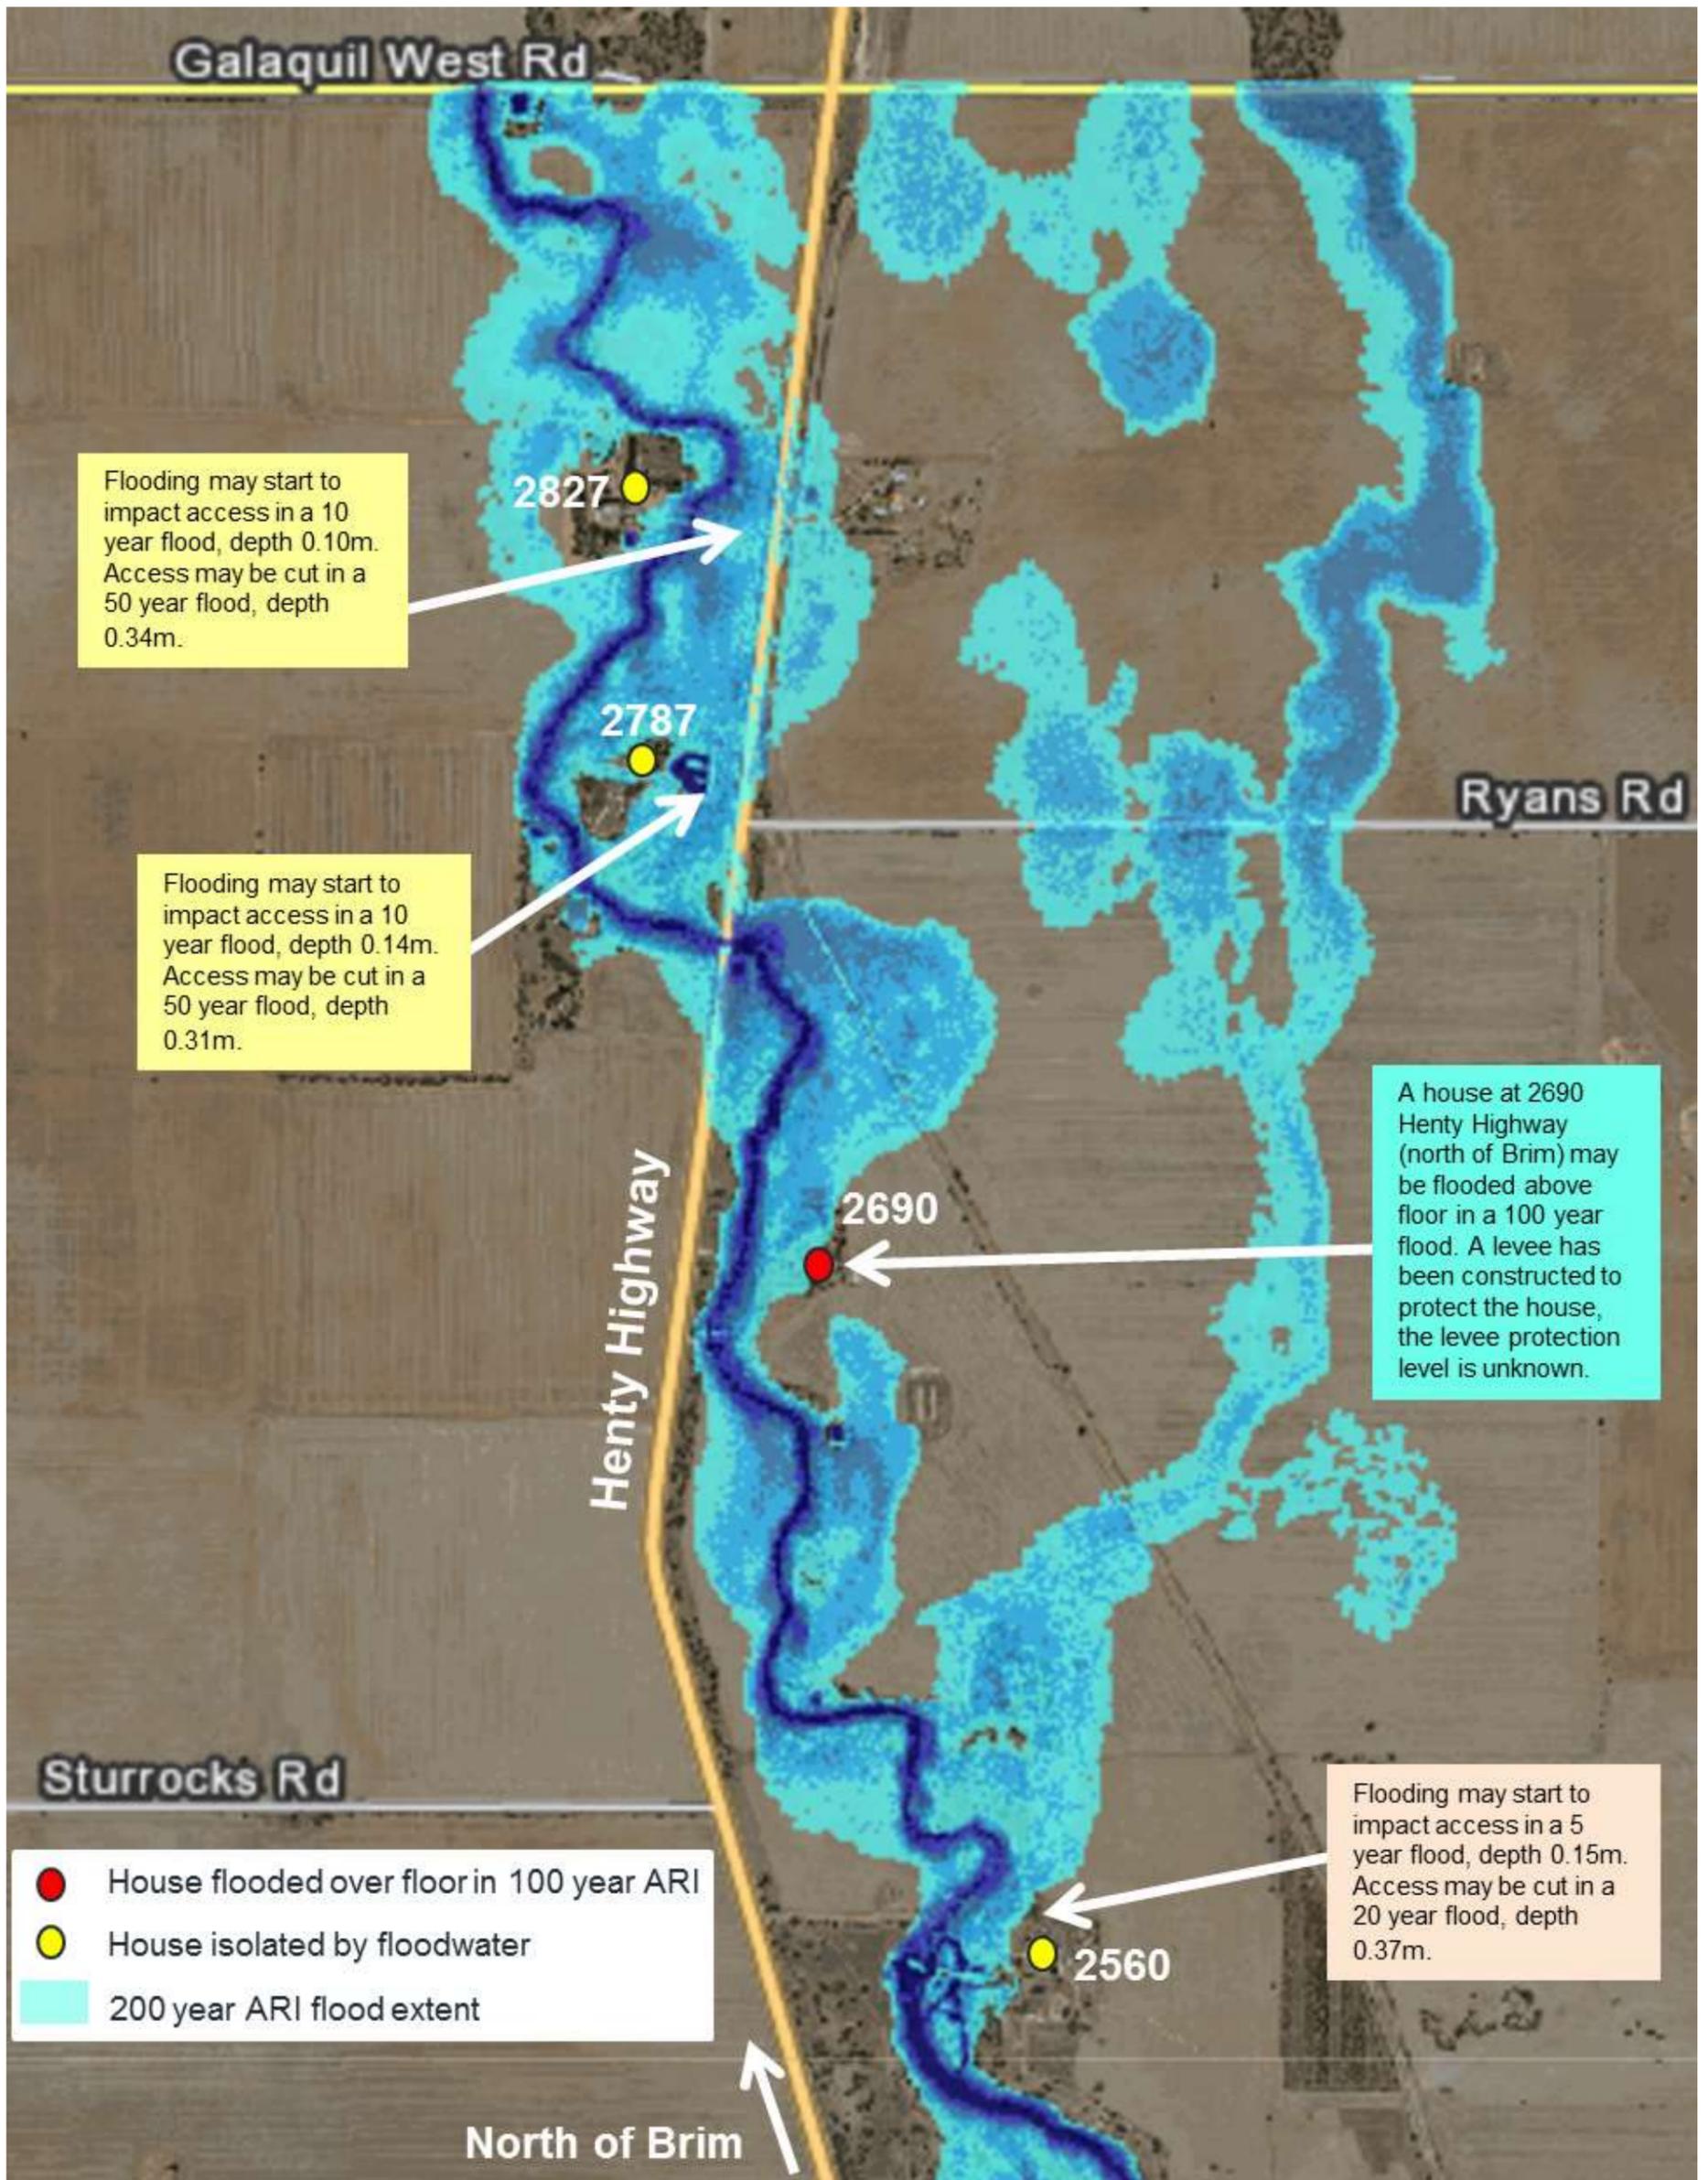
Houses impacted by Yarriambiack Creek flooding north of Brim with the 200 year ARI flood extent.

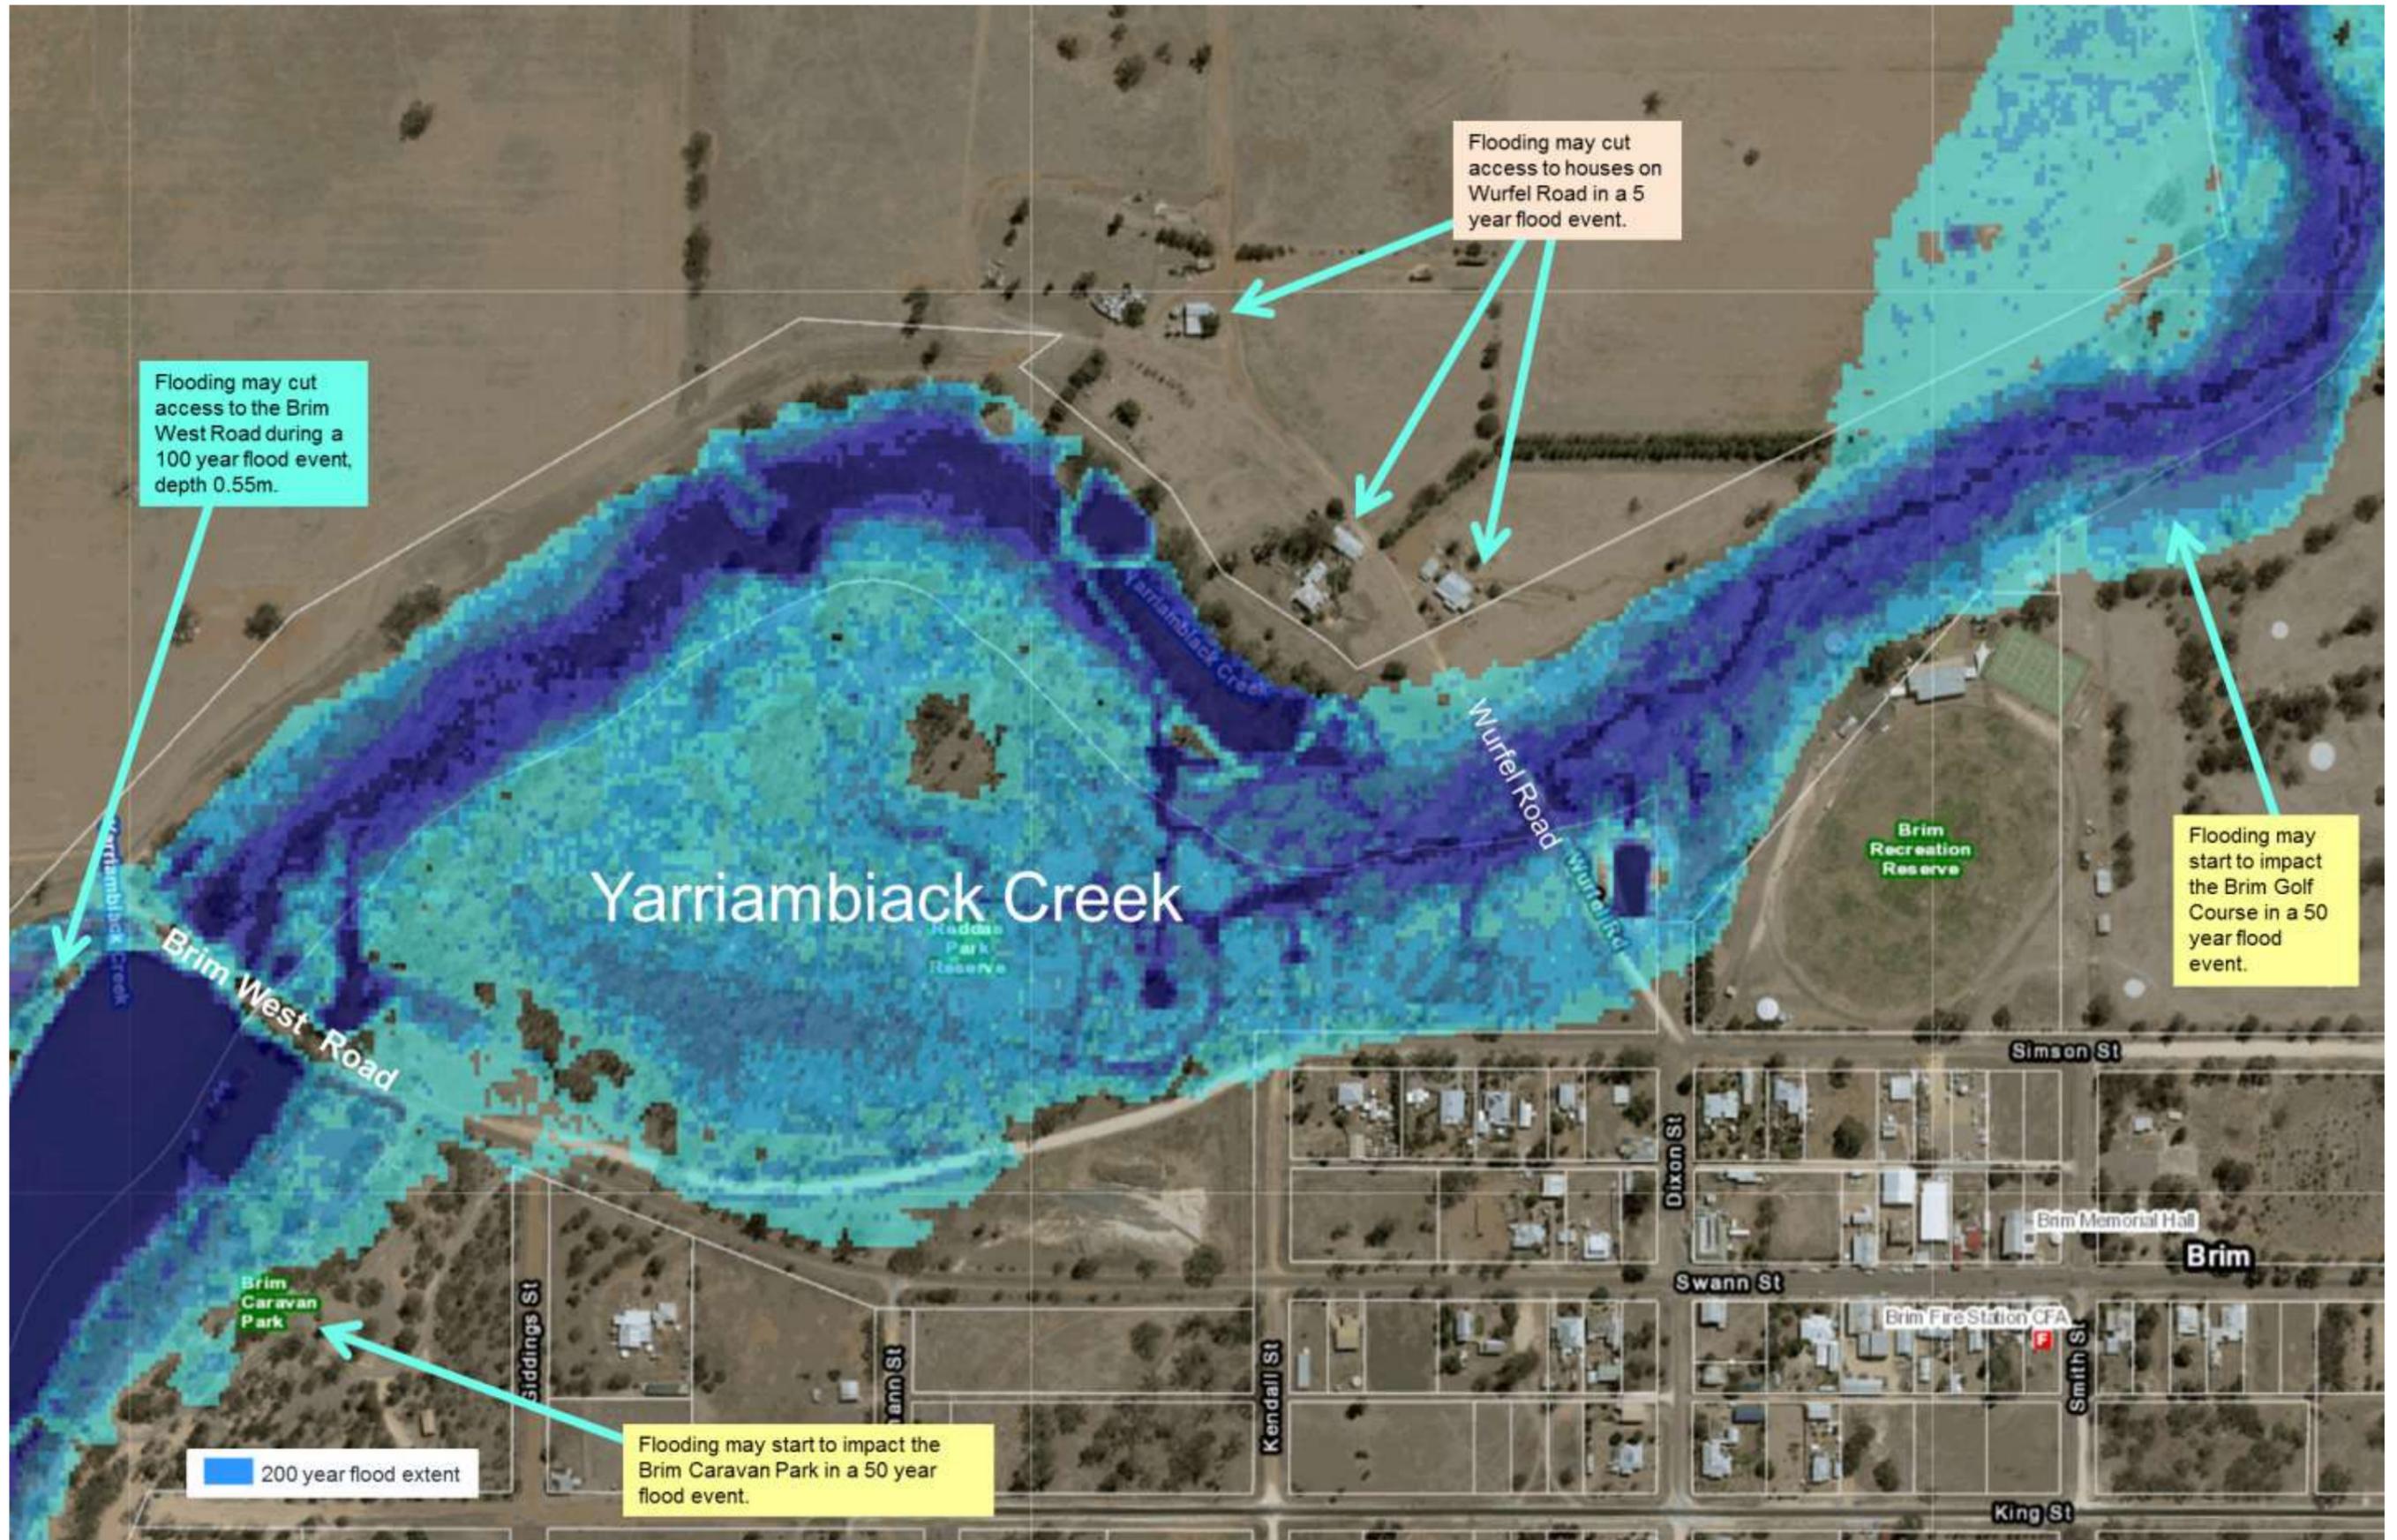
Brim assets impacted by flooding during a range of design flood events (Water Technology 2016)

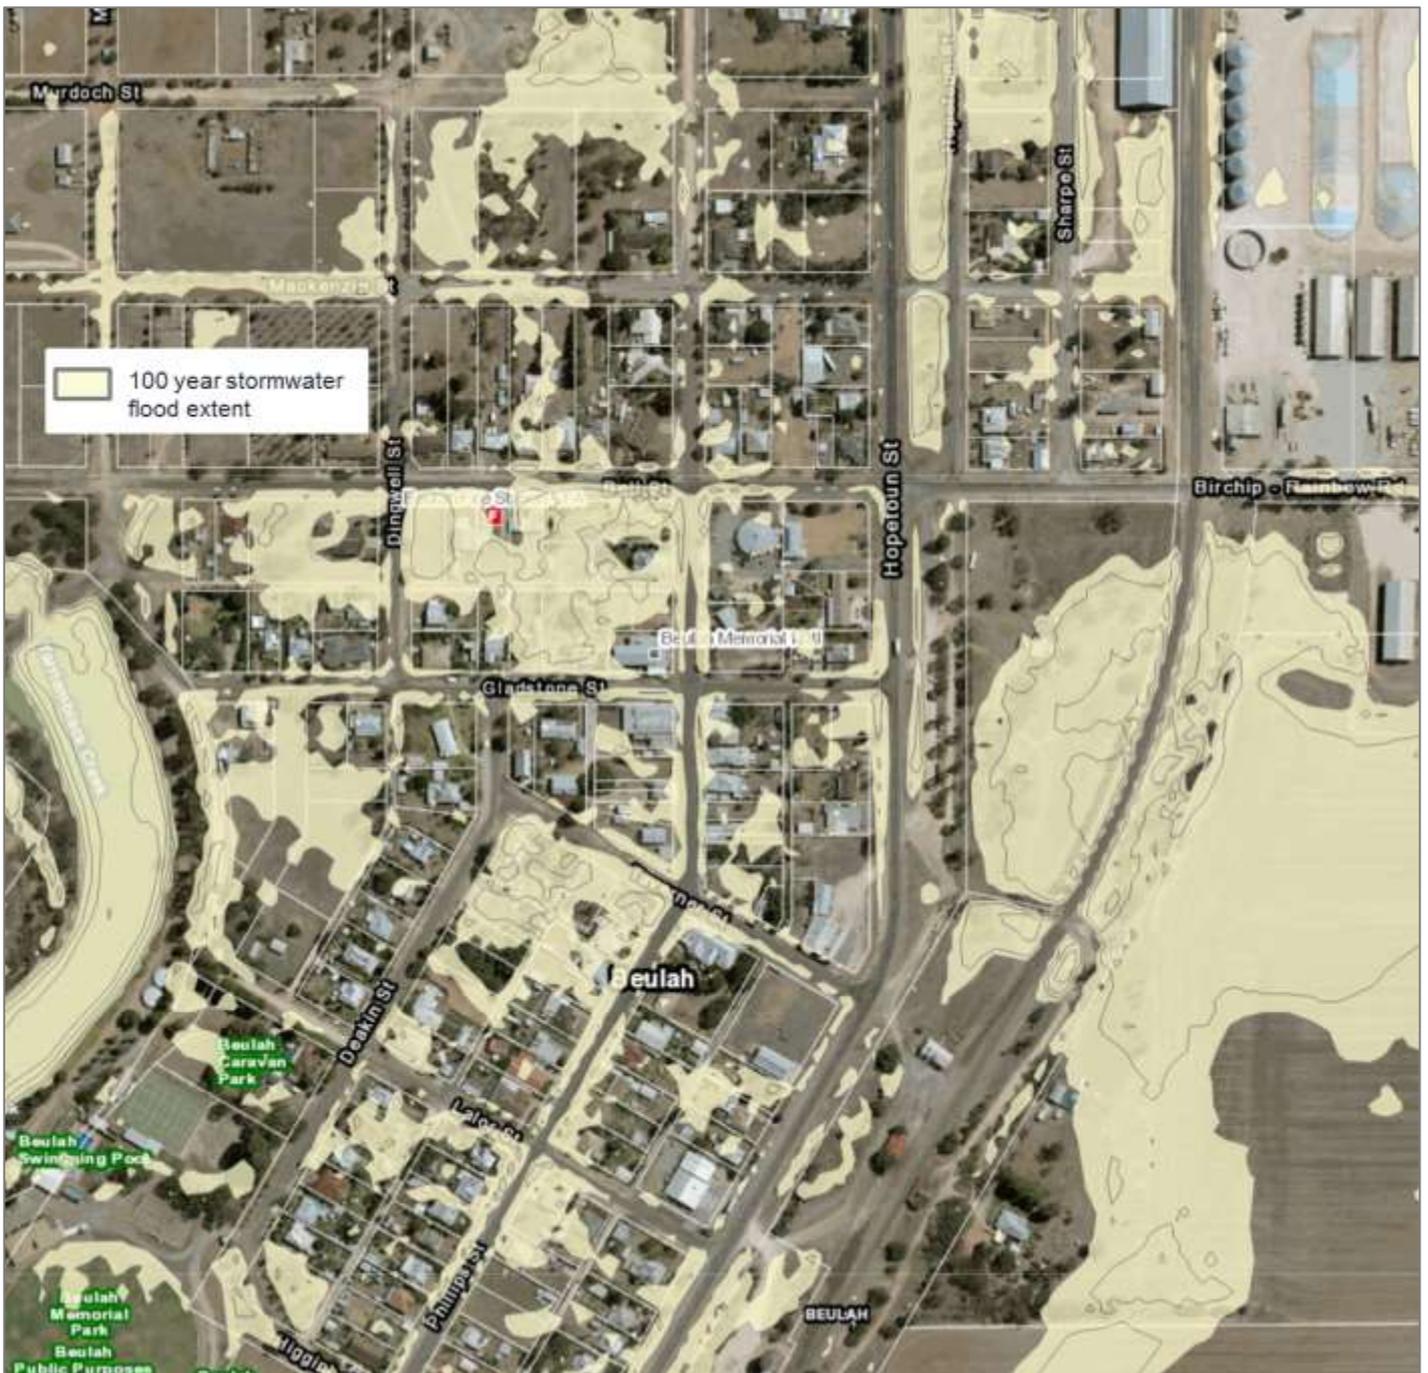
Beulah stormwater flood mapping, 100 year 2 hour duration (Water Technology 2006)

Stormwater modelling shows that limited ponding occurs in the area bounded by Bell, Phillips, Gladstone and Dingwell Streets, refer to the map below. This ponding appears to result from the raised road crest in Bell Street. Improved drainage under Bell Street is likely to reduce the ponding extent. From Bell Street, a small overland flow path continues north to the stormwater dam located at Lascelles Street. Further limited ponding occurs in the area bounded by Tavernor, Phillips, Lalor and Deakin Streets.

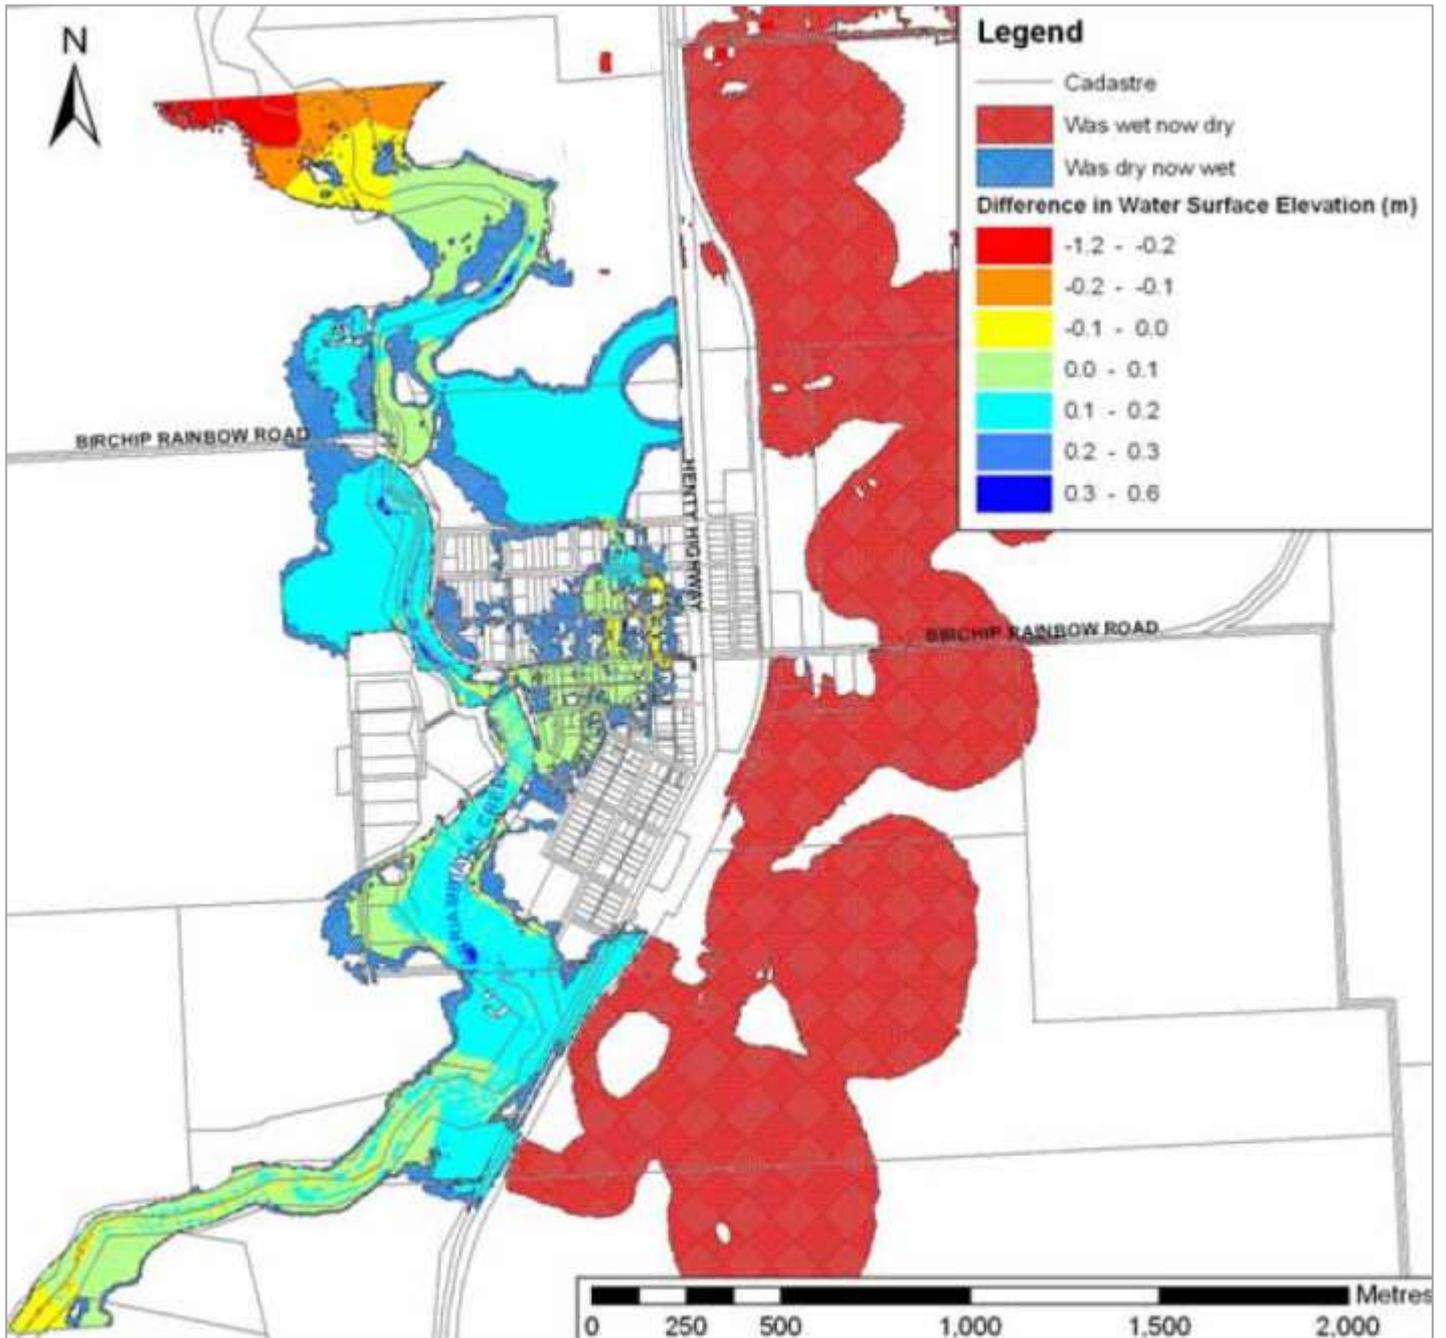
Blockage of culvers under the railway line south of Beulah (Water Technology 2007).

An assessment of the potential impact of the blockage of two culverts to the south of Beulah, that enable flood flows to pass under the railway line. The impact of this blockage was assessed for a 100 year ARI flood event. Refer to the impact map below for the difference in flood level caused by the blockage. This model shows that if the culverts are blocked, this will cause significant number of properties to be impacted by flooding within Beulah, raising the flood level in some areas by over 300mm.

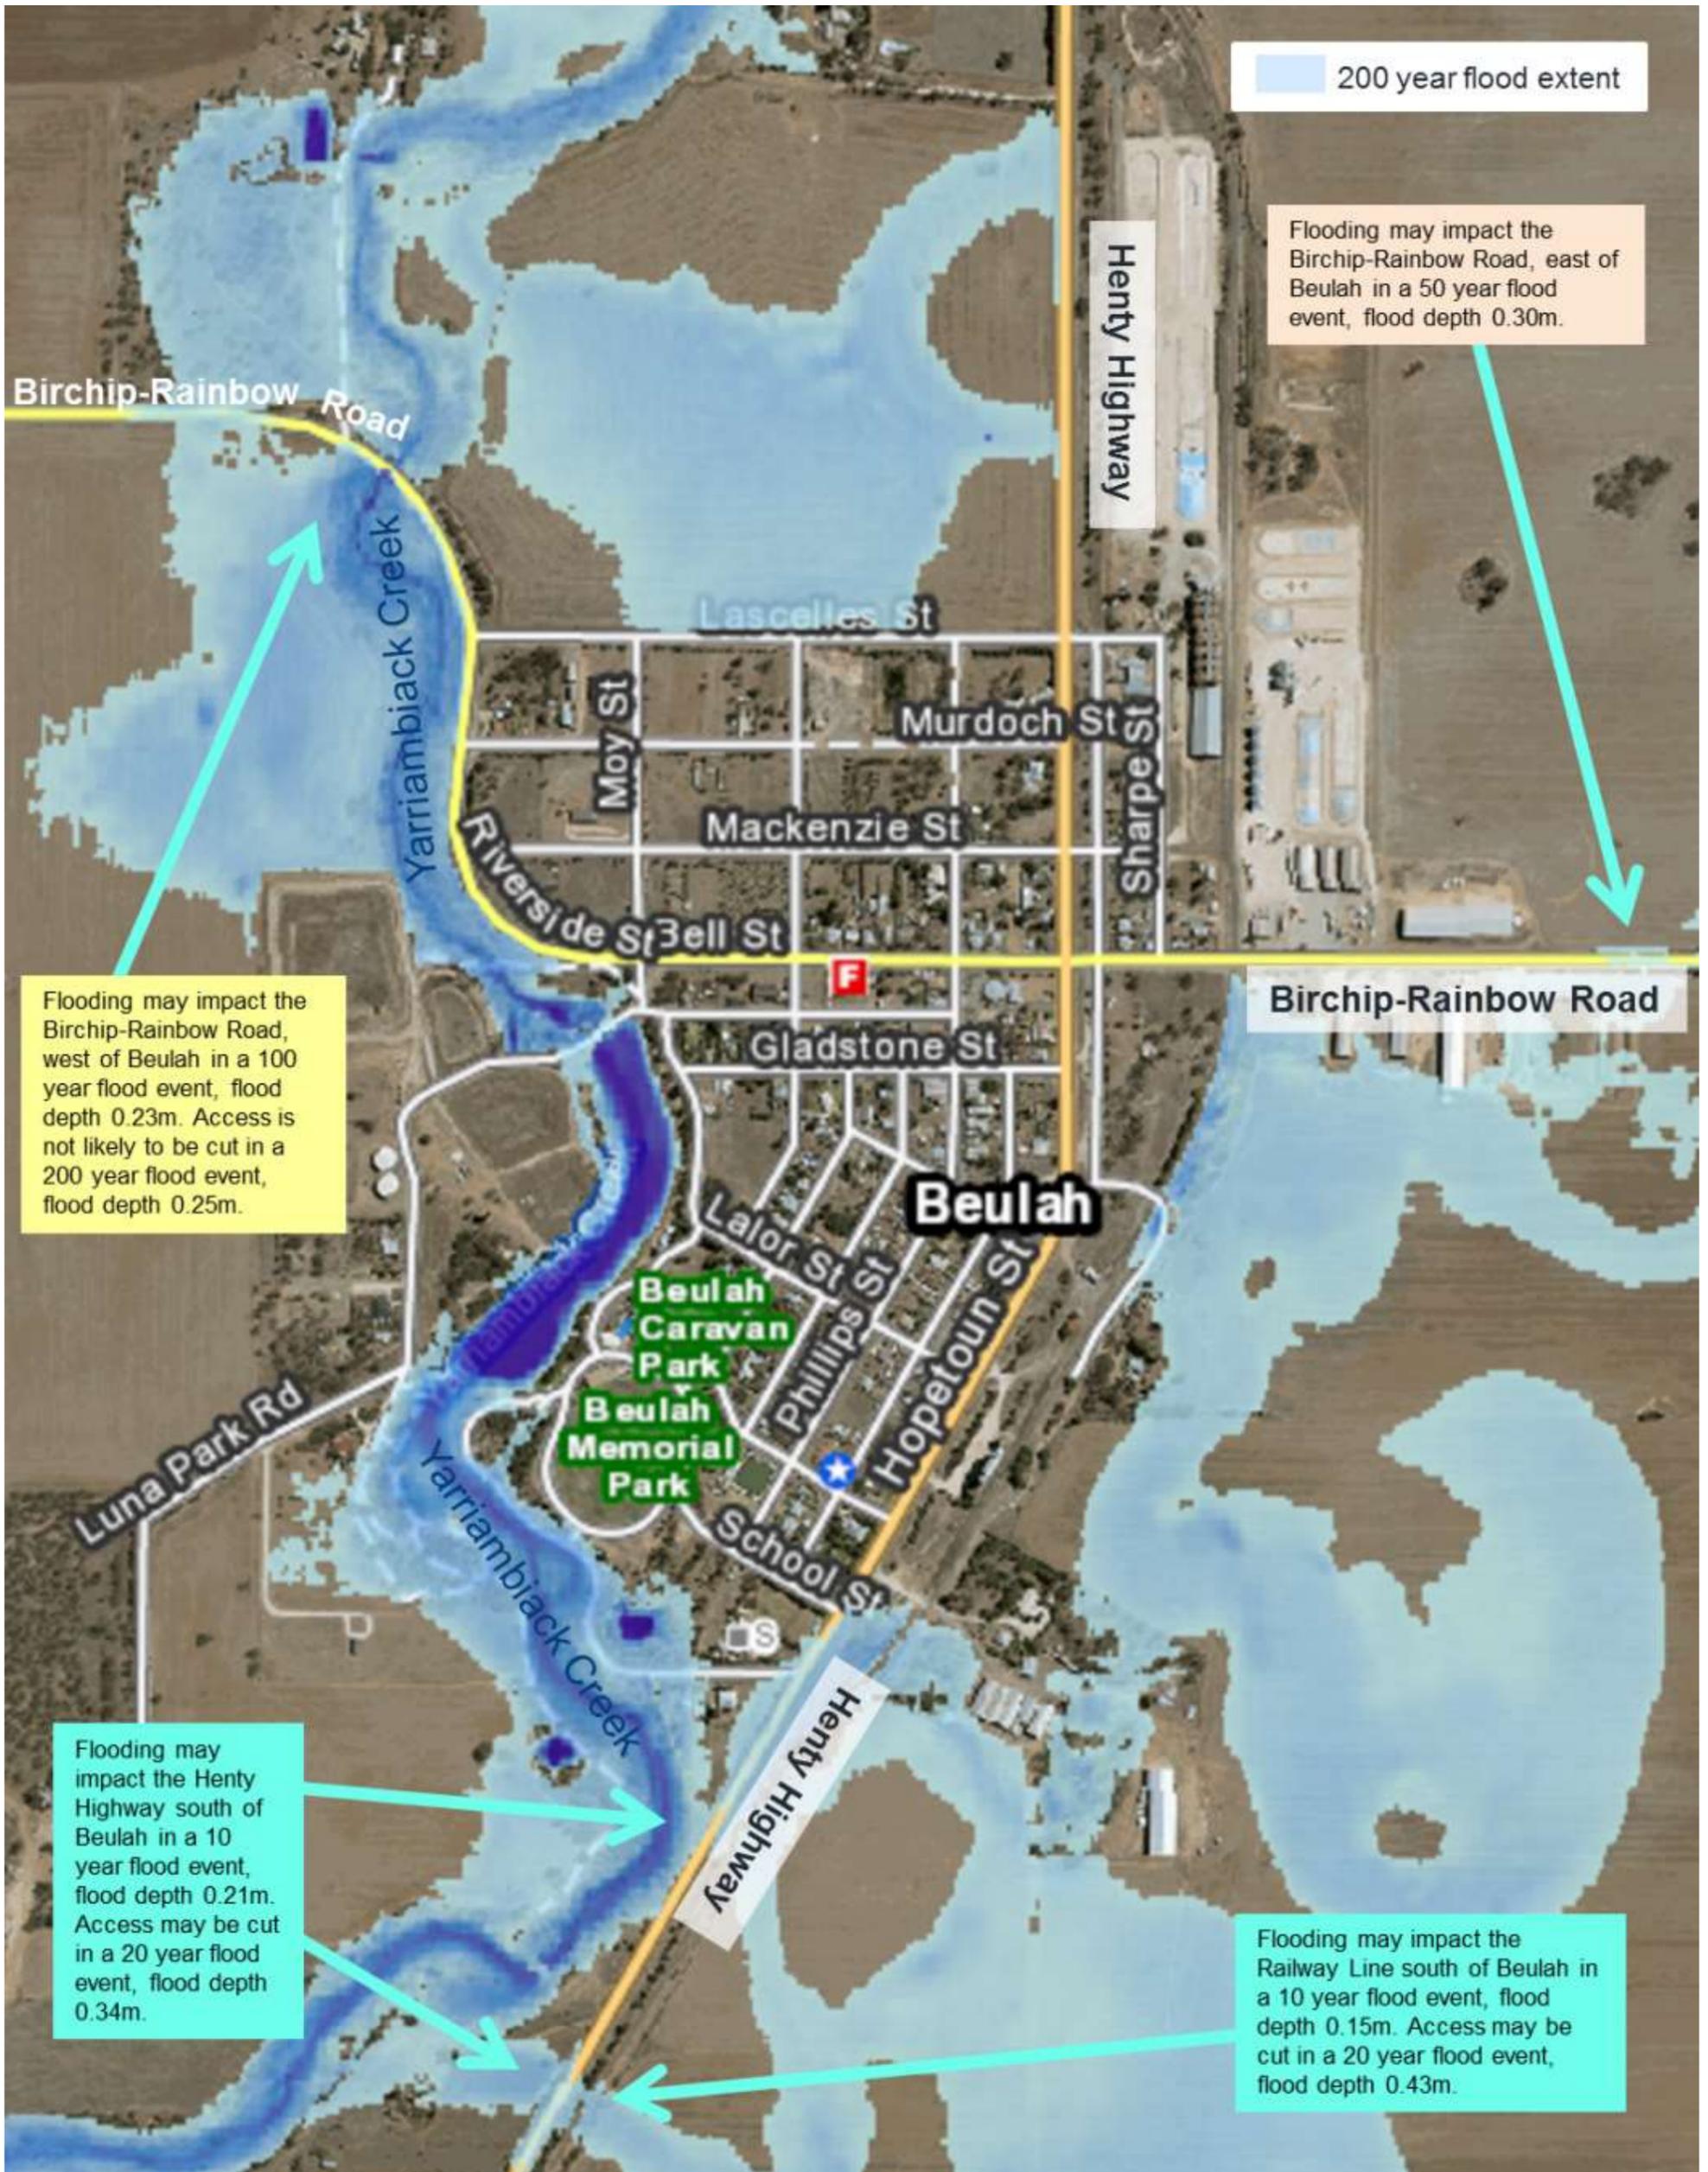
Roads impacted by flooding in Beulah (Water Technology 2006 & 2013).

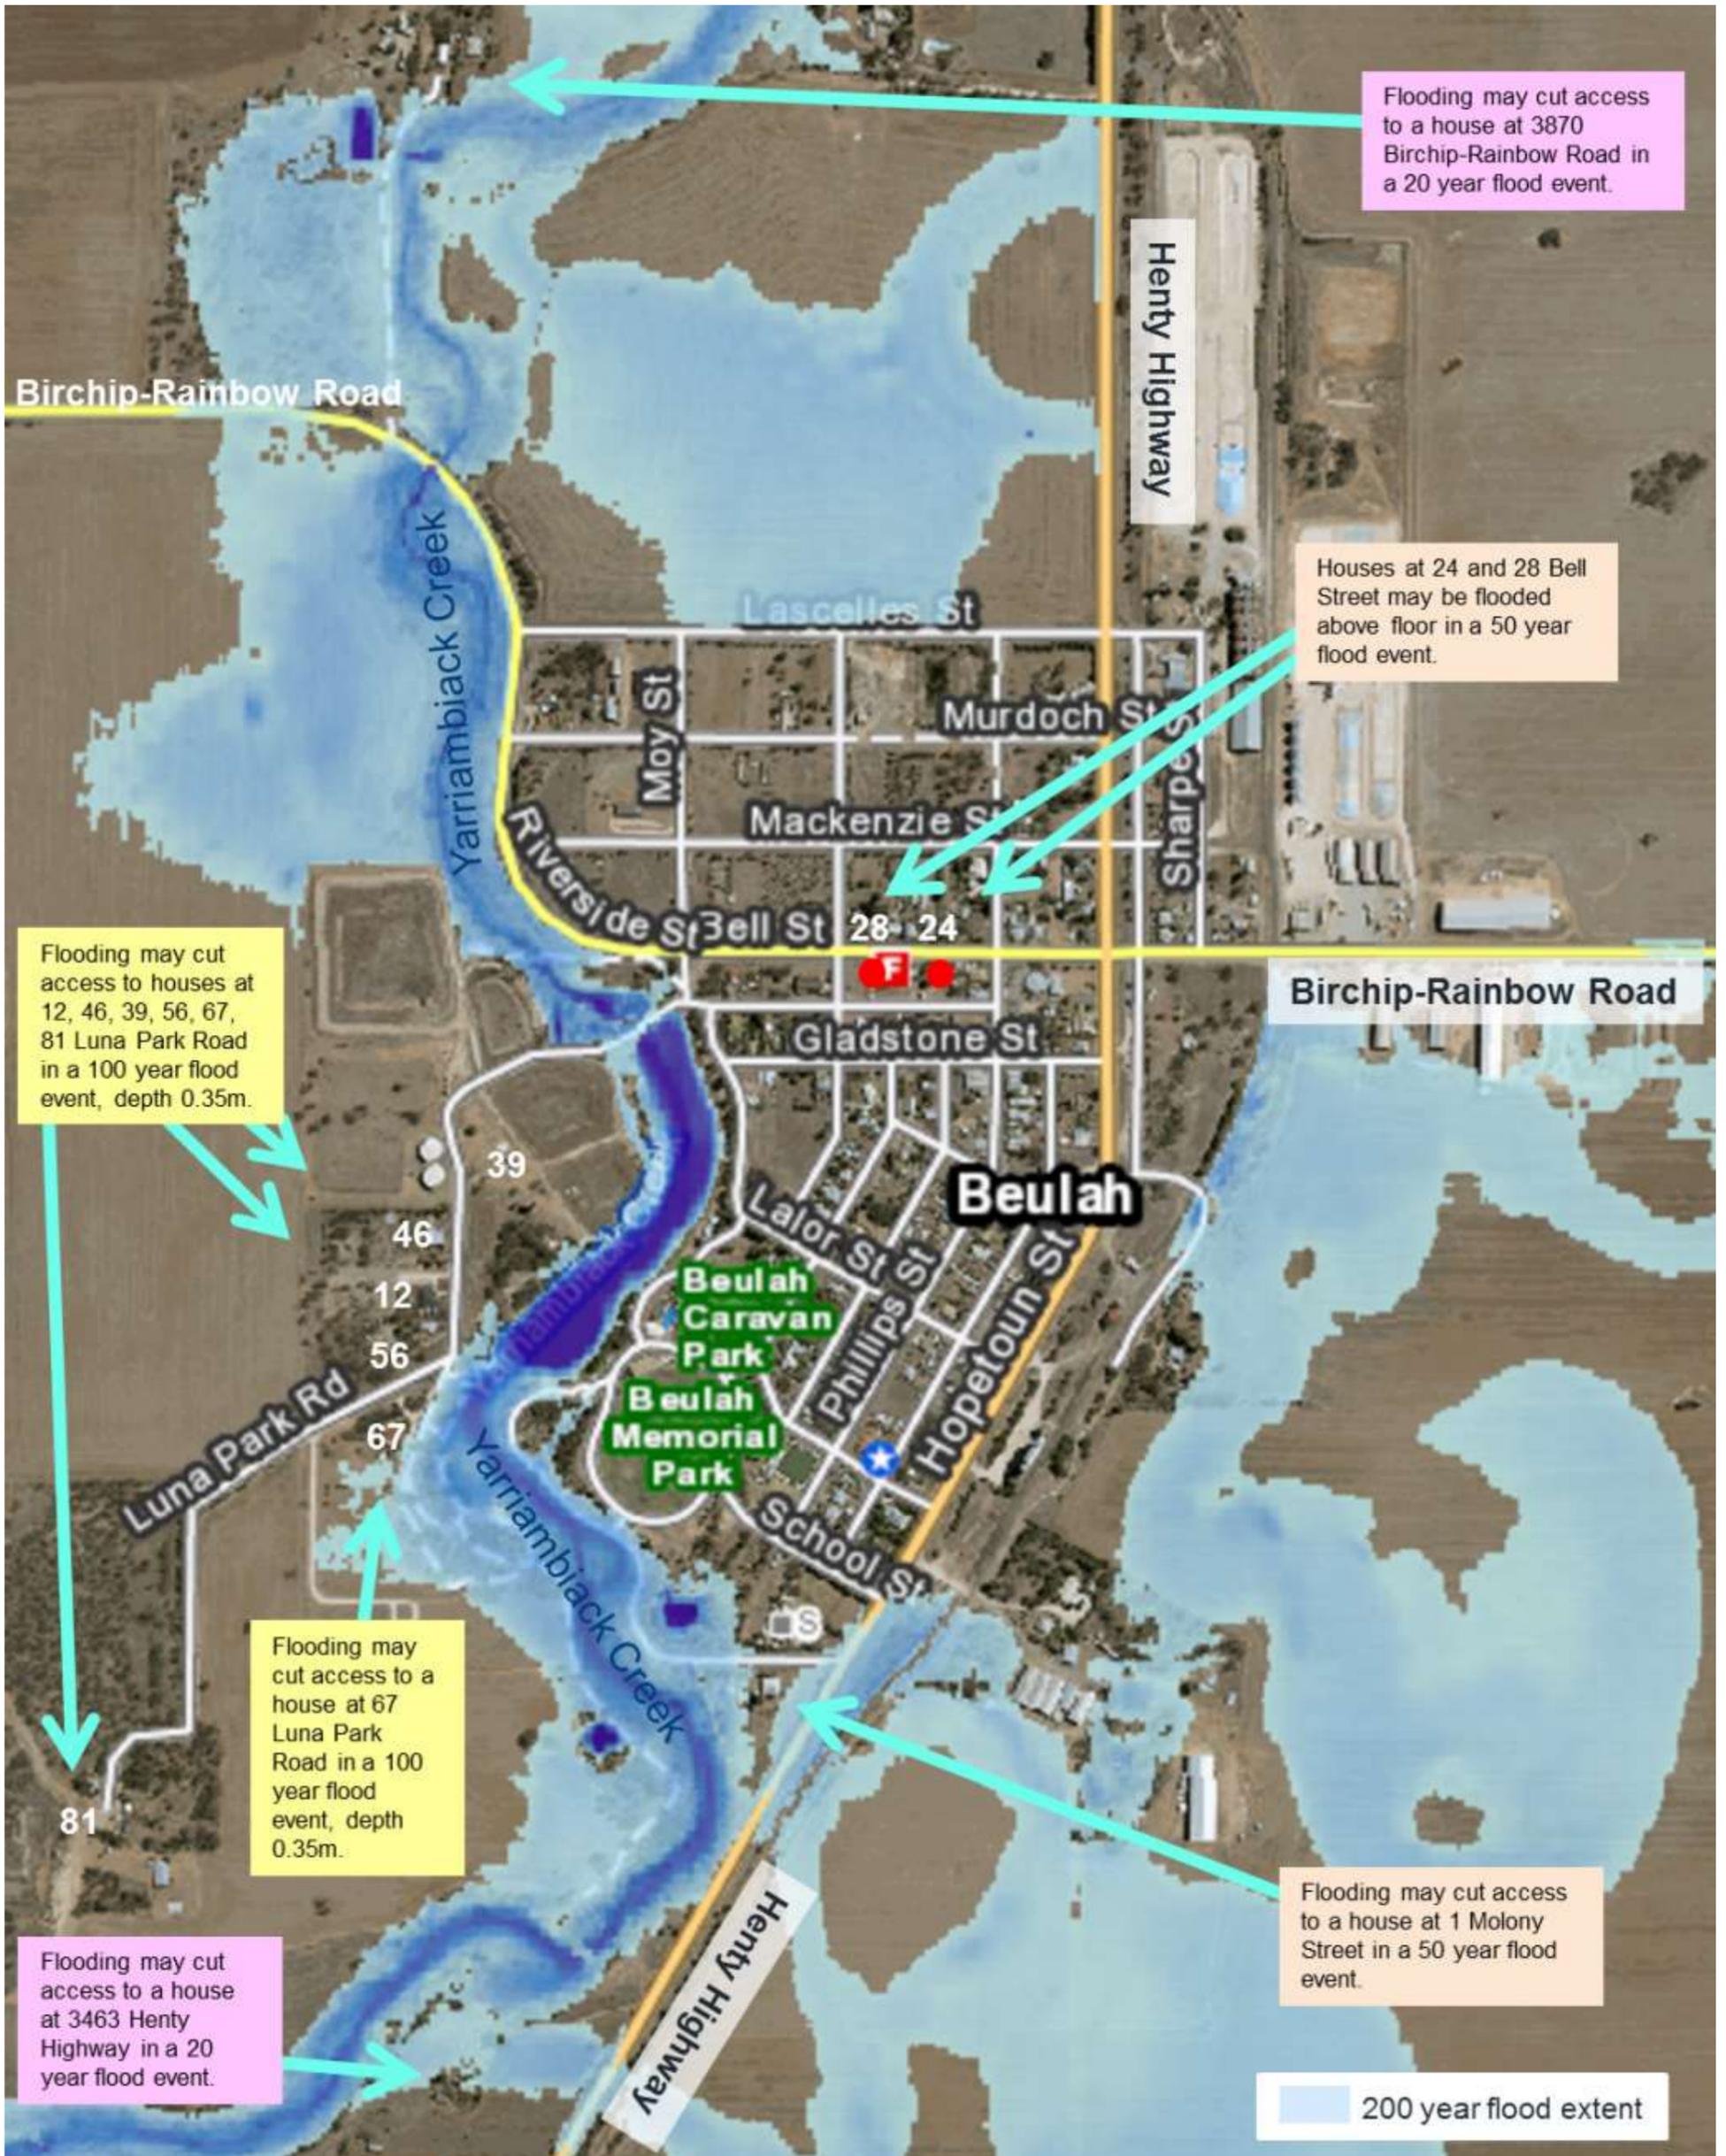
Buildings impacted by flooding in Beulah (Water Technology 2006 & 2013)

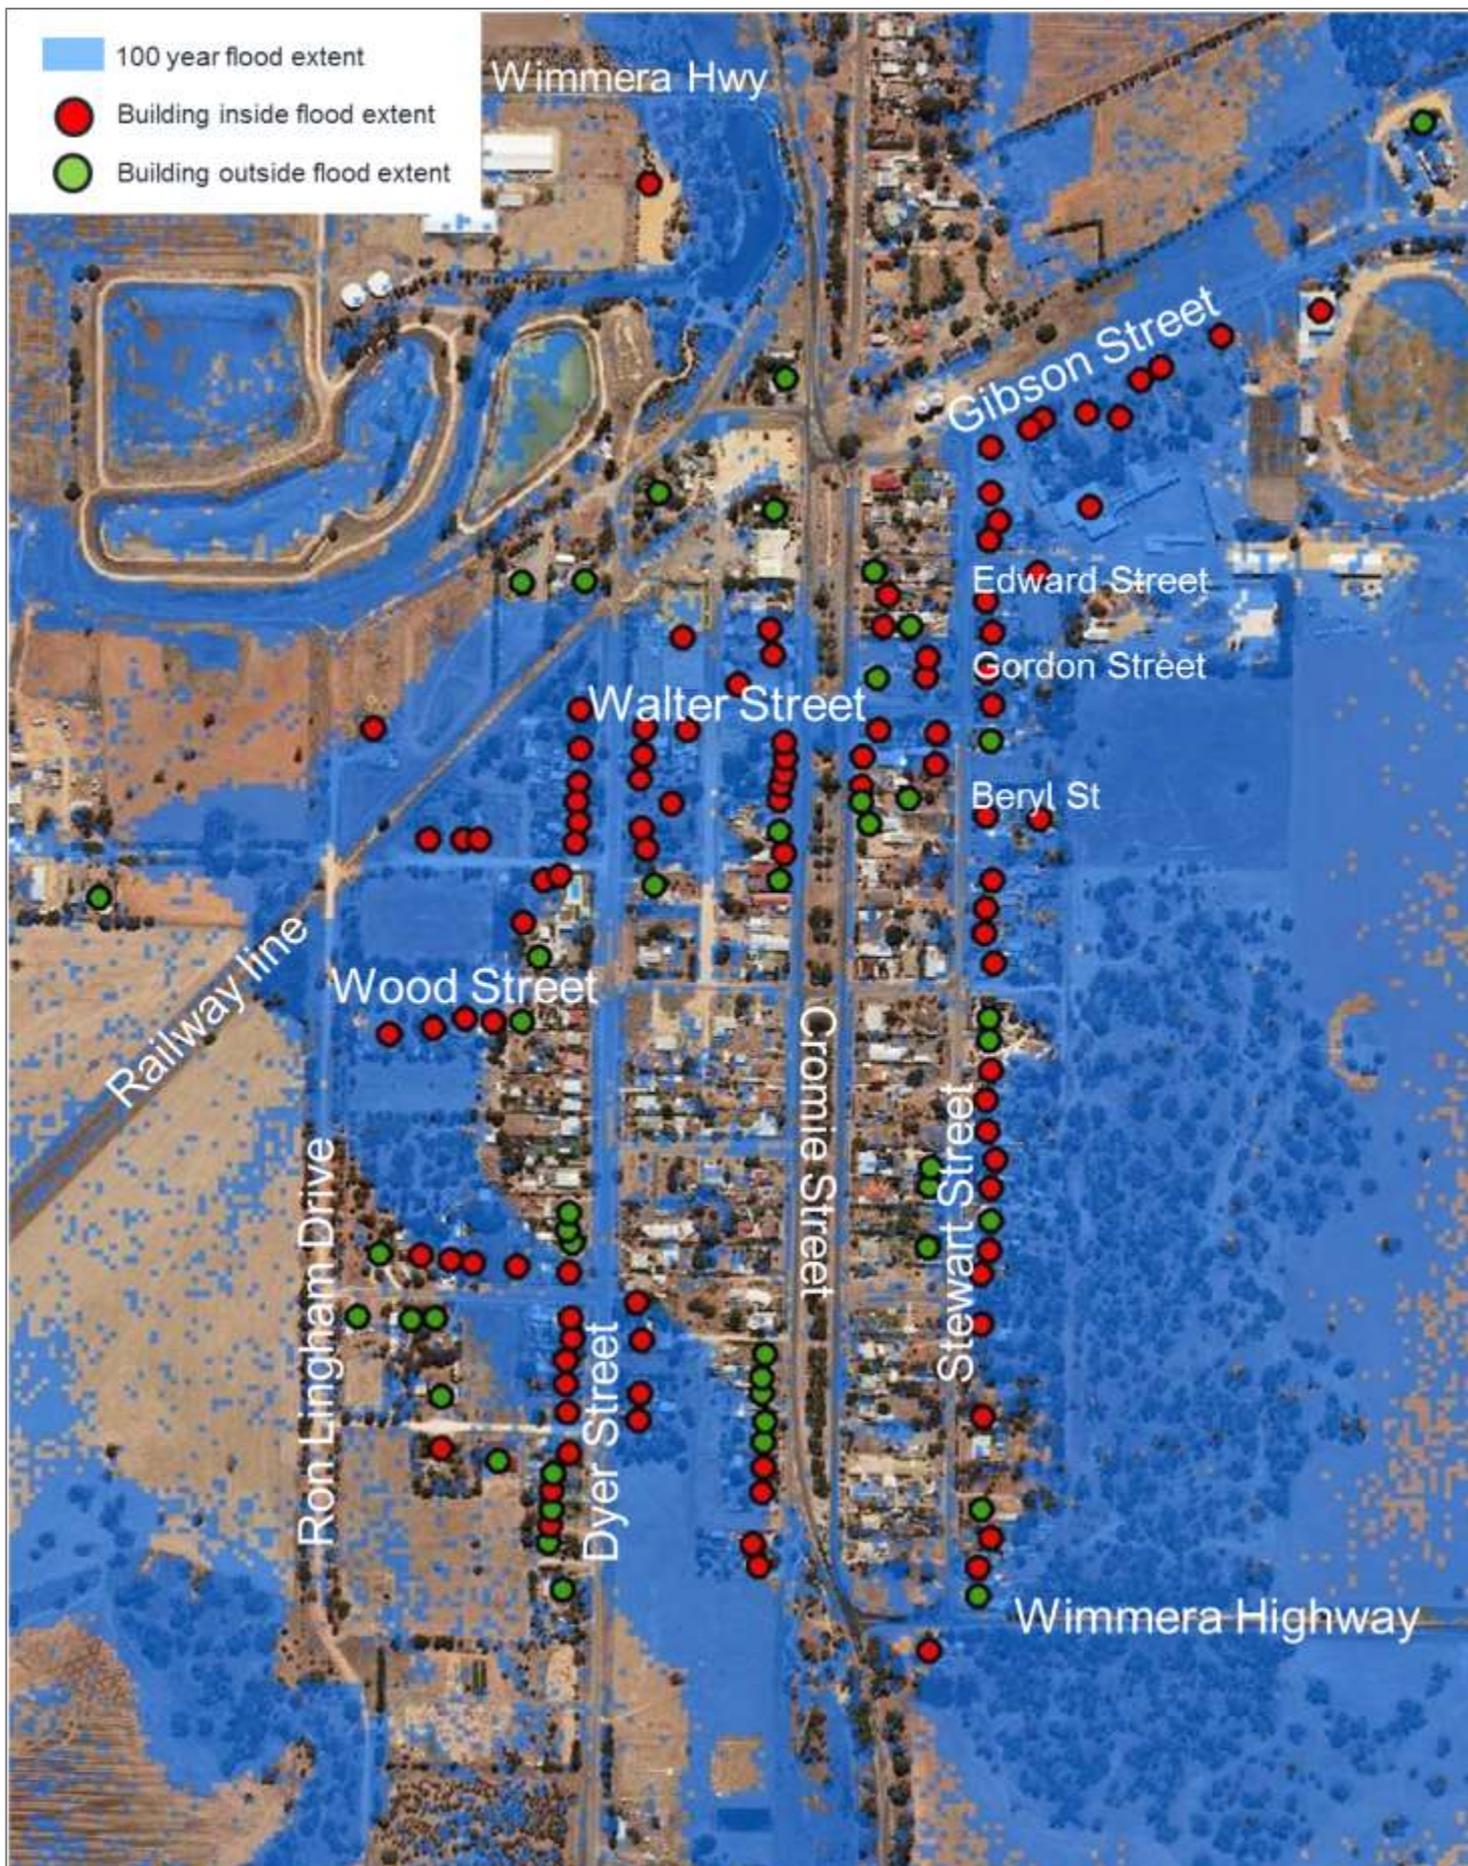
Rupanyup stormwater flood mapping, 100 year ARI 2 hour duration event (Water Technology 2018).
