Yarriambiack Shire Council

FLOOD EMERGENCY PLAN

A Sub-Plan of the Municipal Emergency Management Plan

Version 2, February 2020

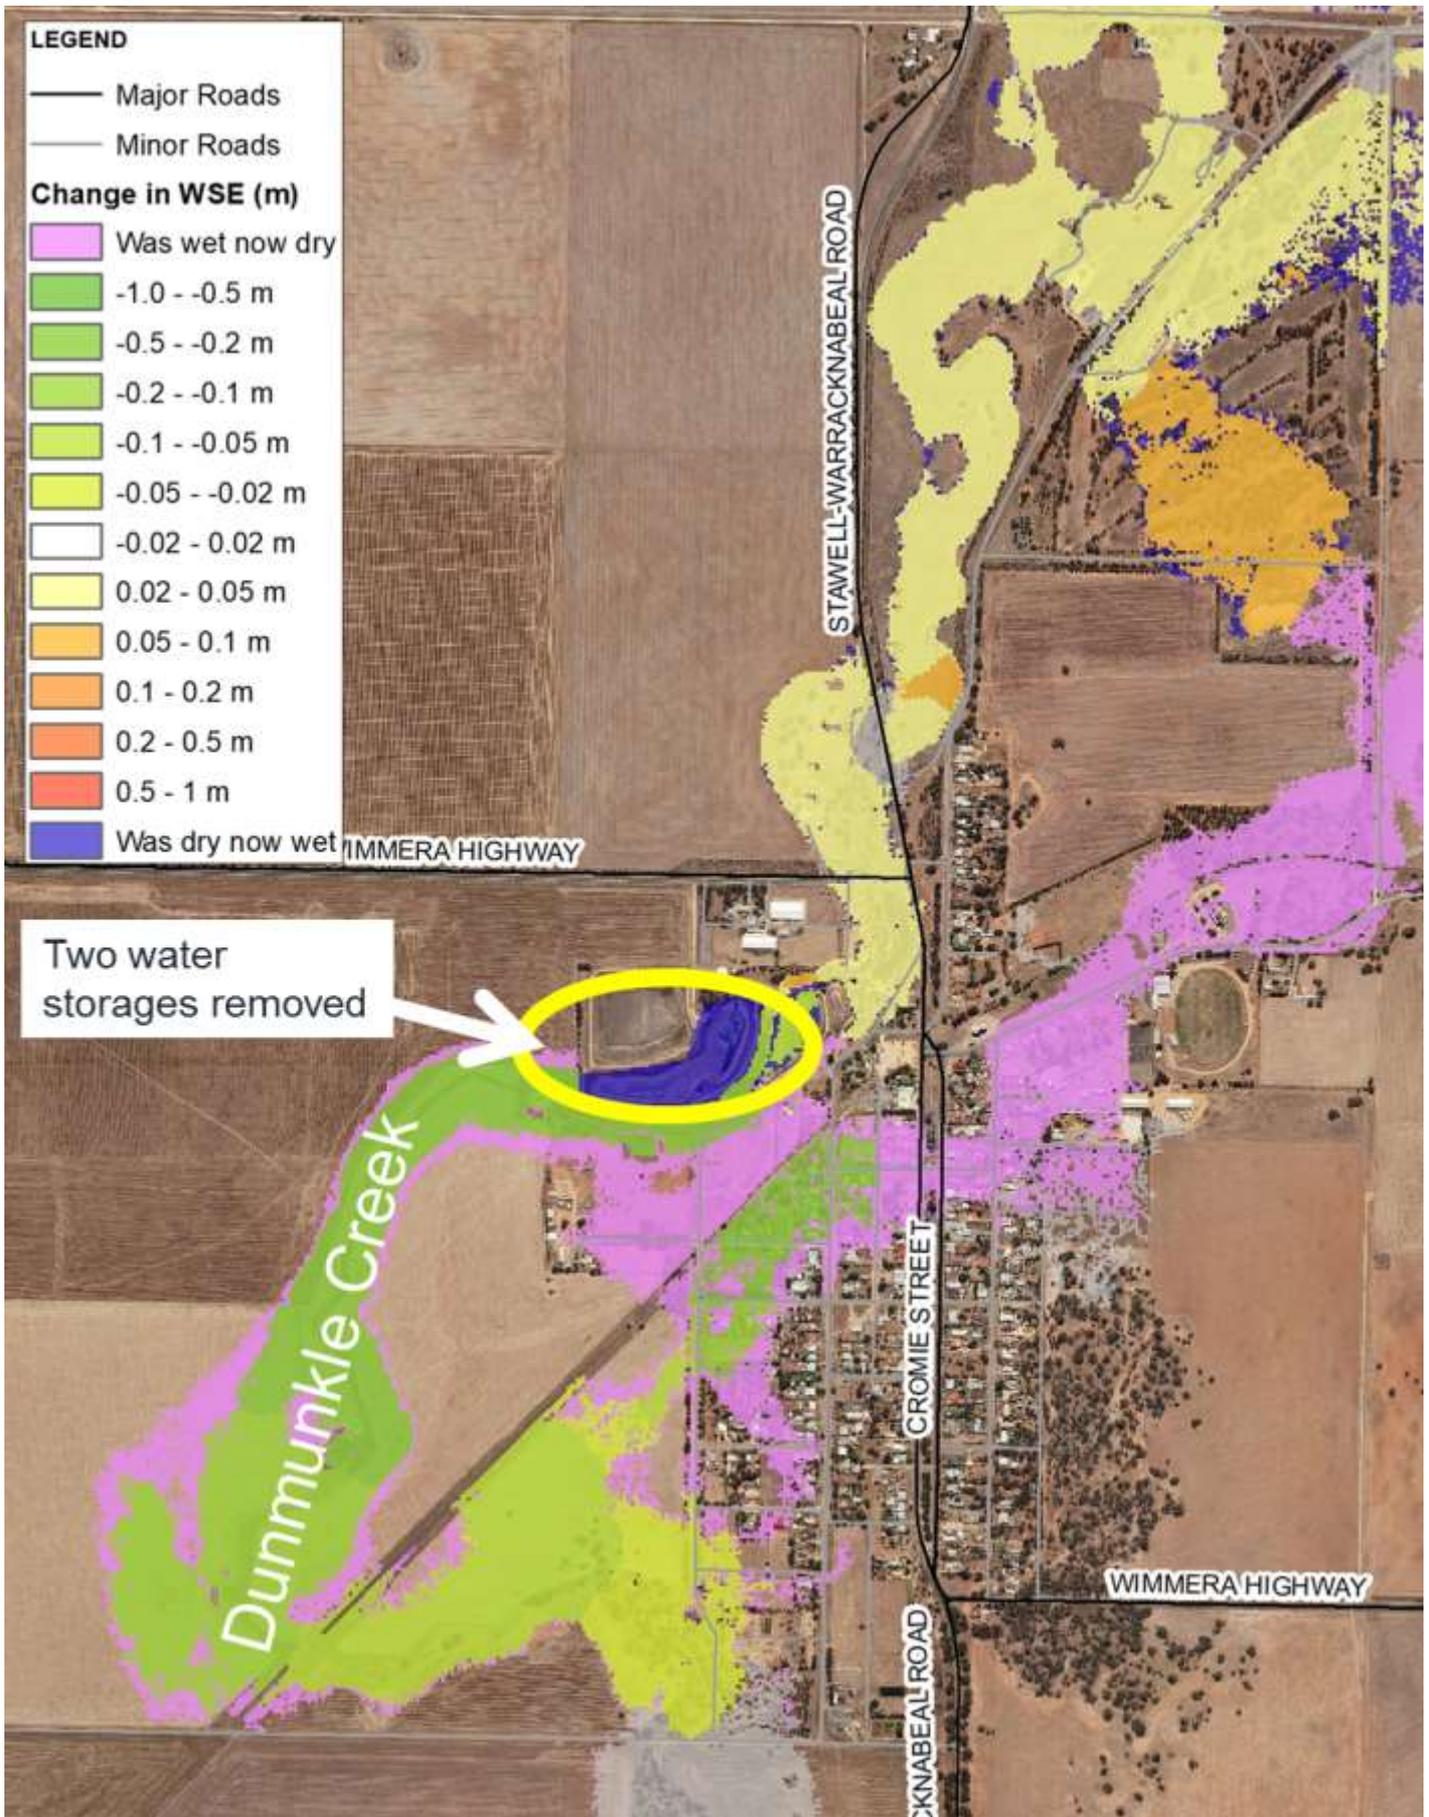
Flood impact assessment of removal of water storages in Rupanyup during a 100 year ARI flood event (Water Technology 2018).

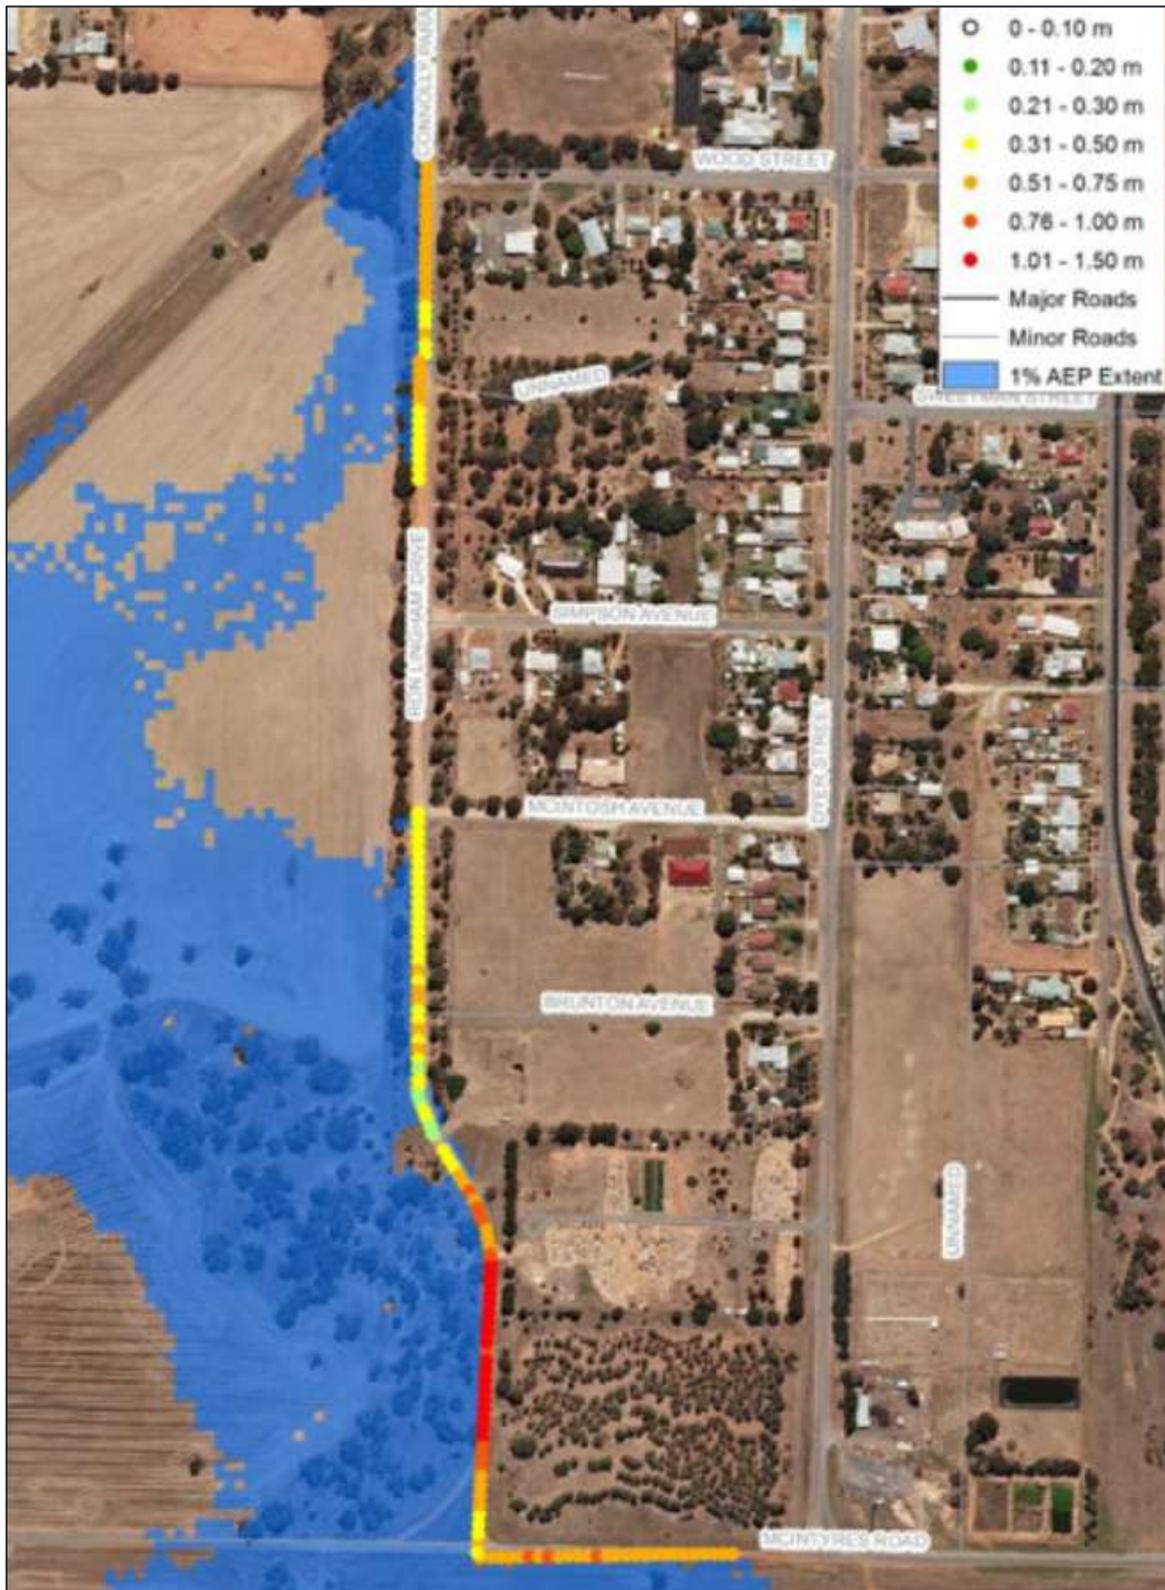
Rupanyup's proposed the Ron Lingham Drive and McIntyres Road levee event (Water Technology 2018).

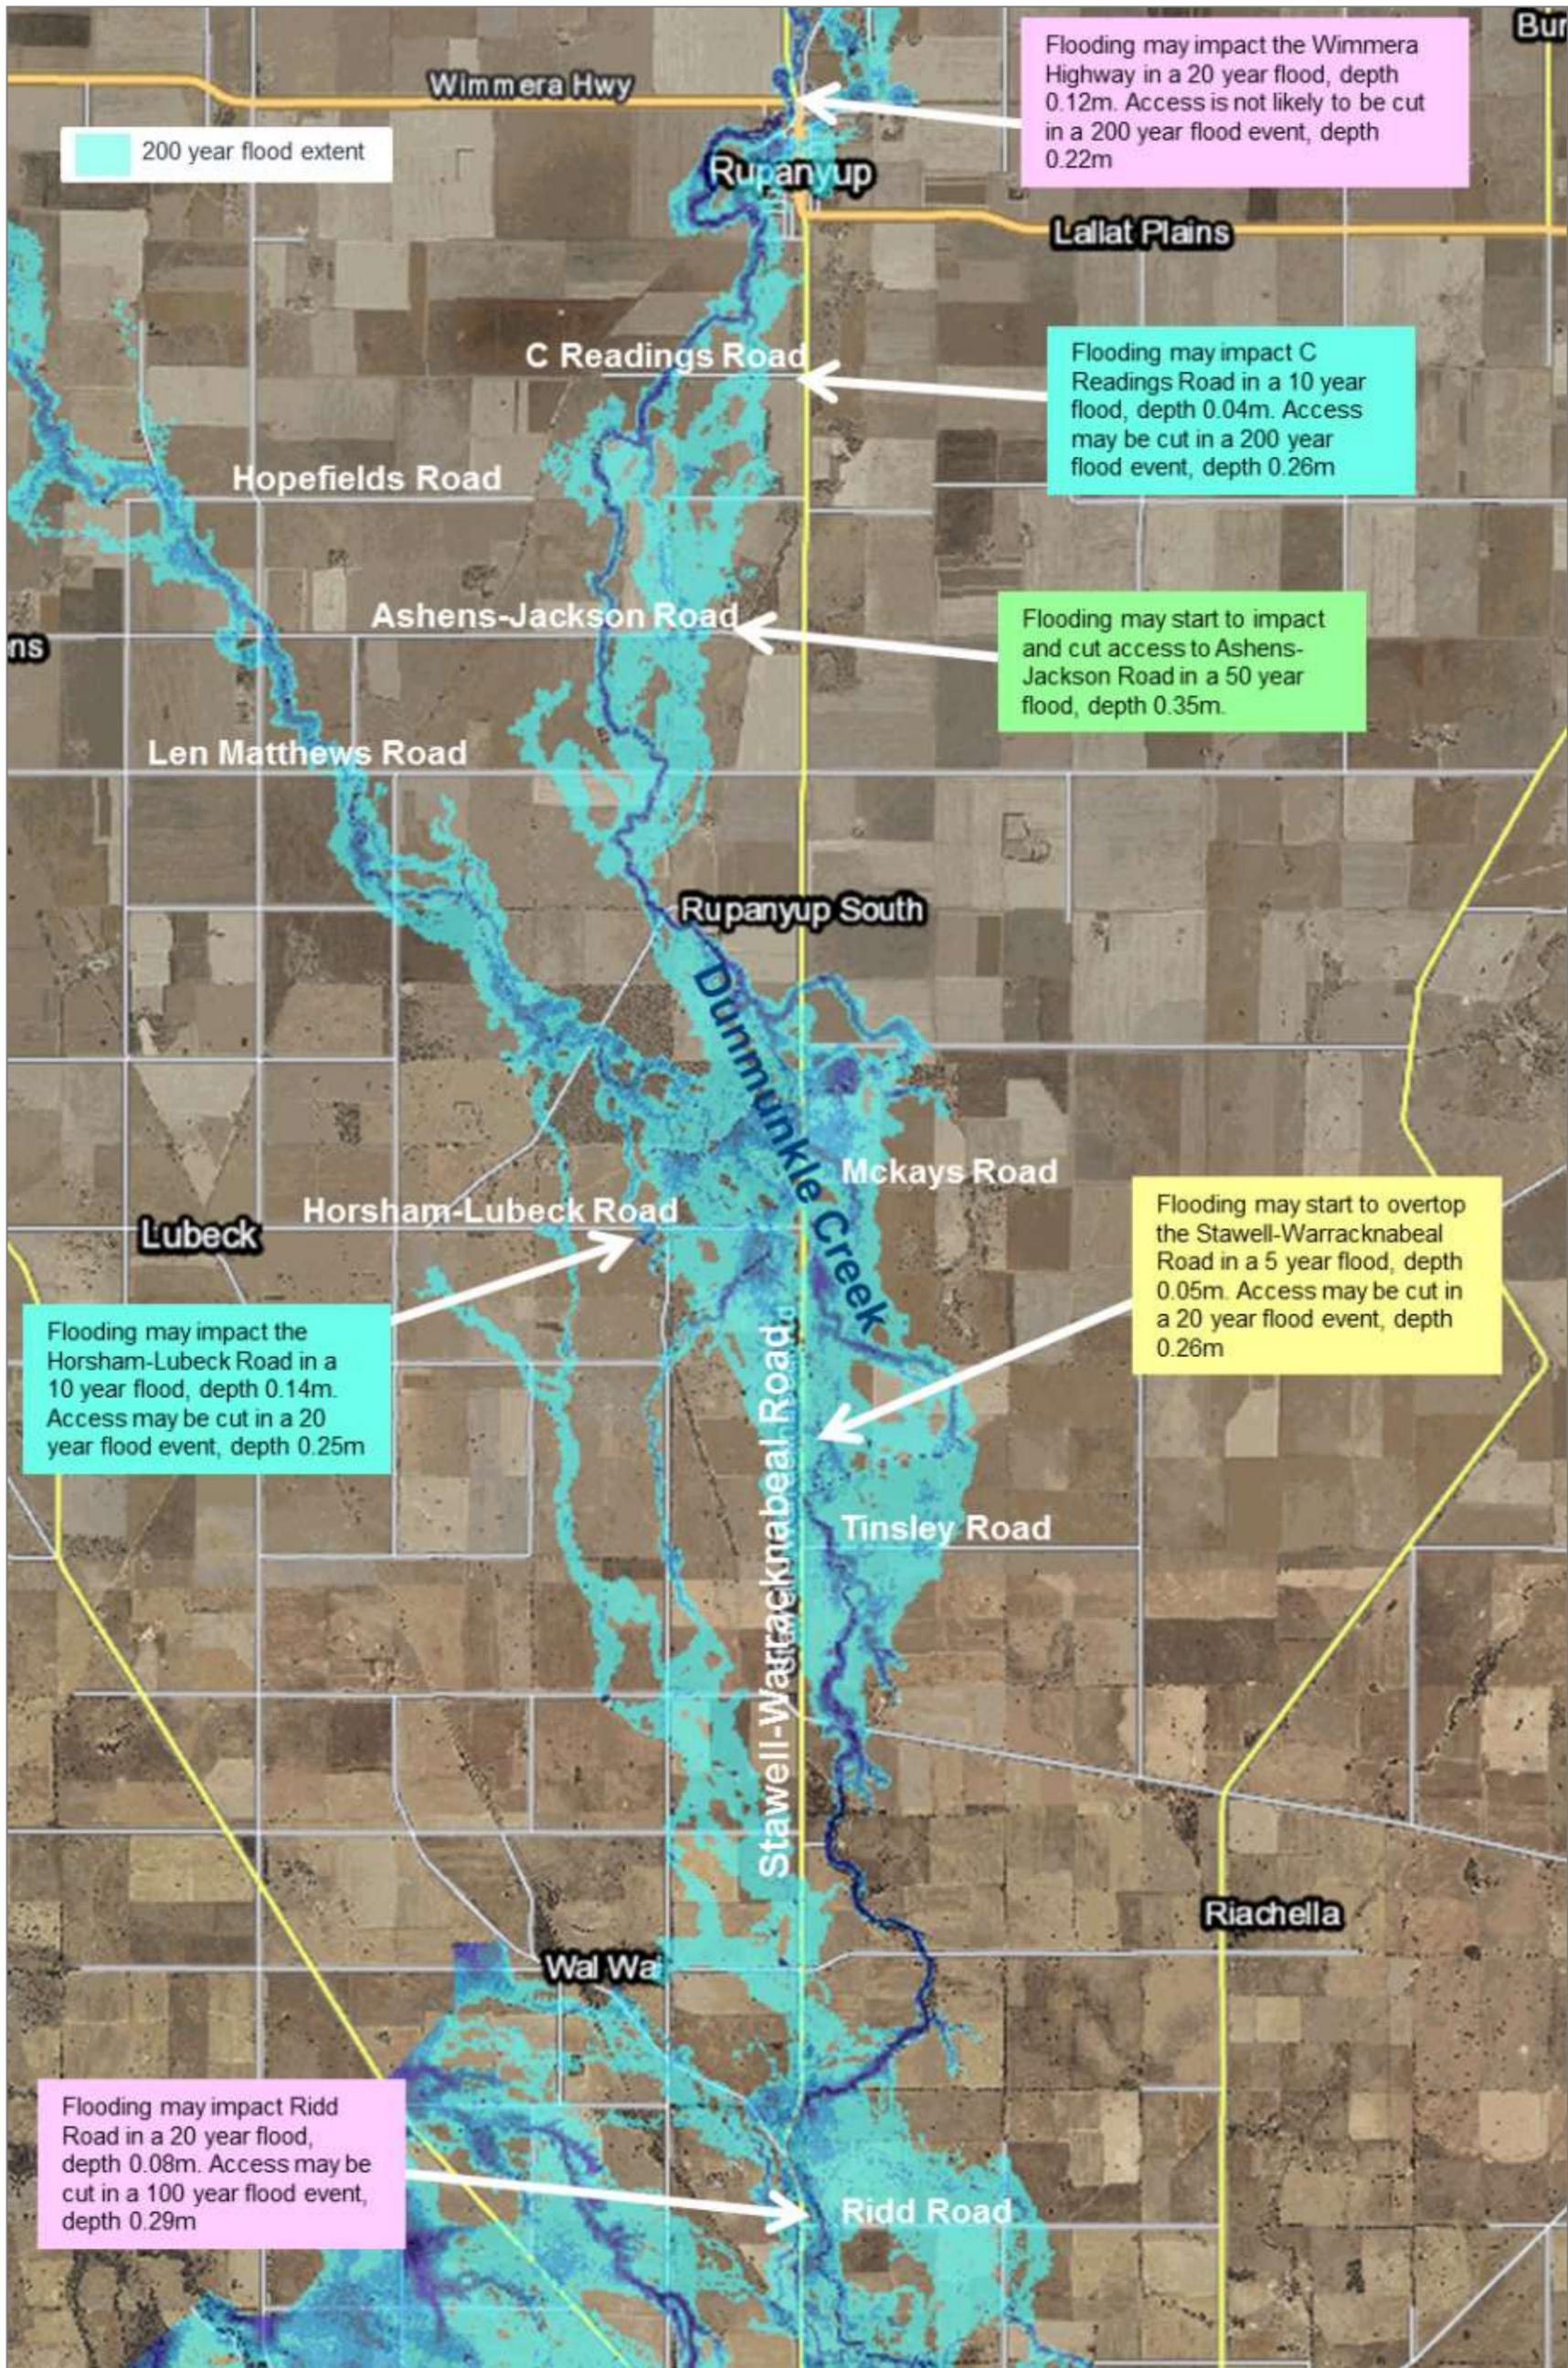
Roads impacted by flooding along Dunmunkle Creek, south of Rupanyup (Water Technology 2018).

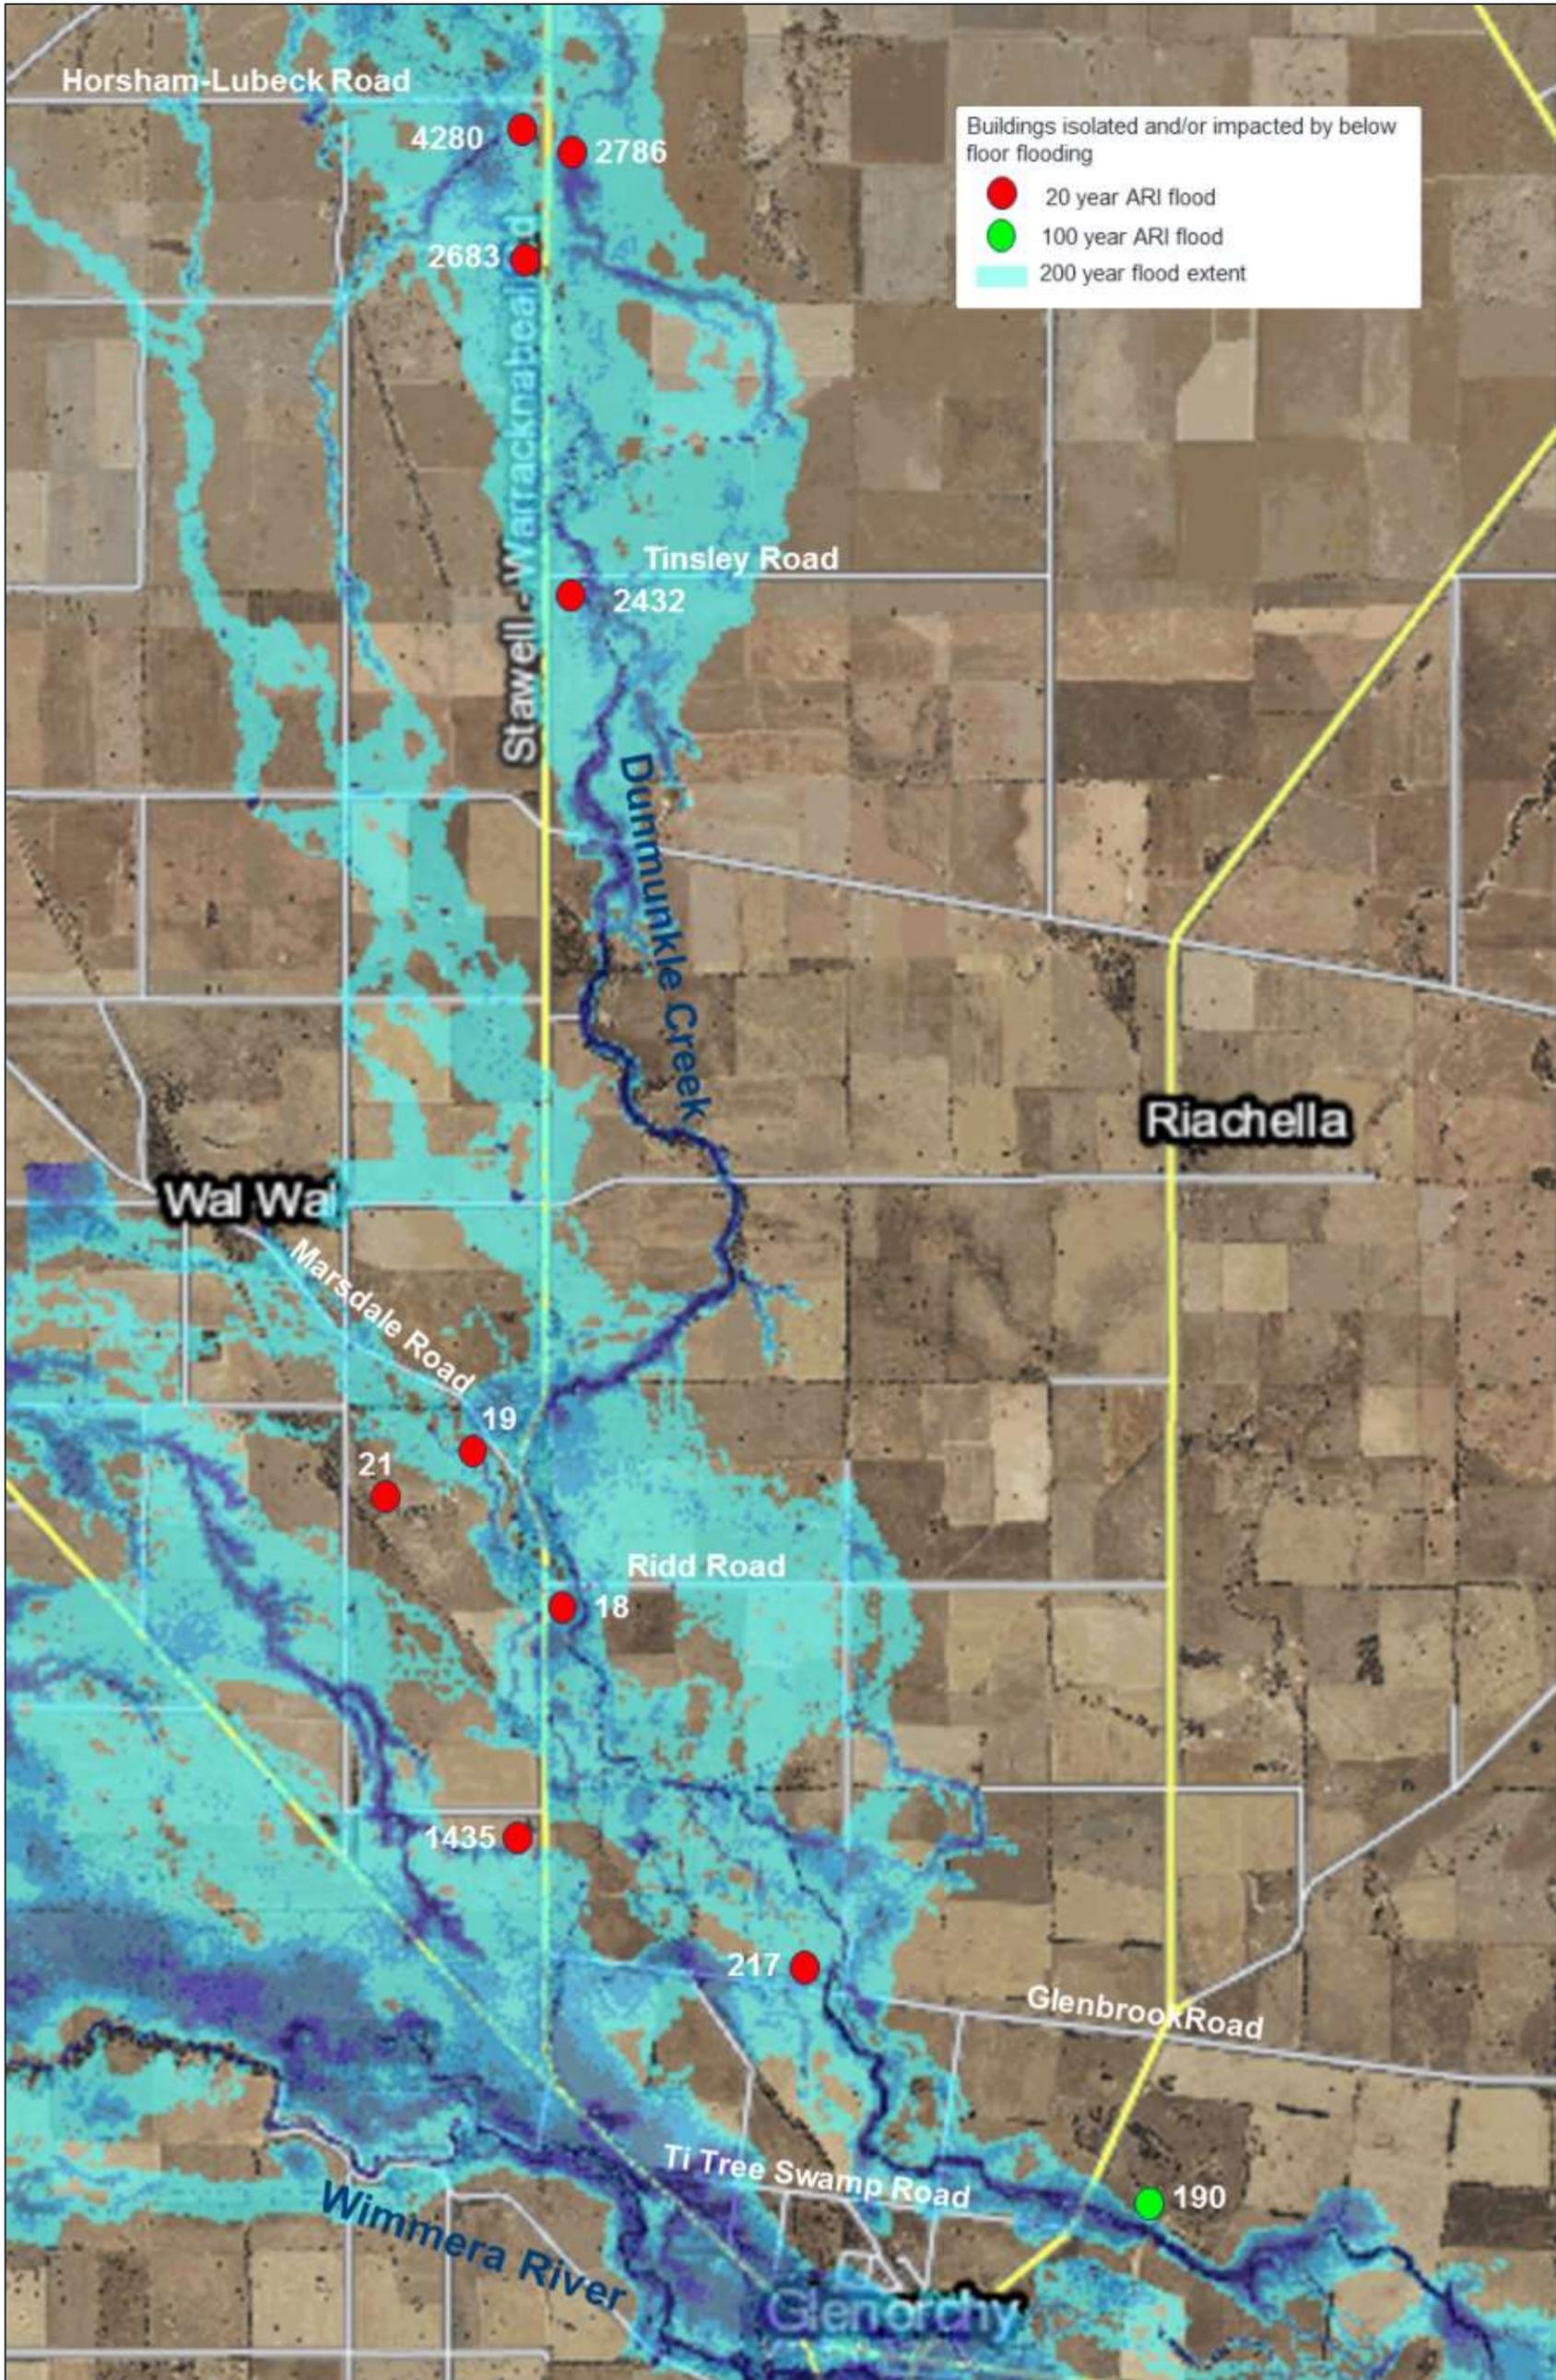
Buildings isolated and/or impacted by below floor flooding along Dunmunkle Creek, north of Glenorchy (Water Technology 2018).

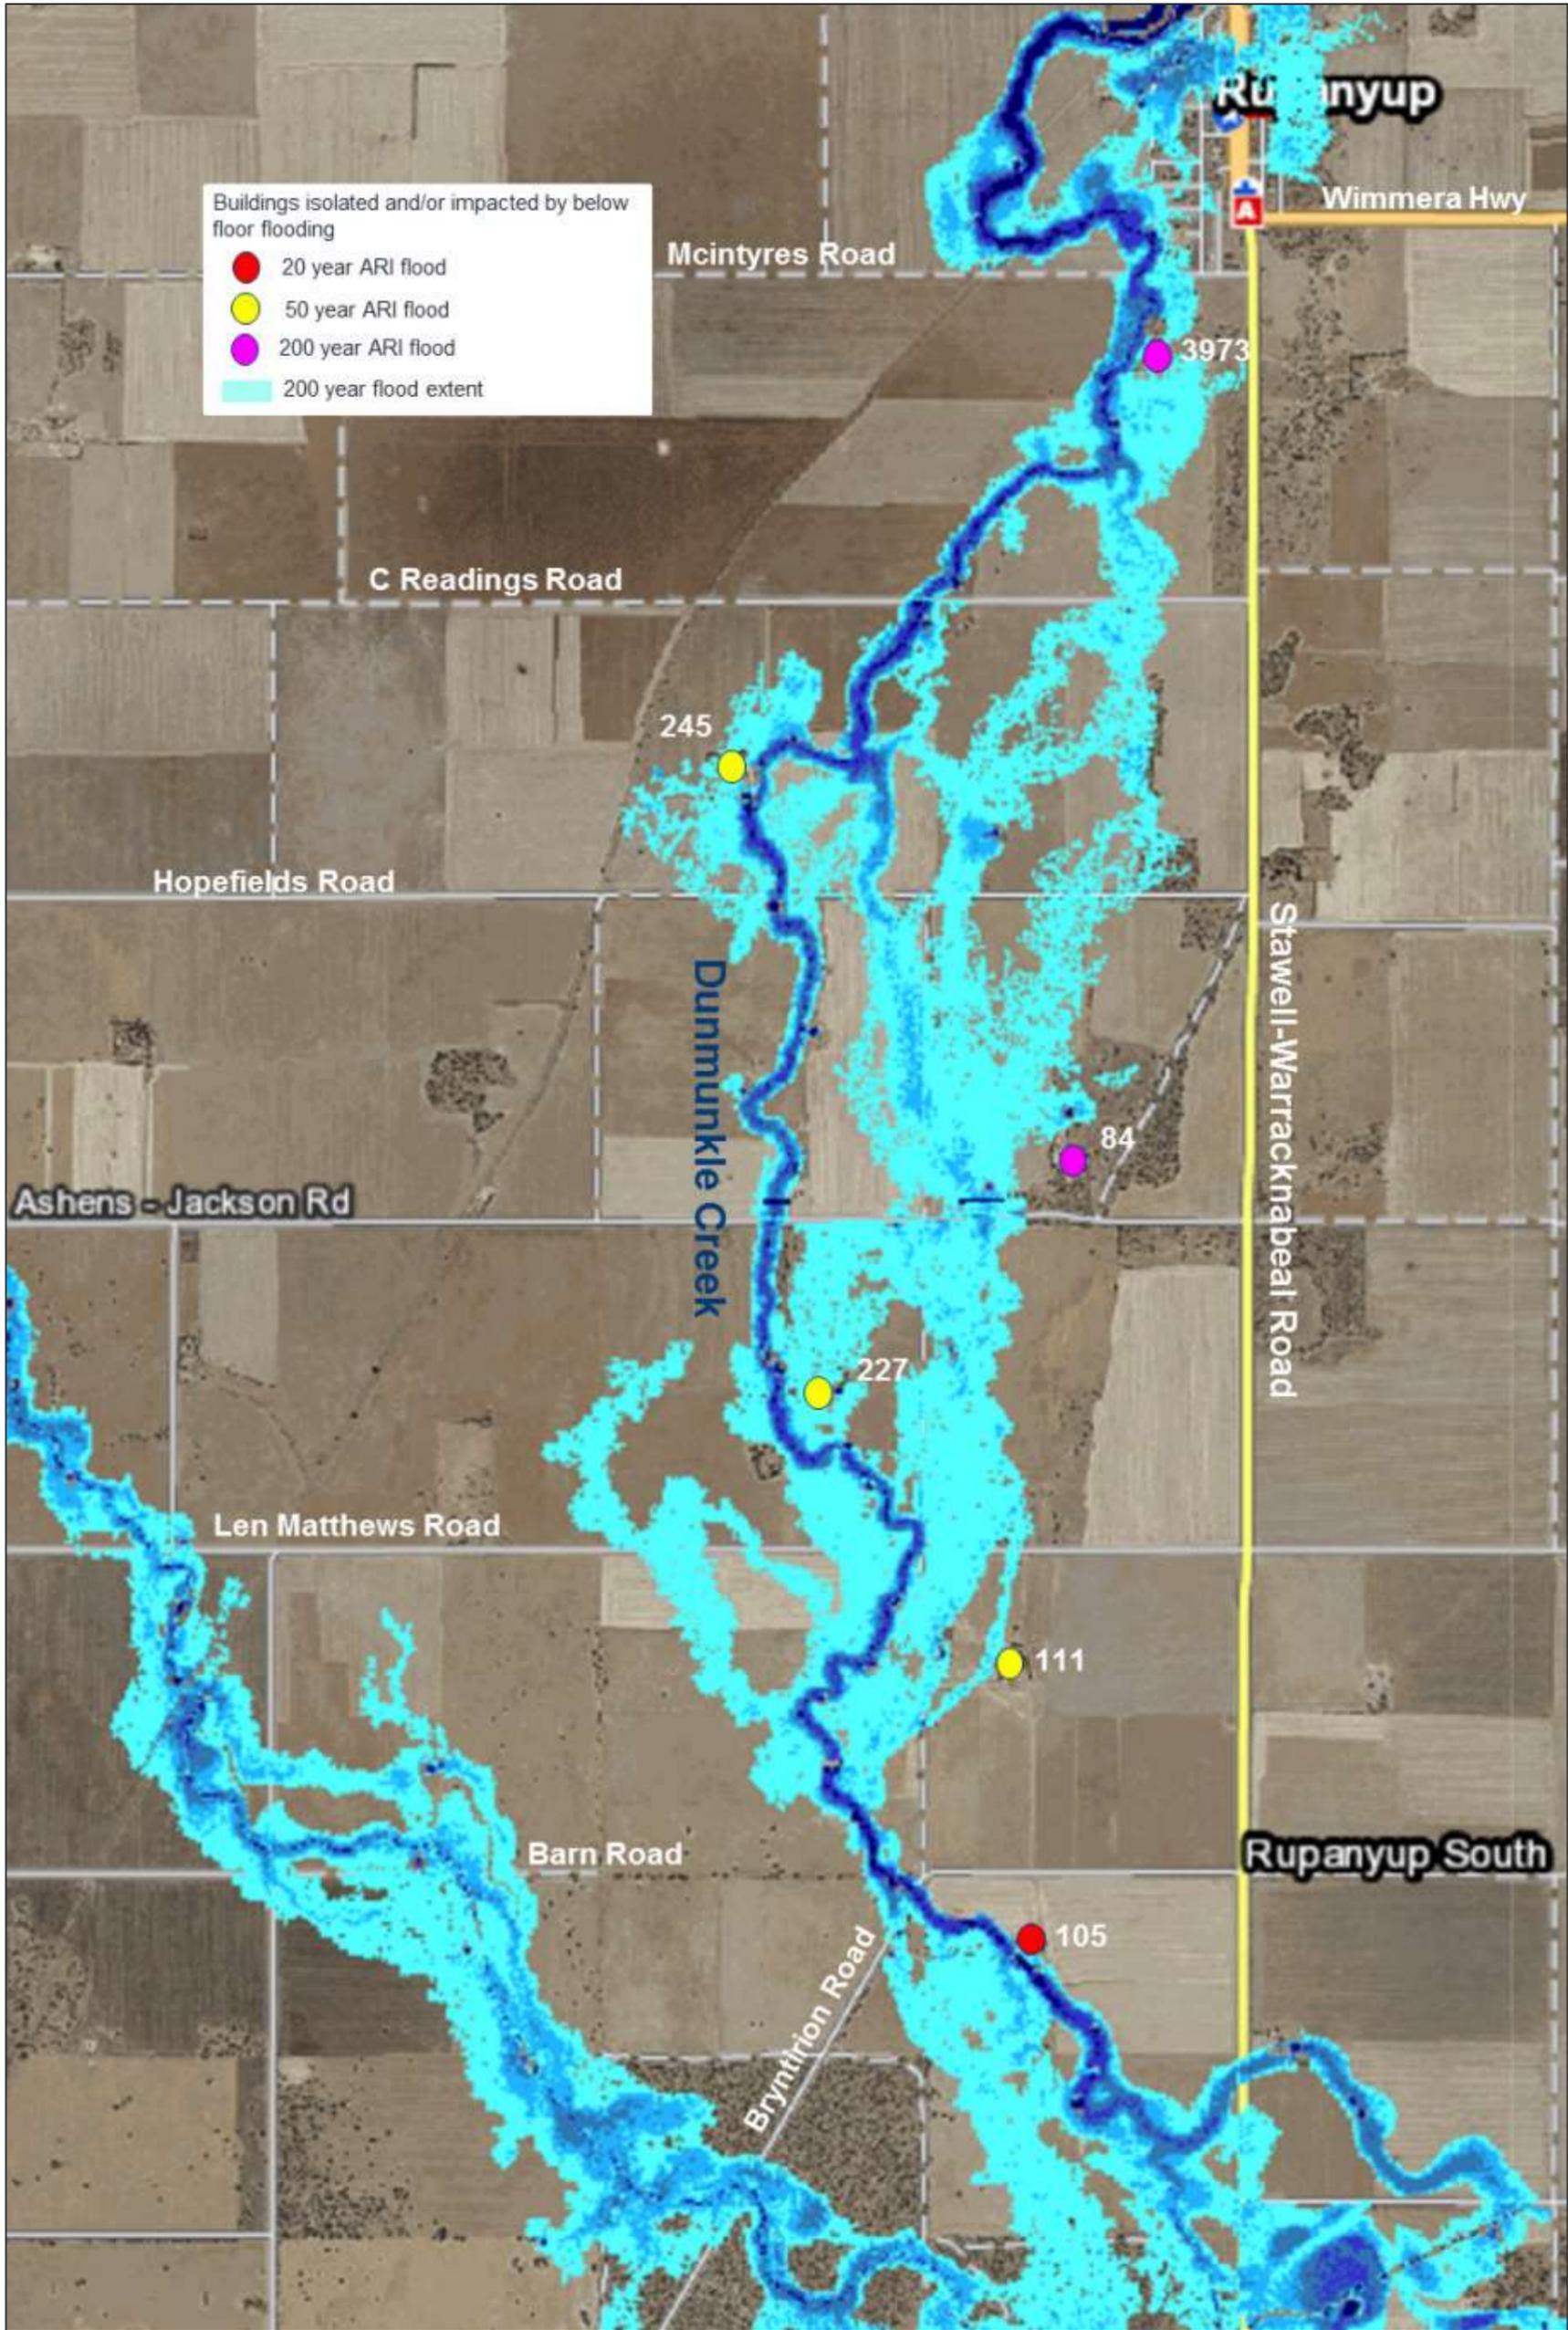
Buildings isolated and/or impacted by below floor flooding along Dunmunkle Creek, south of Rupanyup (Water Technology 2018).

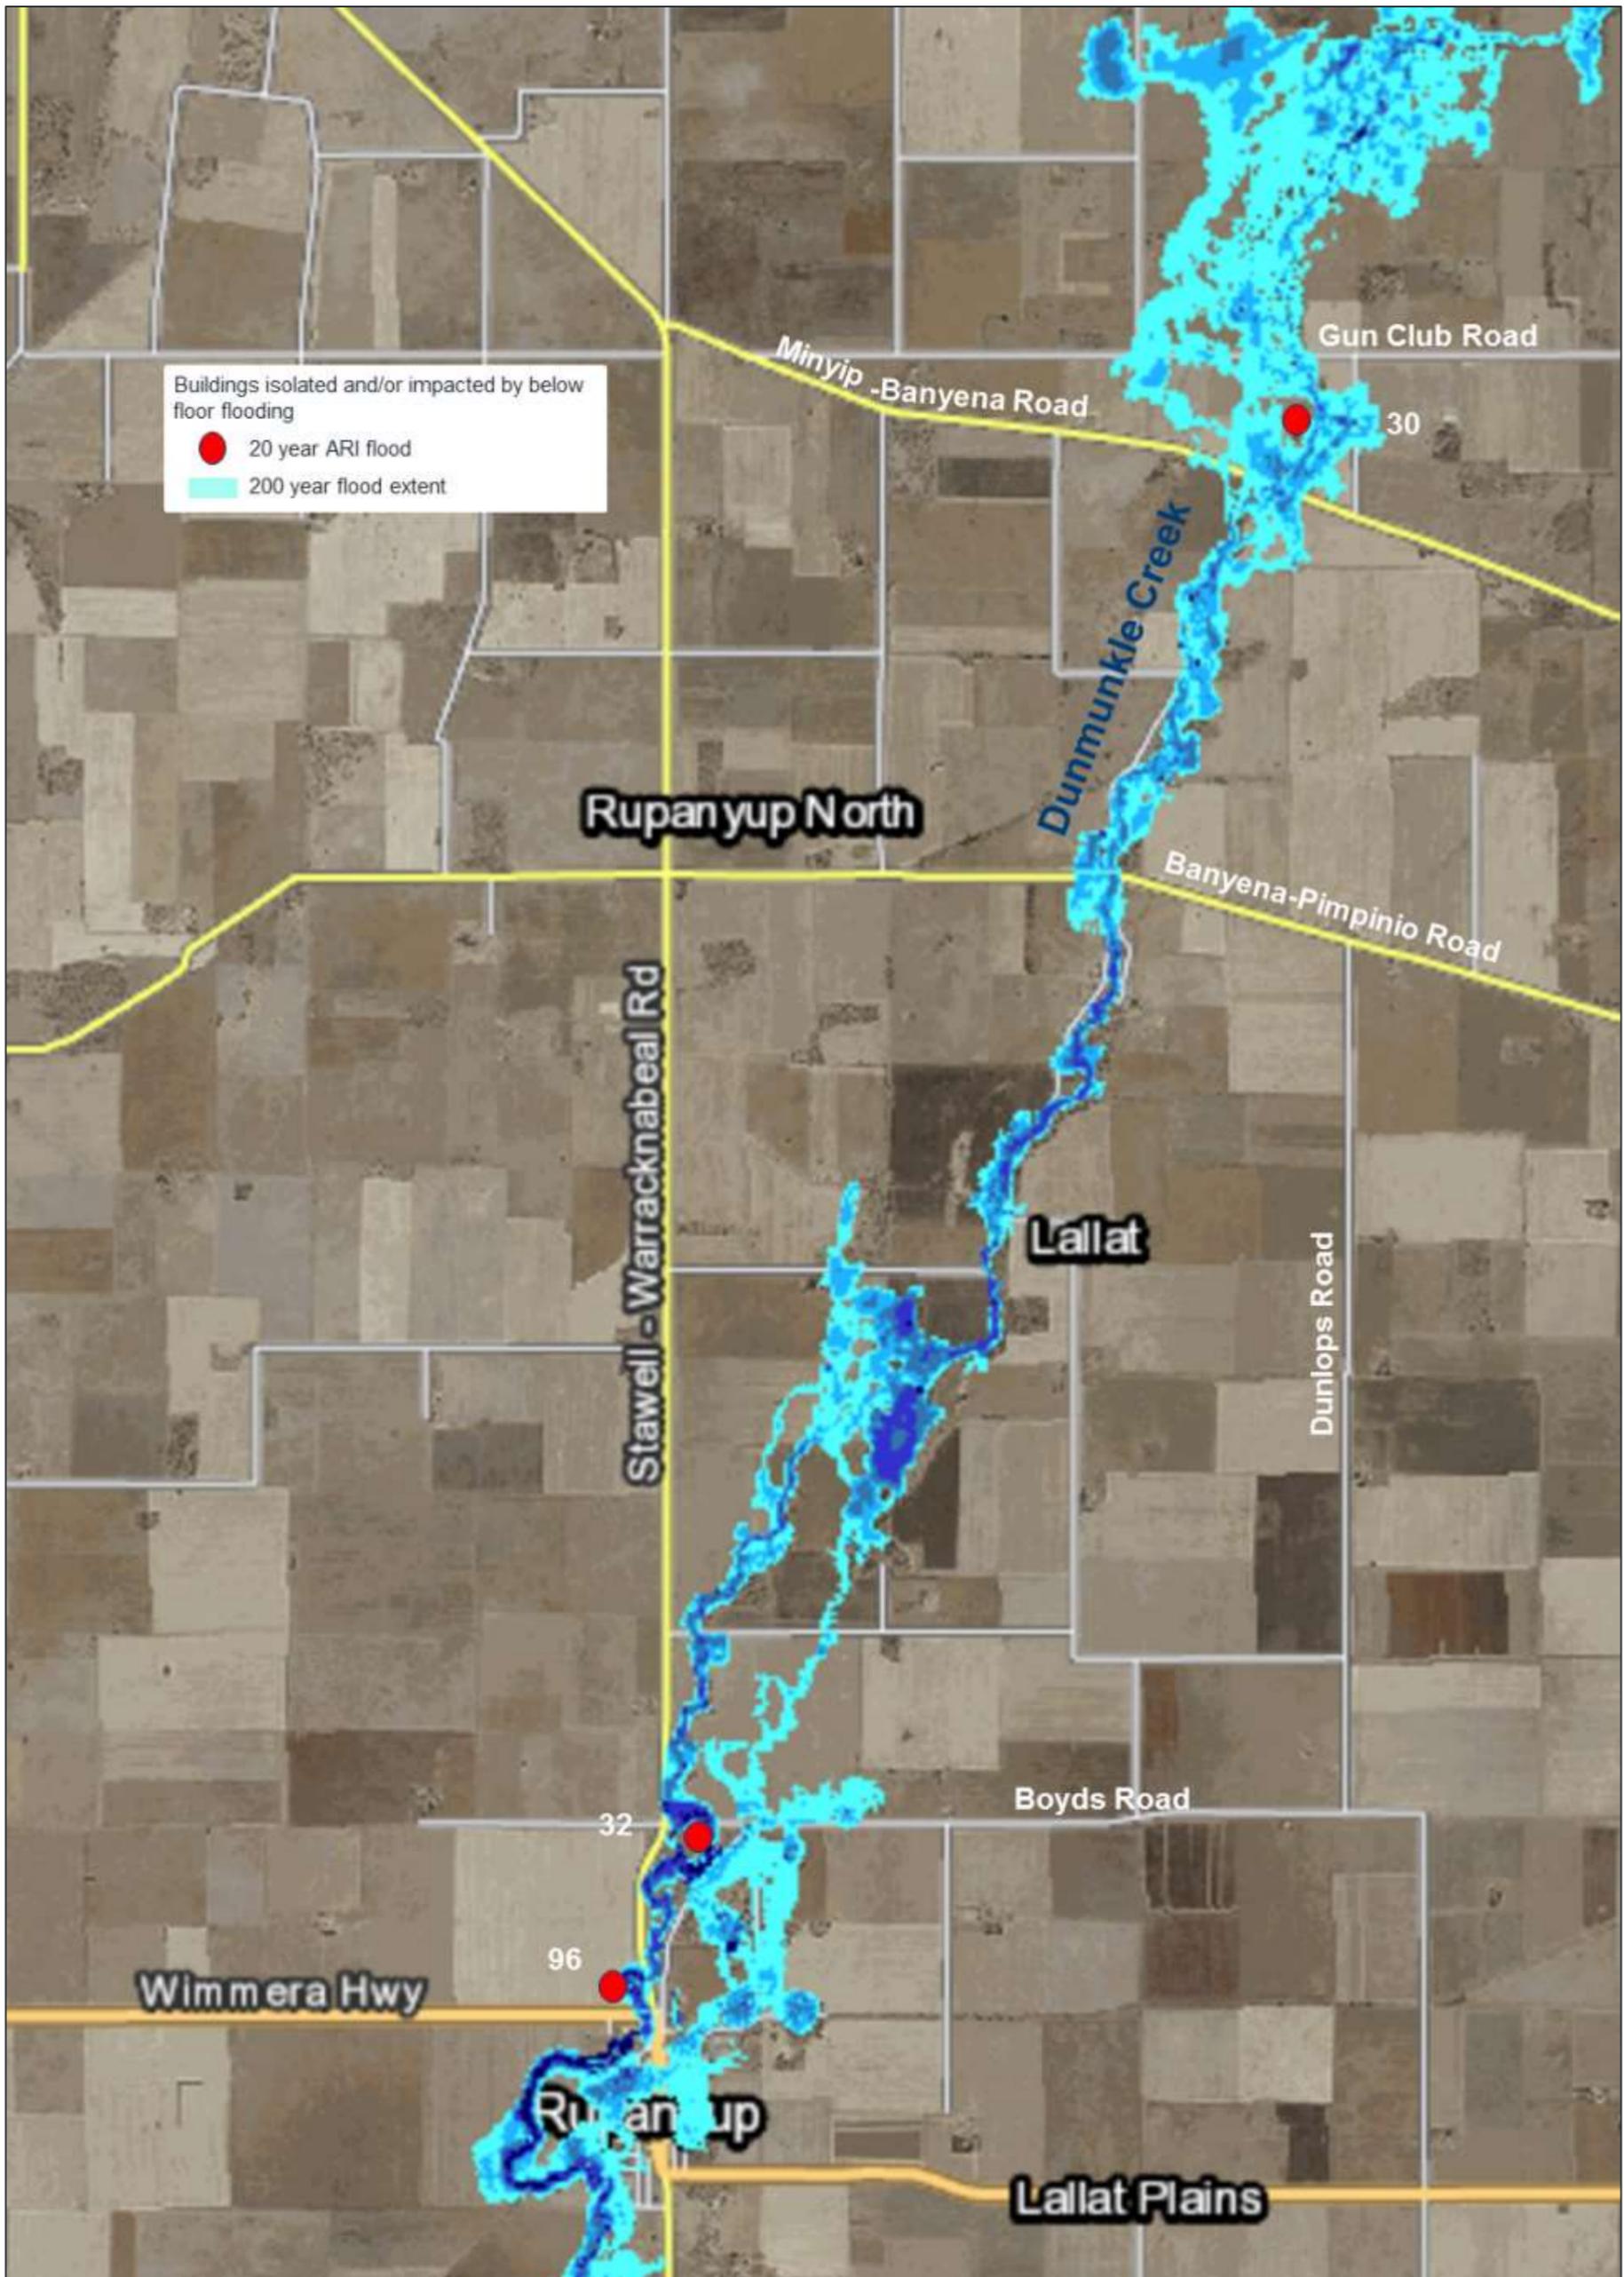
Buildings isolated and/or impacted by below floor flooding along Dunmunkle Creek, north of Rupanyup (Water Technology 2018).

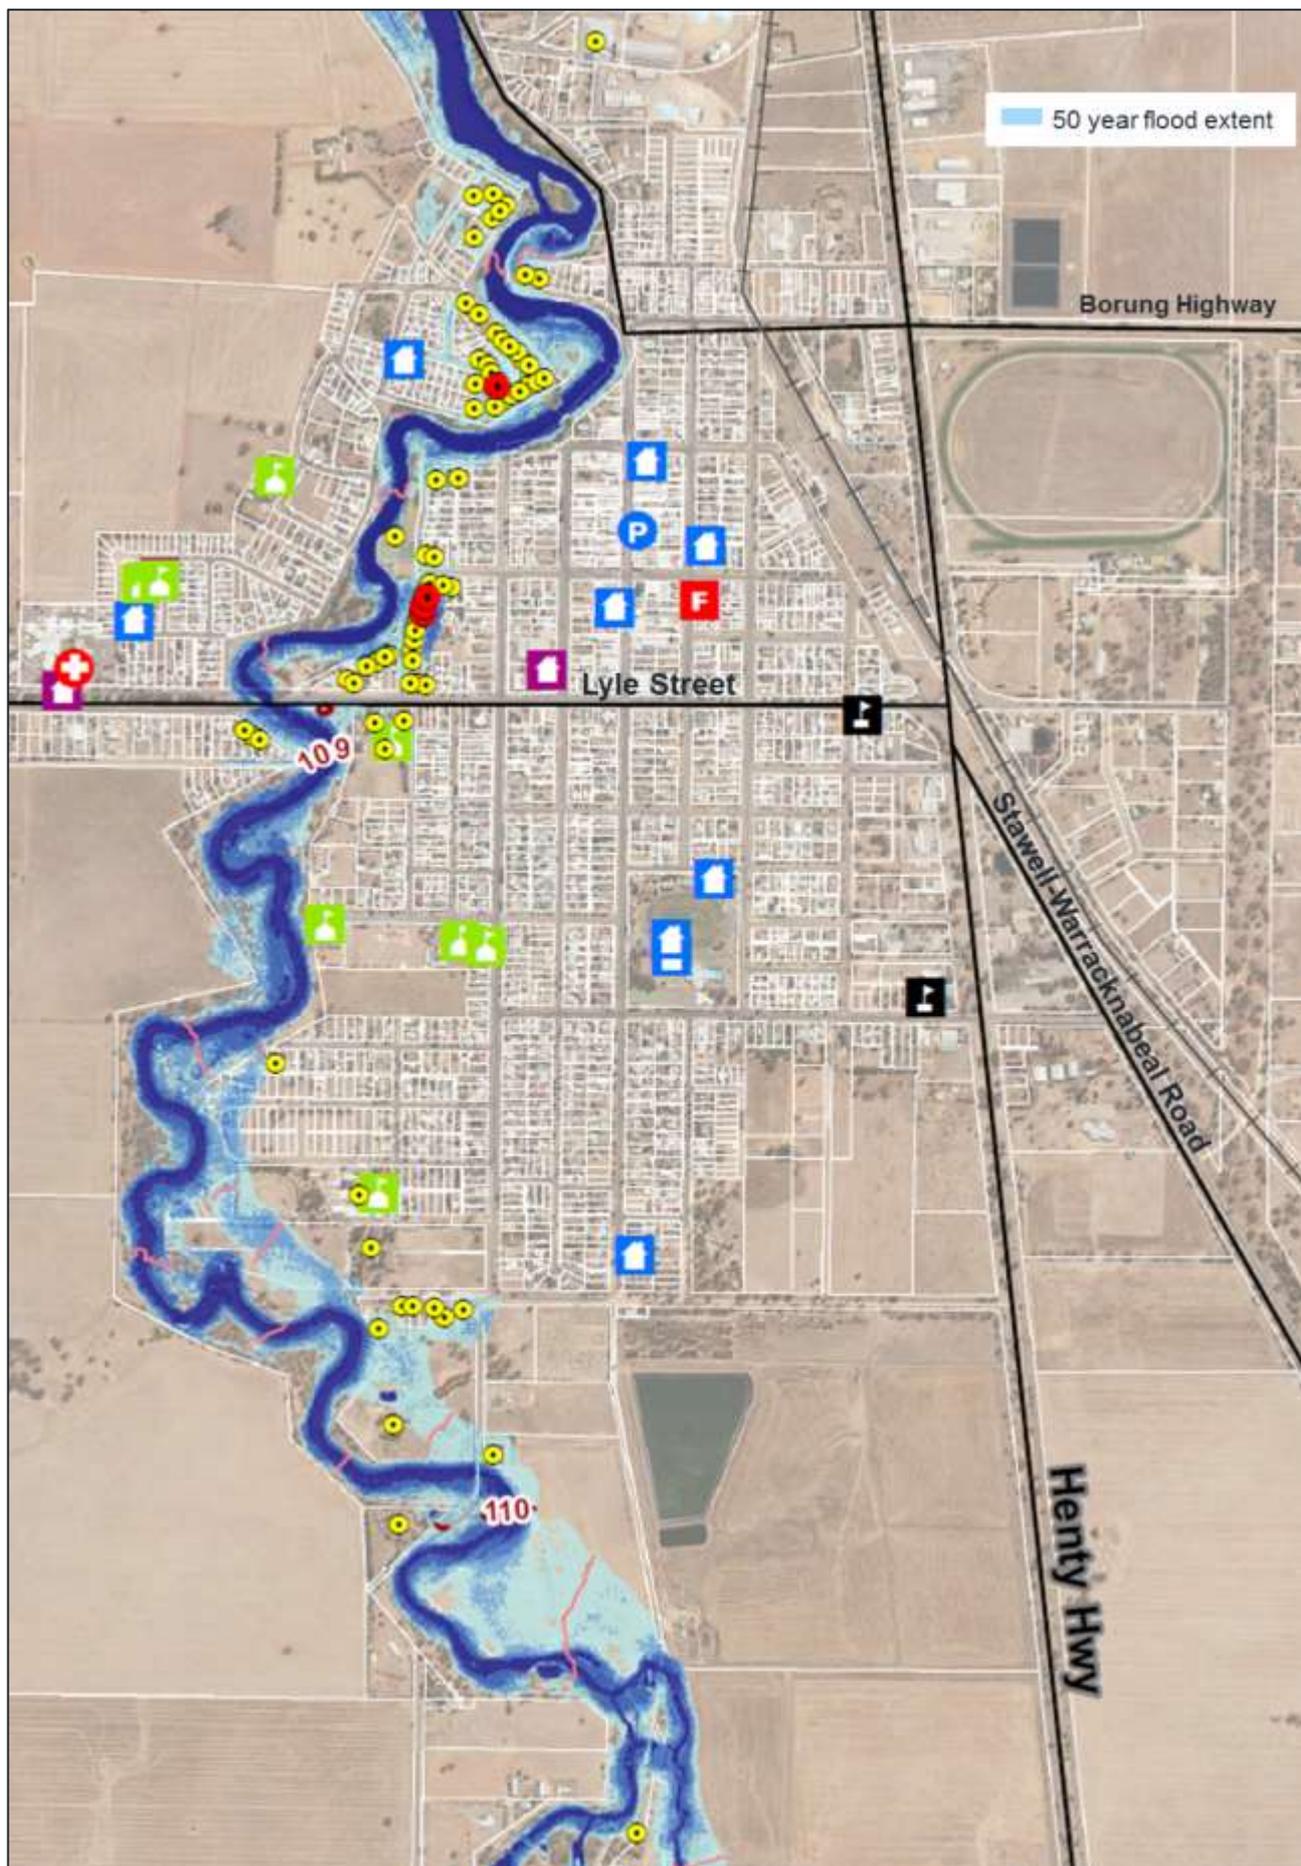
Warracknabeal (Yarriambiack Creek) 200 year ARI flood extent map (Water Technology 2016).
