Yarriambiack Shire Council

FLOOD EMERGENCY PLAN

A Sub-Plan of the Municipal Emergency Management Plan

Version 2, February 2020

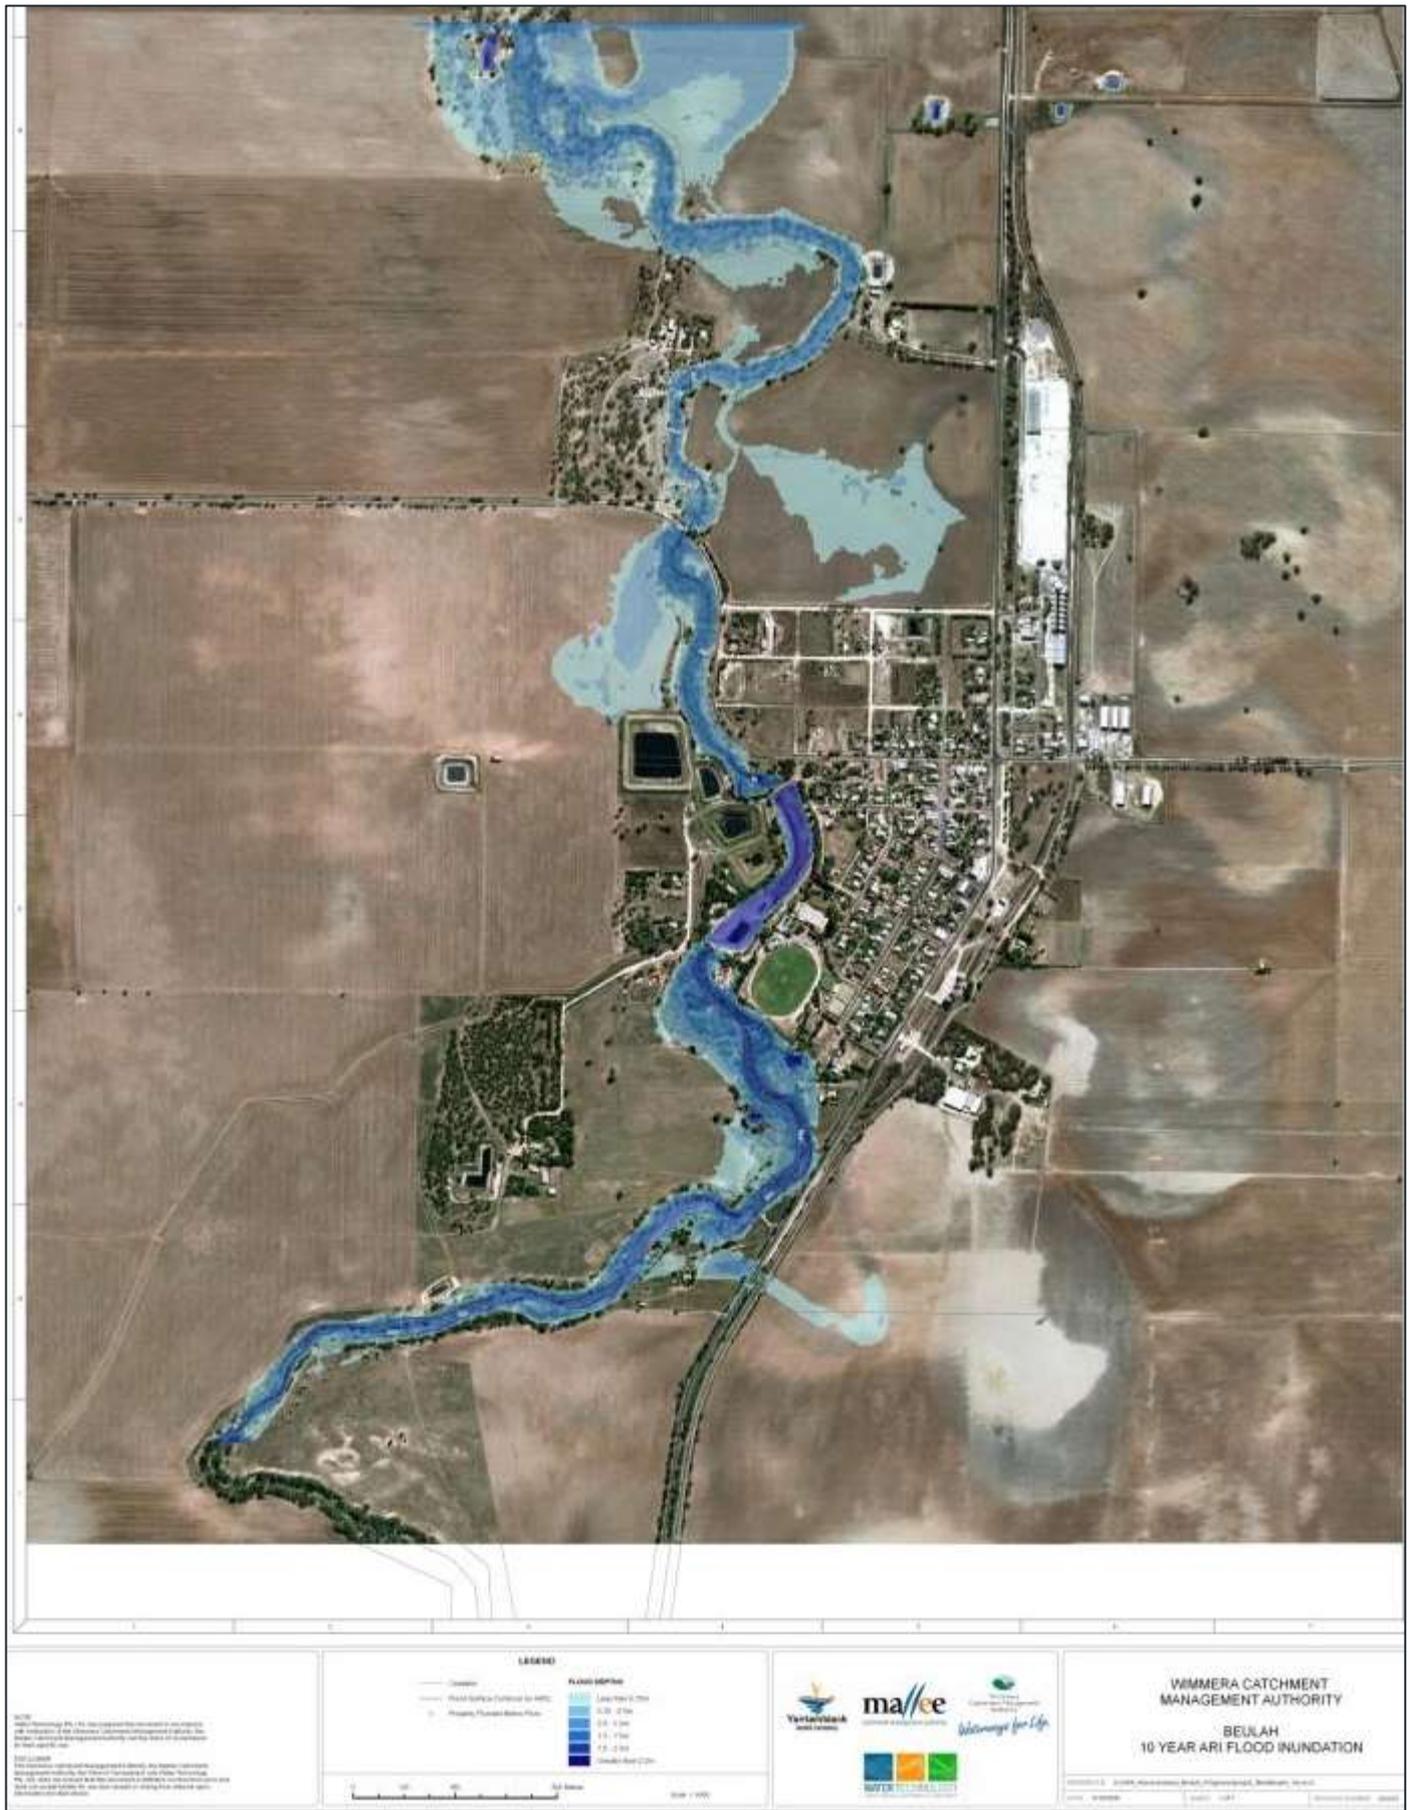
Beulah 20 year ARI flood extent map (Water Technology 2013).

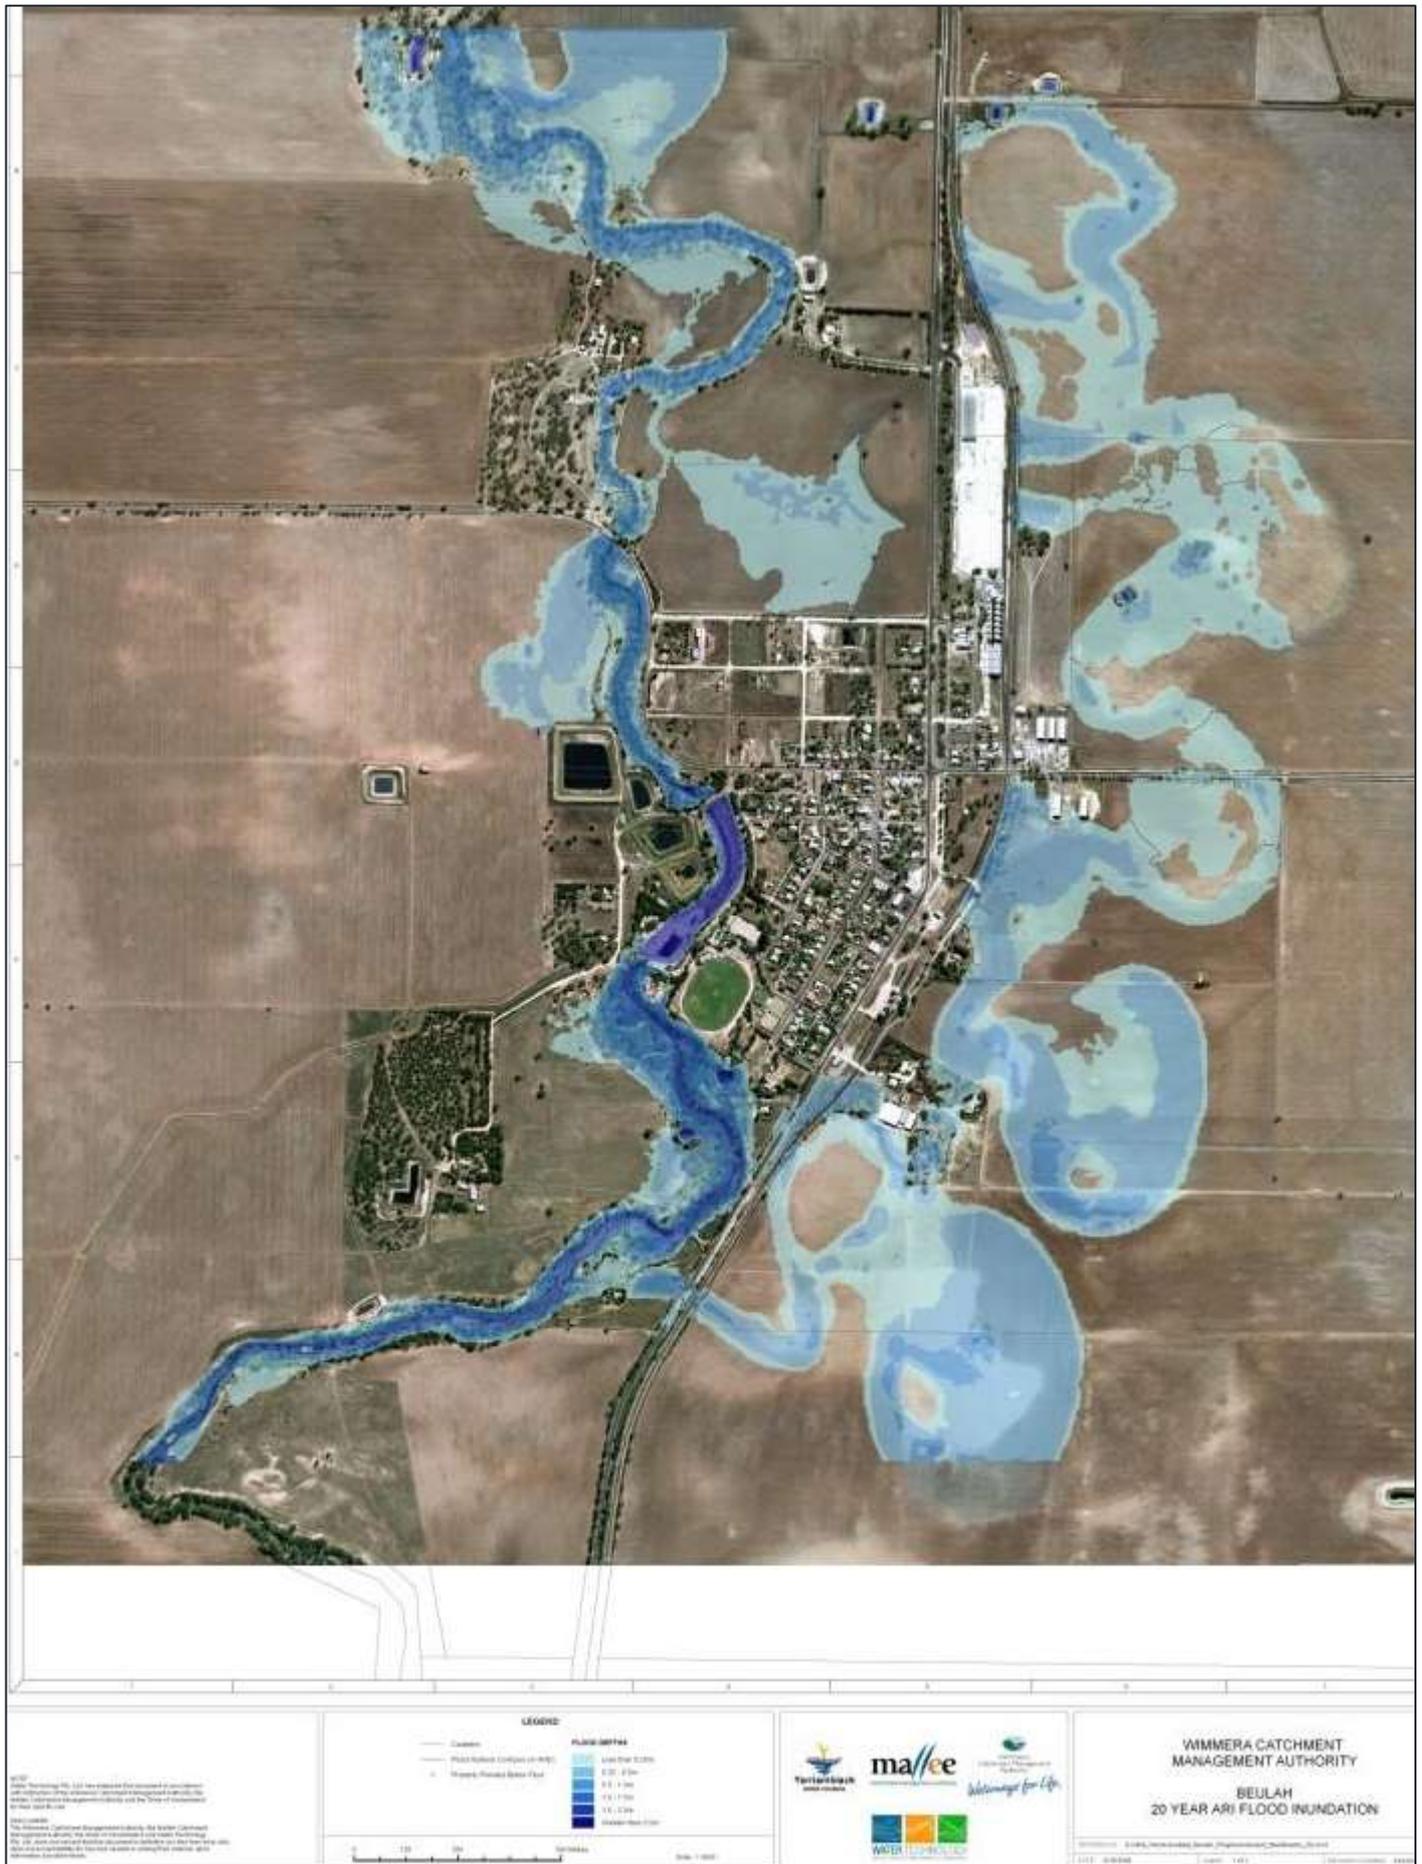
Beulah 200 year ARI flood extent map (Water Technology 2013).
